Airworthiness Directive

| 81-74/2 Schleicher

| Schleicher ASW 19, all models,

| Aileron hinge

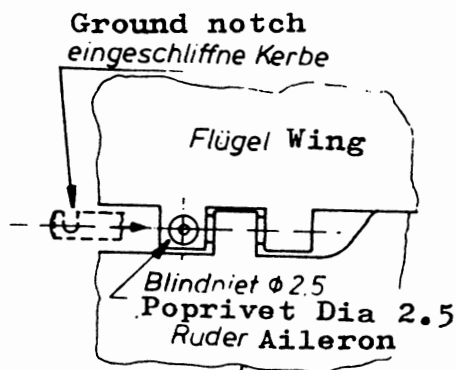
| It may be possible that the aileron hinge shaft
| is not correctly secured.

| Unless already accomplished, check the aileron hinges
| prior to next flight after publication of this AD to
| see, whether the pop rivet securing the aileron hinge
| shaft is in its place (see figure).
| The rivet head can be felt under the adhesive tape.
| If necessary, remove this tape to facilitate checking.
