Kind : LBA Airworthiness Directive AD-Note No. 78 - 303

Subject : Safety measures for inspection hole cover in fuselage.

Effectivity : All ASW 19s, serial numbers 19 001 through 19 232.

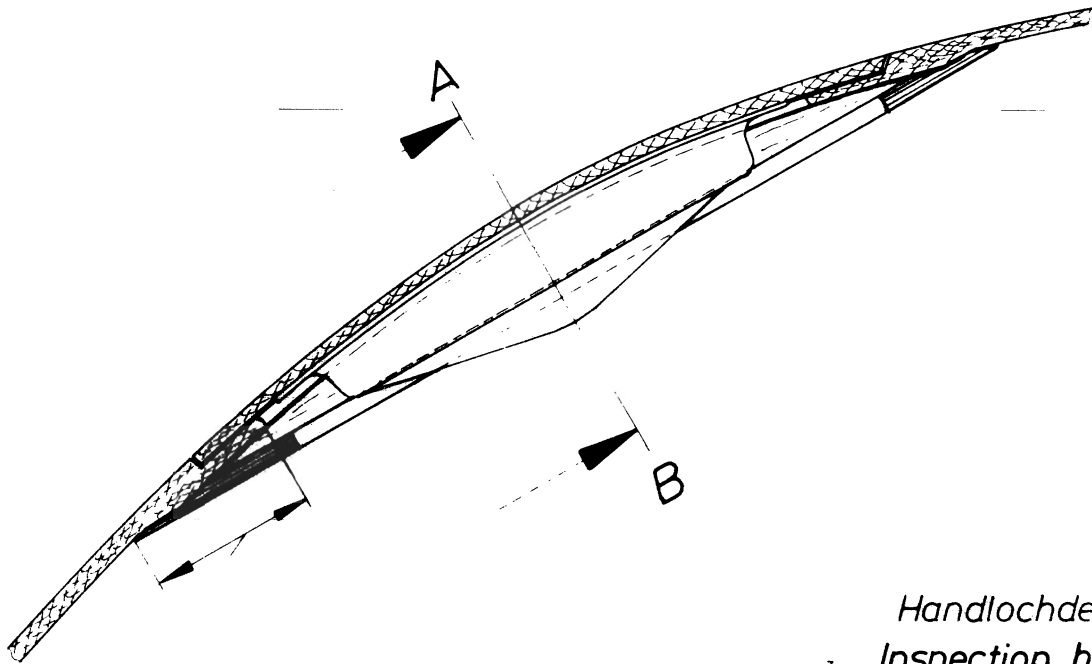
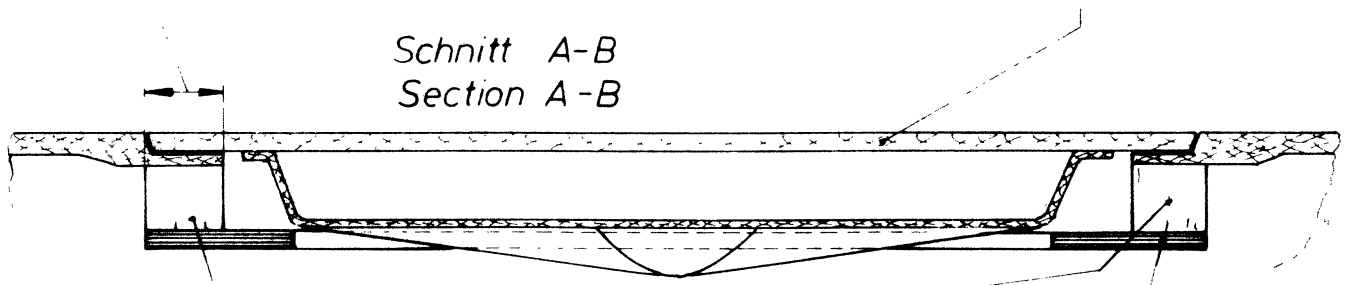
Schnitt A-B
Section A-B

Reason : During a cross country flight with an ASW 20 the inspection hole cover which was not taped was lifted up during a pullup into a strong thermal and was, subsequently, pulled into the fuselage by the attached bungee. There it jammed temporarily the aileron and flap control. The inspection hole of the ASW 19 and ASW 20 being identical, such an incident seems to be possible for the ASW 19, too.

Instructions : TN 7a :
By means of a plywood ring (P/N 190.11.0125) the hole of which is narrower than the smallest width of the inspection hole cover it is prevented that the cover can get into the fuselage.
Prior to glueing in the plywood ring the glue joints must be well fitted and sanded.
A mixture of
100 parts in weight of Epikote 162
38 parts in weight of Epikure 113,
thickened by 10 - 15 parts in weight of Aerosil,
may be used as a glue. However, it may be as well used Aerodux or a two-component glue (like UHU-plus).

For the cover itself or the bungee no modification is necessary. See the drawing on sheet 4 of this TN.

After the installation the plywood ring and the sanded areas around it are preserved by paint or epoxy resin.
