Subject: Continued airworthiness; precautions against elevator flutter.

Affected gliders: All ASW 19 and ASW 19 B; serial numbers 19001 thru 19402 with the exception of 19019 and 19210.

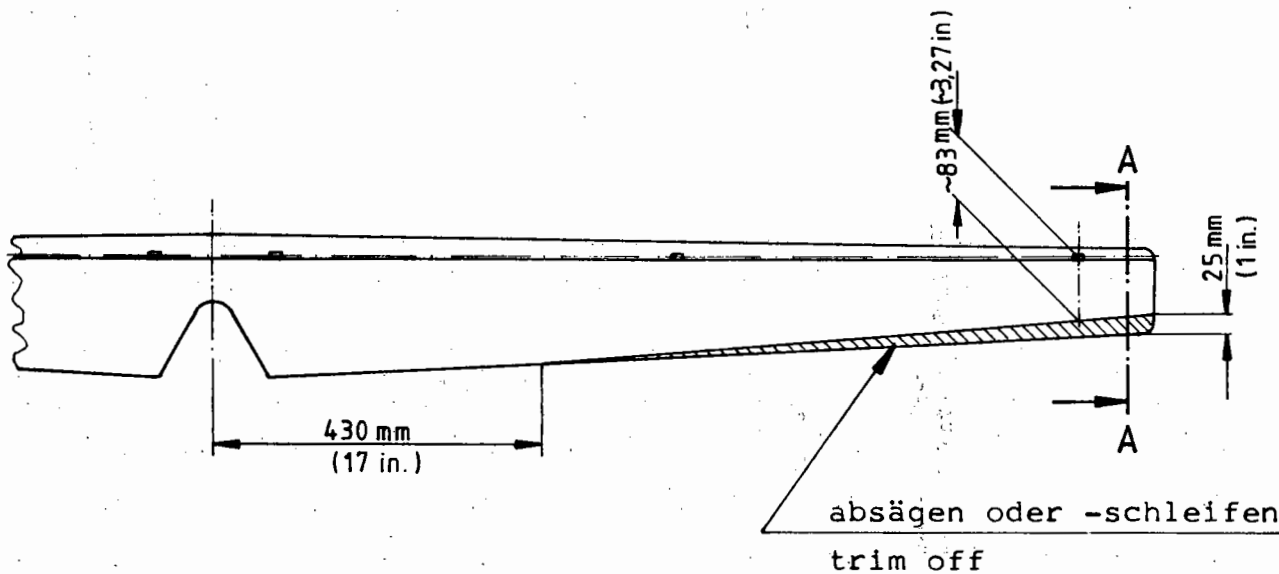
A - A

A further flutter calculation showed that a trimming of the elevator trailing edge mainly in the tip region (see sketch on sheet 4 and also corrected drawing 190.35.S1) removes the possibility of above flutter cases within the approved speed limits, even if the elevator control circuit is weakened or partially damaged.

Verleimung, glue joint

min. 7 mm (0,28 in.)
max. 12 mm (0,47 in.)

Hinterkante verjüngen
reshape trailing edge

alte Kontour
old contour

2. According to the sketch on sheet 4 of this TN, the elevator trailing edge is cut or ground off and reshaped on the lower surface.

The glue joint must be at least 7 mm wide, but no more than 12 mm.

The mass reduction by trimming and reshaping the trailing edge has the same effect as a much heavier mass balance in front of the elevator hingeline. Therefore, it is important to remove as much weight as possible from the trailing edge and to reduce a necessary glue joint to a minimum.
