Subject: Possible incorrect mounting of the tow release cable guiding fittings, resulting in malfunction.

Affected gliders: All ASW 19 and ASW 19 B, serial numbers 19001 thru 19405.

84-15 50 618

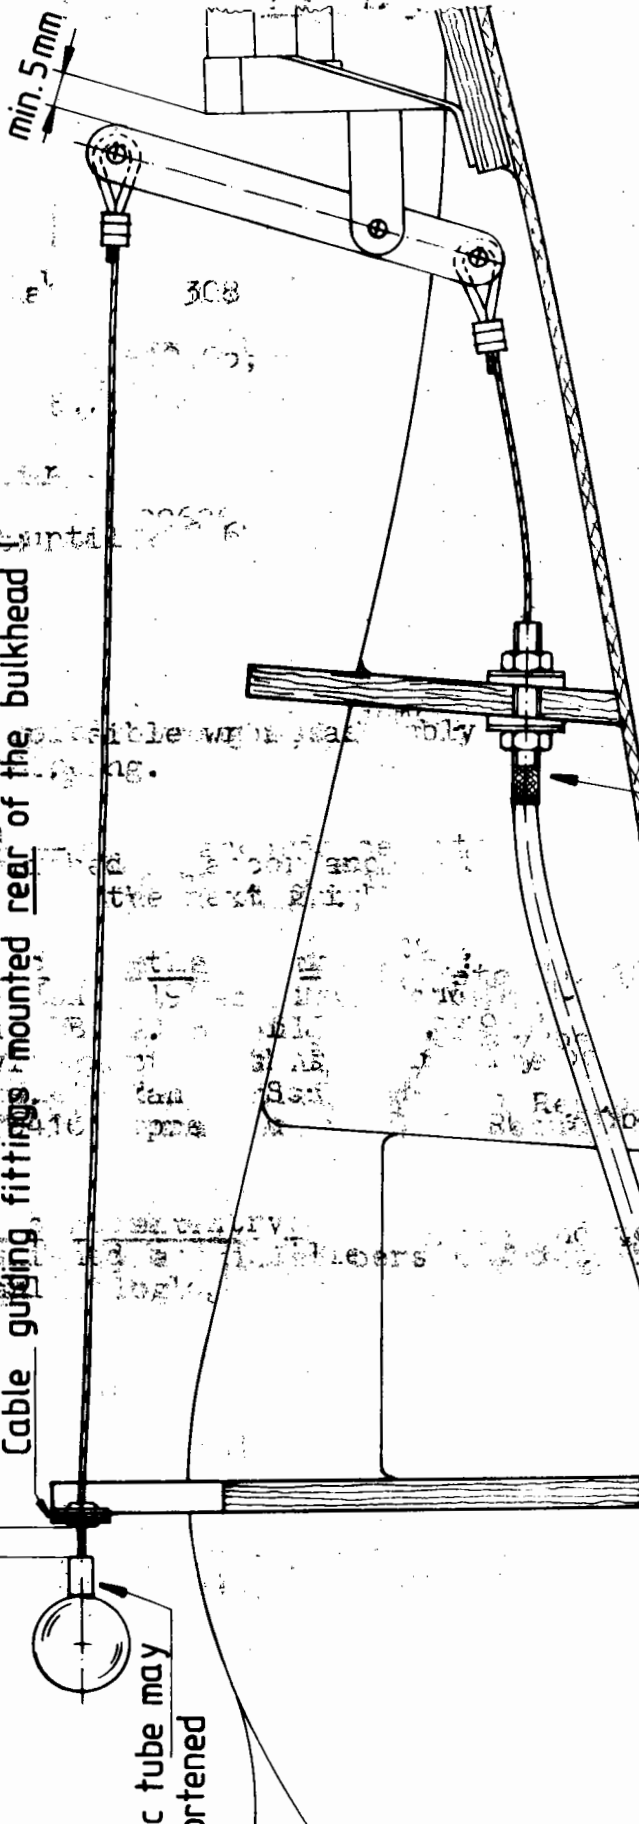
Background: With older ASW 19 and ASW 19 B the cable guiding fittings were mounted in front of the control bulkhead (as shown in Fig.1), while with newer gliders the fittings were mounted as standard rear of the control bulkhead (See Fig.2).

If the cable guiding fittings are mounted in front of the control bulkhead with sufficient neutral travel, the neutral travel disappears in case that the fittings are mounted by mistake rear of the control bulkhead.

Here the neutral travel can be extended by turning in the turnbuckle.

Plastic tube may be shortened

Therefore, all ASW 19 and ASW 19 B must be changed as standard to the mounting of the cable guiding fittings to the rear of the control bulkhead, with sufficient neutral travel (Fig.2).

1. Check whether the cable guiding fittings are mounted in front of the bulkhead (Fig.1) or rear of it (Fig.2).
2. If the fittings are mounted in front of the bulkhead, they must be remounted to the rear !
3. Now you have to check whether sufficient neutral travel is left, as indicated in Fig.2. With too little neutral travel the plastic tube at the ball grip may be shortened accordingly and/or the neutral travel may be extended by turning in the turnbuckle (Fig.2).
