Checking and securing the L'Hotellier quick-close connections of the control circuit

Inspection program for extending service life

Inspection, maintenance and adjustment of the tow hook

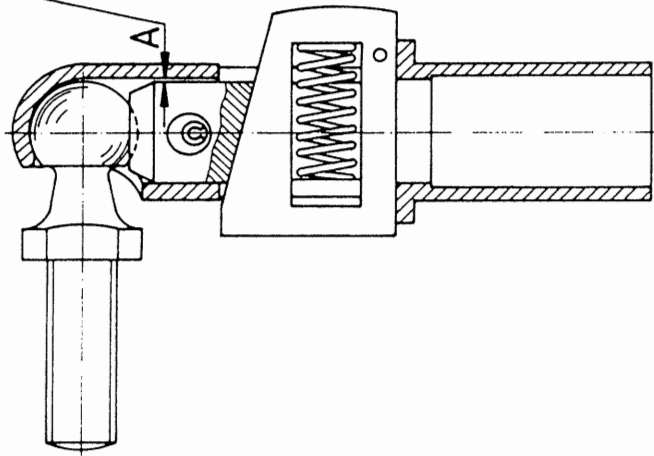
Clearance A must not exceed 0,15 mm (0,006 in);
check by using a wire of 0,15 mm diameter !

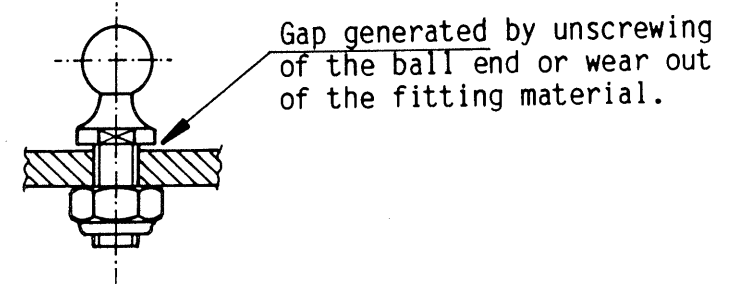
The tight seat of the ball ends inside the fittings must be checked, as loose ball ends may be broken due to bending loads in the thread area.

Gap generated by unscrewing of the ball end or wear out of the fitting material.

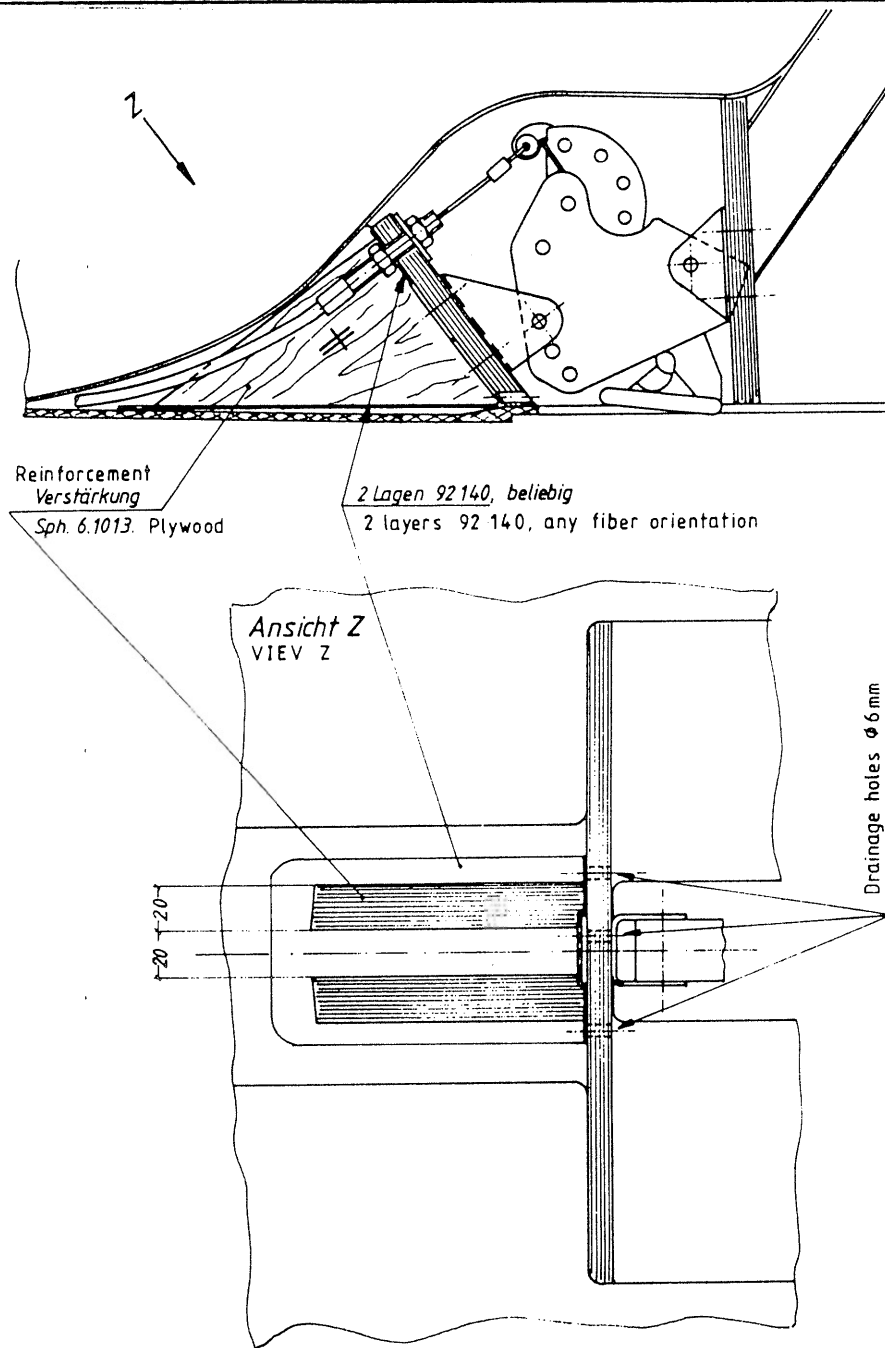
- a) The modification to the double ring pair (large ring oval) makes it possible for the second ring (which is now larger) to touch the structure surrounding the tow hook and, if the cable is twisted, it can then cause the automatic mechanism to unlatch.

The solution here is to relieve the structure which surrounds the tow hook (this material is a mudguard only). The seam which supports the landing gear doors, can also be shortened to about 5 mm (0,2 in) in front of the tow hook.
