Airworthiness Directive

| 81-74/2 Schleicher

| Schleicher ASW 19, all models,

Aileron hinge

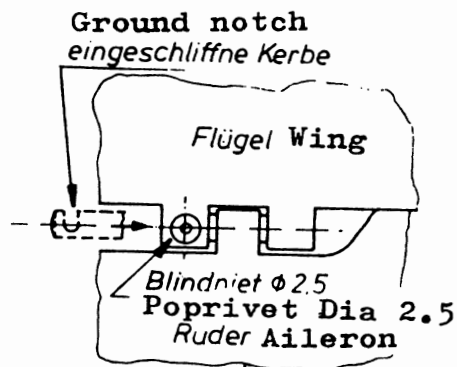
It may be possible that the aileron hinge shaft
is not correctly secured.

Unless already accomplished, check the aileron hinges
prior to next flight after publication of this AD to
see, whether the pop rivet securing the aileron hinge
shaft is in its place (see figure).
The rivet head can be felt under the adhesive tape.
If necessary, remove this tape to facilitate checking.
