Kind : LBA Airworthiness Directive AD-Note no. 78 -

Subject : Safety measures for inspection hole cover in fuselage.

Effectivity : All ASW 20_s. serial numbers 20 001 through 20113, except 20111.

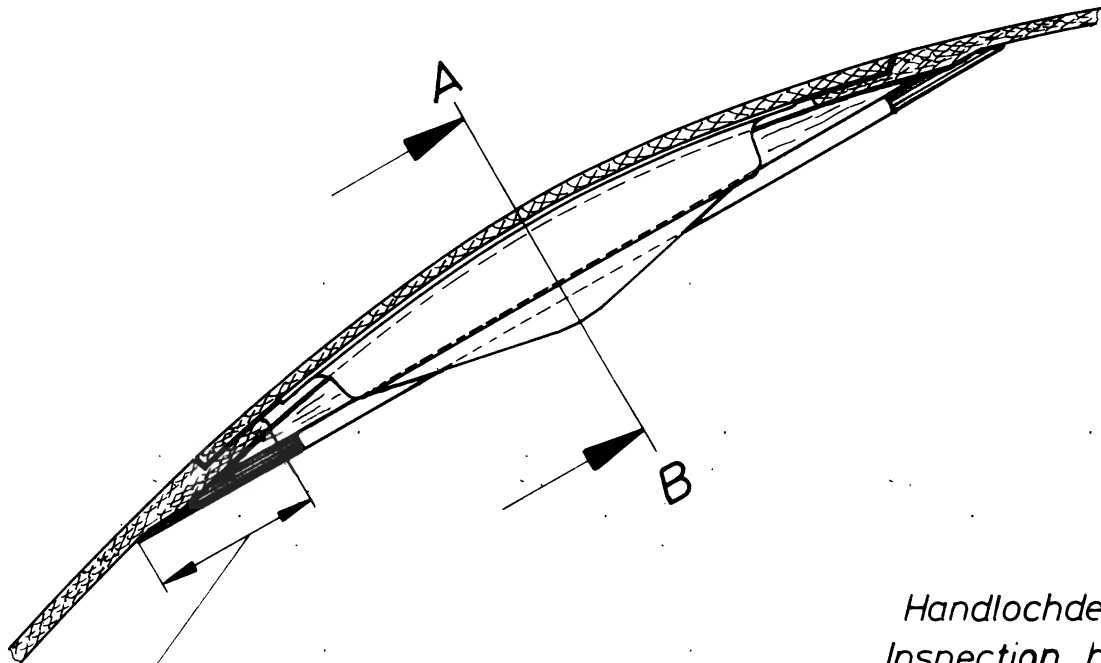
Reason : During a cross country flight with an ASW 20 the inspection hole cover which was not taped was lifted up during a pullup into a strong thermal and was, subsequently, pulled into the fuselage by the attached bungee. There it jammed temporarily the aileron and flap control.

Instructions :
TN 4a :
By means of a plywood ring shield (P/N 200.11.0127) the hole of which is narrower than the smallest width of the inspection hole cover it is prevented that the cover can get into the fuselage.

For the cover itself or the bungee no modification is necessary.
See drawing on sheet 4 of this TN.

Prior to glueing in the plywood ring all the glue joints must be well fitted and sanded.
A mixture of
100 parts in weight of Epikote 162
38 parts in weight of Epikure 113,
thickened by 10 - 15 parts in weight of Aerosil,
may be used as a glue. However, it may be as well used Aerodux or a two-component epoxy glue (like UHU-plus)

After the installation the plywood ring shield and the sanded areas around it are preserved by paint or epoxy resin.
