Subject : Inspection of aileron weight and aileron c.g. and inspection of play (backlash) in aileron and flap control circuits to avoid flutter risk.

Effectivity : Glider model ASW 20, s/n 20 001 thru 20077 and 20 086.

ASW 20
Technical Note
No.12

Alexander Schleicher
Segelflugzeugbau
6416 Poppenhausen

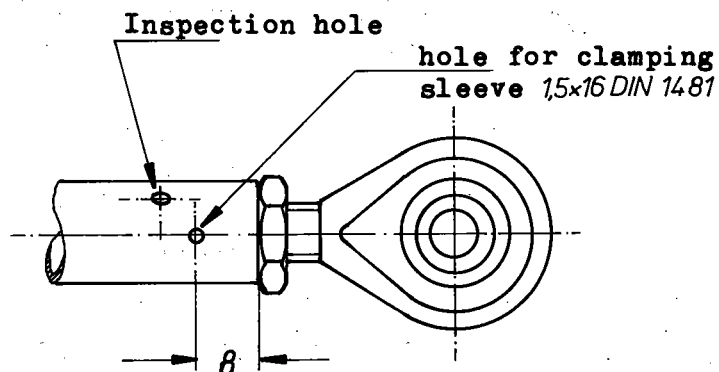
4. Please check if the lever at the mixer is at the end of the track when the flap handle is locked in position 1 (-11°).
If the handle can be pushed past the hole of position 1, one of the spheric ball joints of the flap pushrod, which is found on the left cockpit wall, must be turned in to shorten the pushrod. This must be done until the flap handle can just be locked in position 1 as the end of the track in the mixer is now touched.
After adjustment both spheric ball joints must be safetied by 1,5mm clamping sleeves against being turned out (in addition to the nuts).

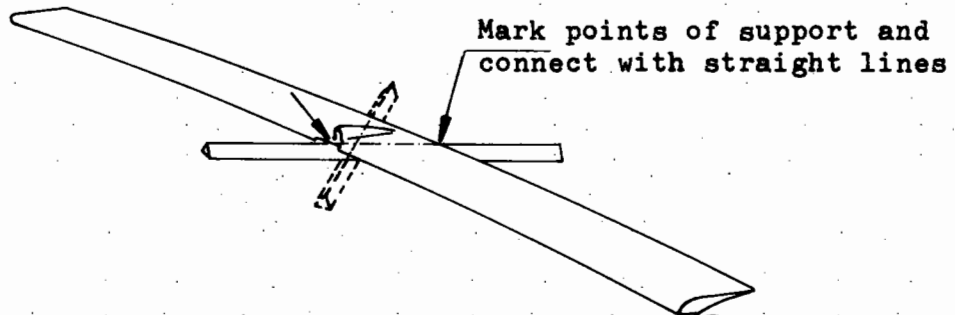
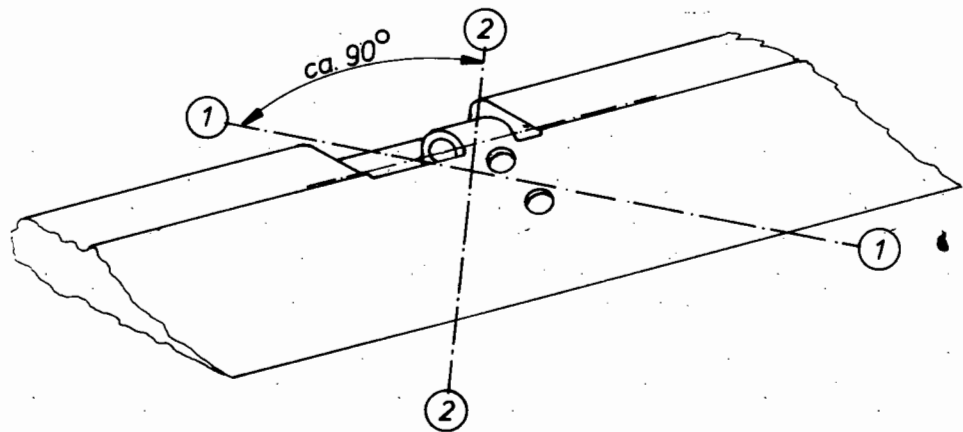
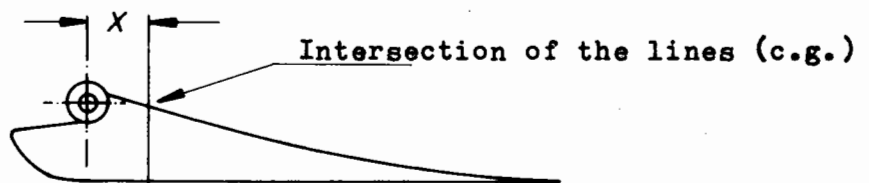
Determination of tailheavy moment of controls by balancing on a cutting edge done twice (triangular strip)

The connecting lines of the points of support ① - ① and ② - ② intersect in the c.g.

X = Distance from the c.g. to the center of the hingeline.

Weight (kg) · X (cm) = Moment (cmkg)

Diverging from the sketch in the Manuals the c.g. of the ailerons is balanced according to the sketch on sheet 5 of this Technical Note. The weight of the aileron (if fittings have been removed, without their 0.07 kg) as determined multiplied by the distance from the c.g. to the hingeline is the tailheavy moment of the aileron. If the actuator fitting was removed, 0.15cmkg must be added. This total moment must not be greater than tolerated by the Manuals.
