Preventive actions against flutter caused by special conditions of operation

Inspection program for extending service life1. General information

Checking and securing the L'Hotellier quick-close connections of the control circuit

#### Inspection, maintenance and adjustment of the tow hook

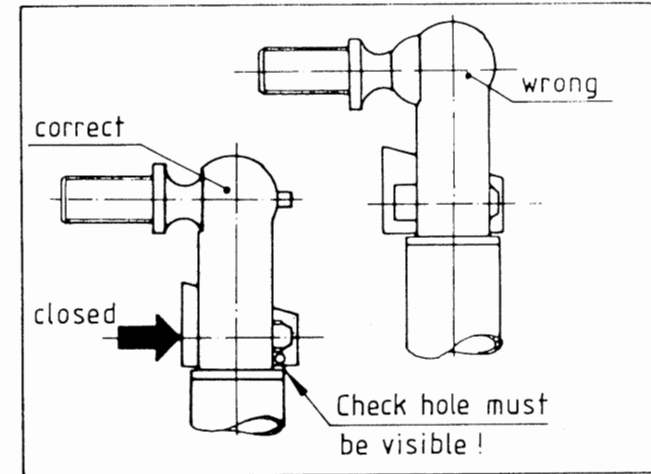
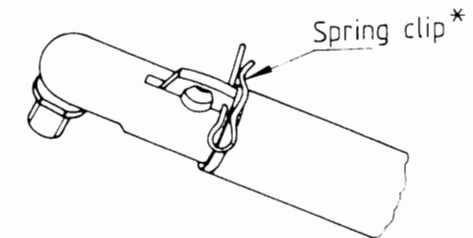
The experience of the past shows that mostly the connection of the elevator was incorrectly fitted or even worse simply was forgotten. A sticker on the fin serves to remind the pilot of the correct connection; in addition the securing by means of a spring pin is recommended.

To do this on older ASW 20 gliders the check hole must be drilled to 1,2 mm in diameter.

Aileron, flap and airbrake connections in the fuselage can be safetied by the same method.

\*Spring pin no.50030771 can be ordered from Alexander Schleicher or from A.Würth, P.O.Box 1261, 7118 Künzelsau, F.R.Germany.

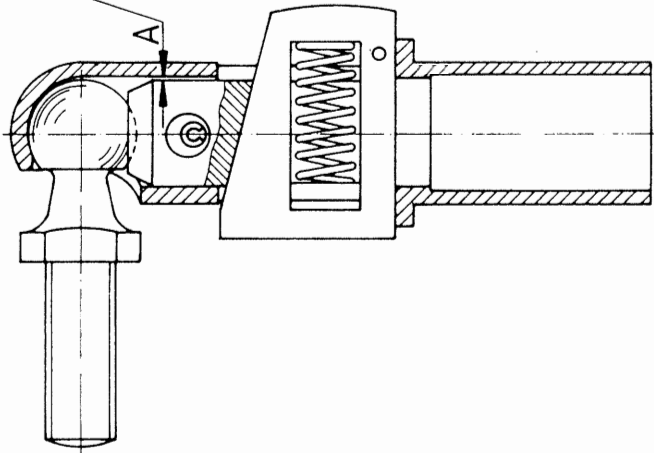
Clearance A must not exceed 0,15 mm (0,006 in);  
check by using a wire of 0,15 mm diameter !

Bad wedging effect causing wear of the ball end.

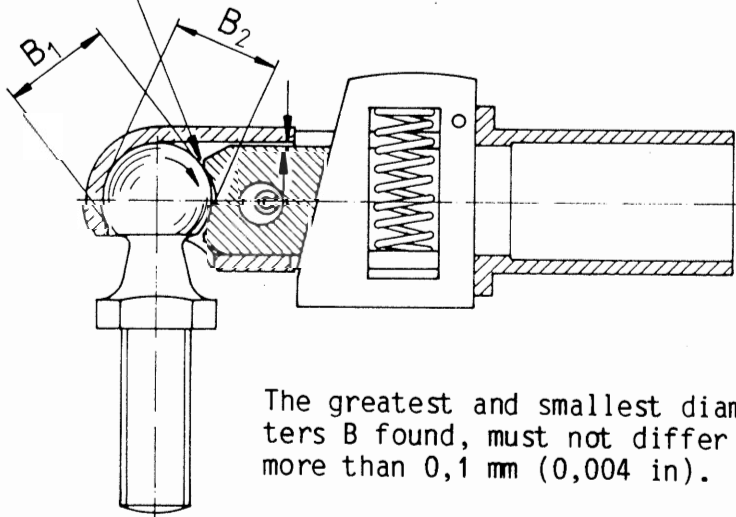
The greatest and smallest diameters B found, must not differ by more than 0,1 mm (0,004 in).

The tight seat of the ball ends inside the fittings must be checked, as loose ball ends may be broken due to bending loads in the thread area.

Gap generated by unscrewing of the ball end or wear out of the fitting material.

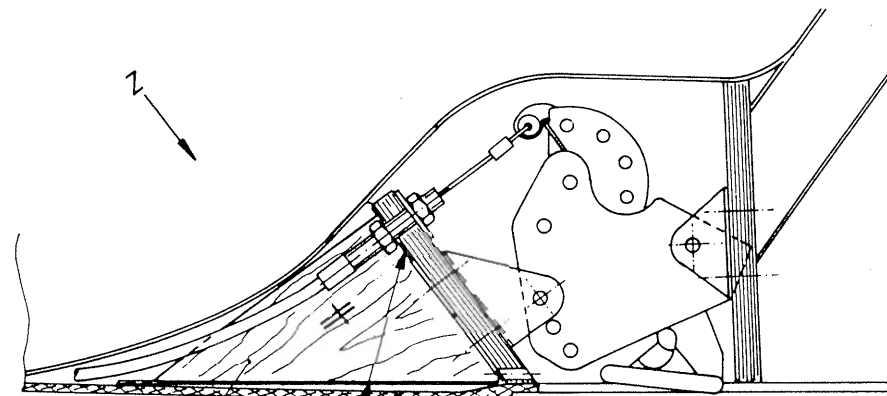
A successful reinforcement to the forward tow hook bulkhead of the C.G. tow hook has proved to be two wedge-shaped plywood blocks (see sketch on page 40h). Two layers of glass cloth 92140 are laid over the joint surfaces of the blocks, with random fiber orientation, and resined together.

Reinforcement  
Verstärkung  
Sph. 6.1013. Plywood

2 Lagen 92 140, beliebig  
2 layers 92 140, any fiber orientation

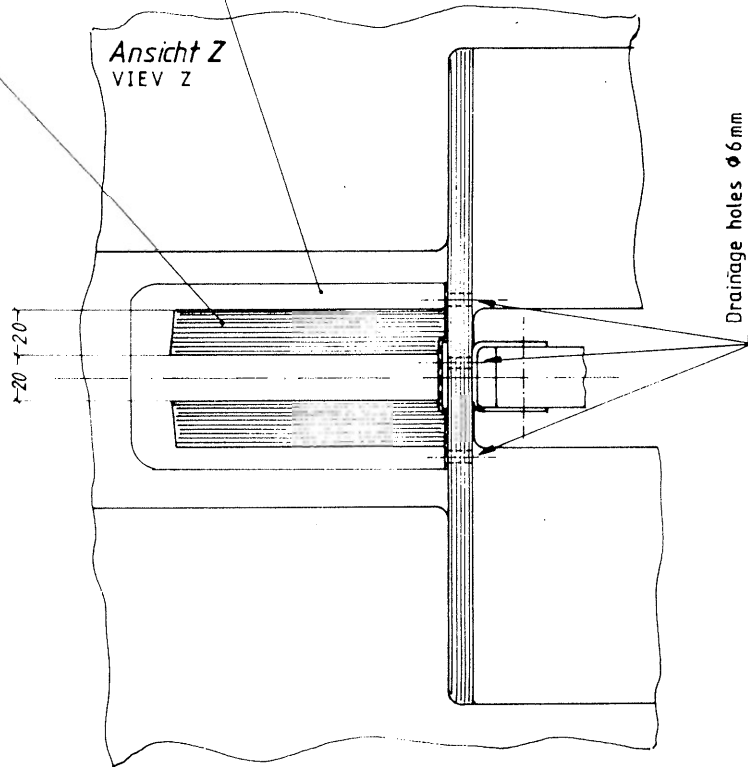
Do not forget to preserve the water drainage holes !

Drainage holes  $\phi$  6 mm

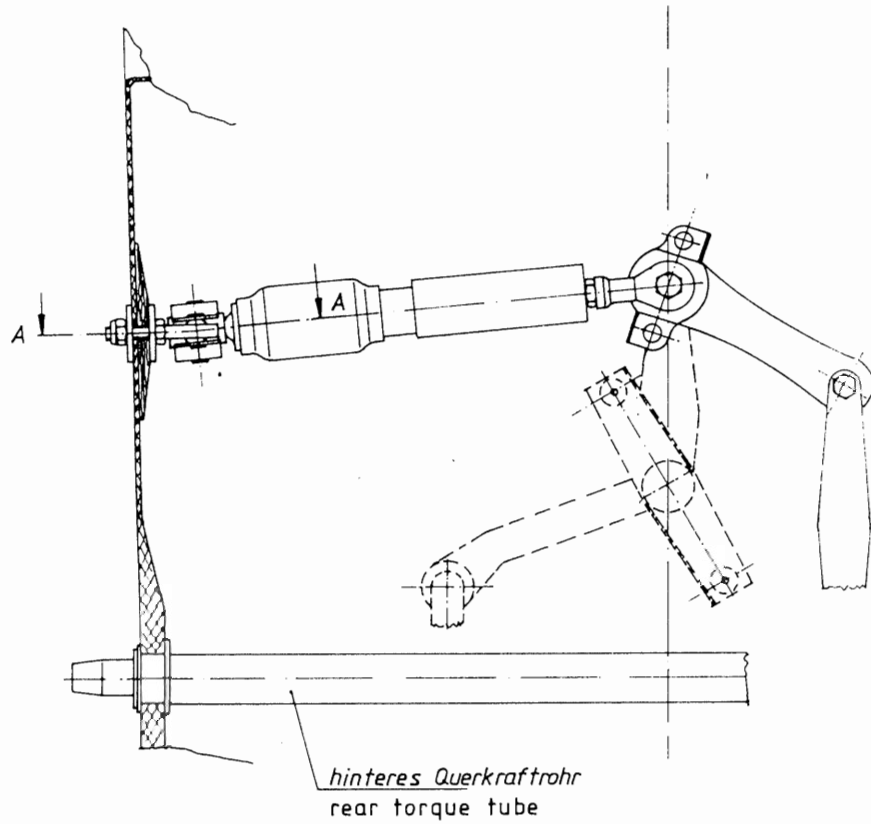
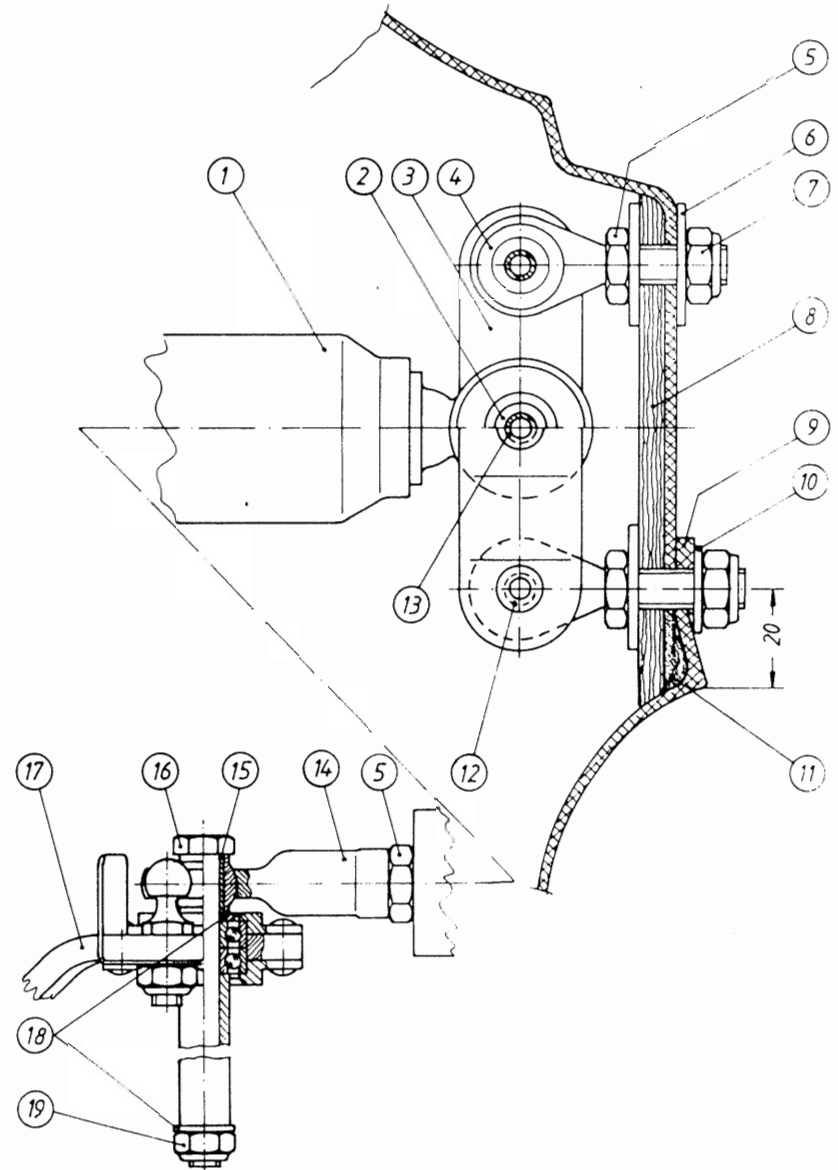
Under operational conditions as detailed on page 17a of the Flight Manual, the installation of a hydraulic damper into the aileron control circuit is strongly recommended. In countries with desert climate where above mentioned conditions may occur several times a year, Schleicher recommends the general installation of this damper.

In the sketches on pages 40n thru 40r the installation of the damper is shown. For proper connection to the aileron control circuit a longer bolt M 6 must be used. For every installation use new self-securing nuts n M6 DIN 980/6 or N M8 DIN 980/6. The plywood ground plate is permanently glued into the wingroot rib (fuselage-side) and well preserved. The cutouts for the pushrods are not prefabricated, as they must be fitted individually for each glider.

After the installation of the damper it is most important to check the aileron control system for free movement in a special test.
