Subject: Preventive measure against unintentional PIO (pilot induced oscillations).

Serial number applicability: All ASW 20 and 20 L, serial no.s 20001 thru 20611.

Compliance: Accomplishment of the action required under this T.N. until the next annual glider inspection, but at the latest until March 31, 1988.

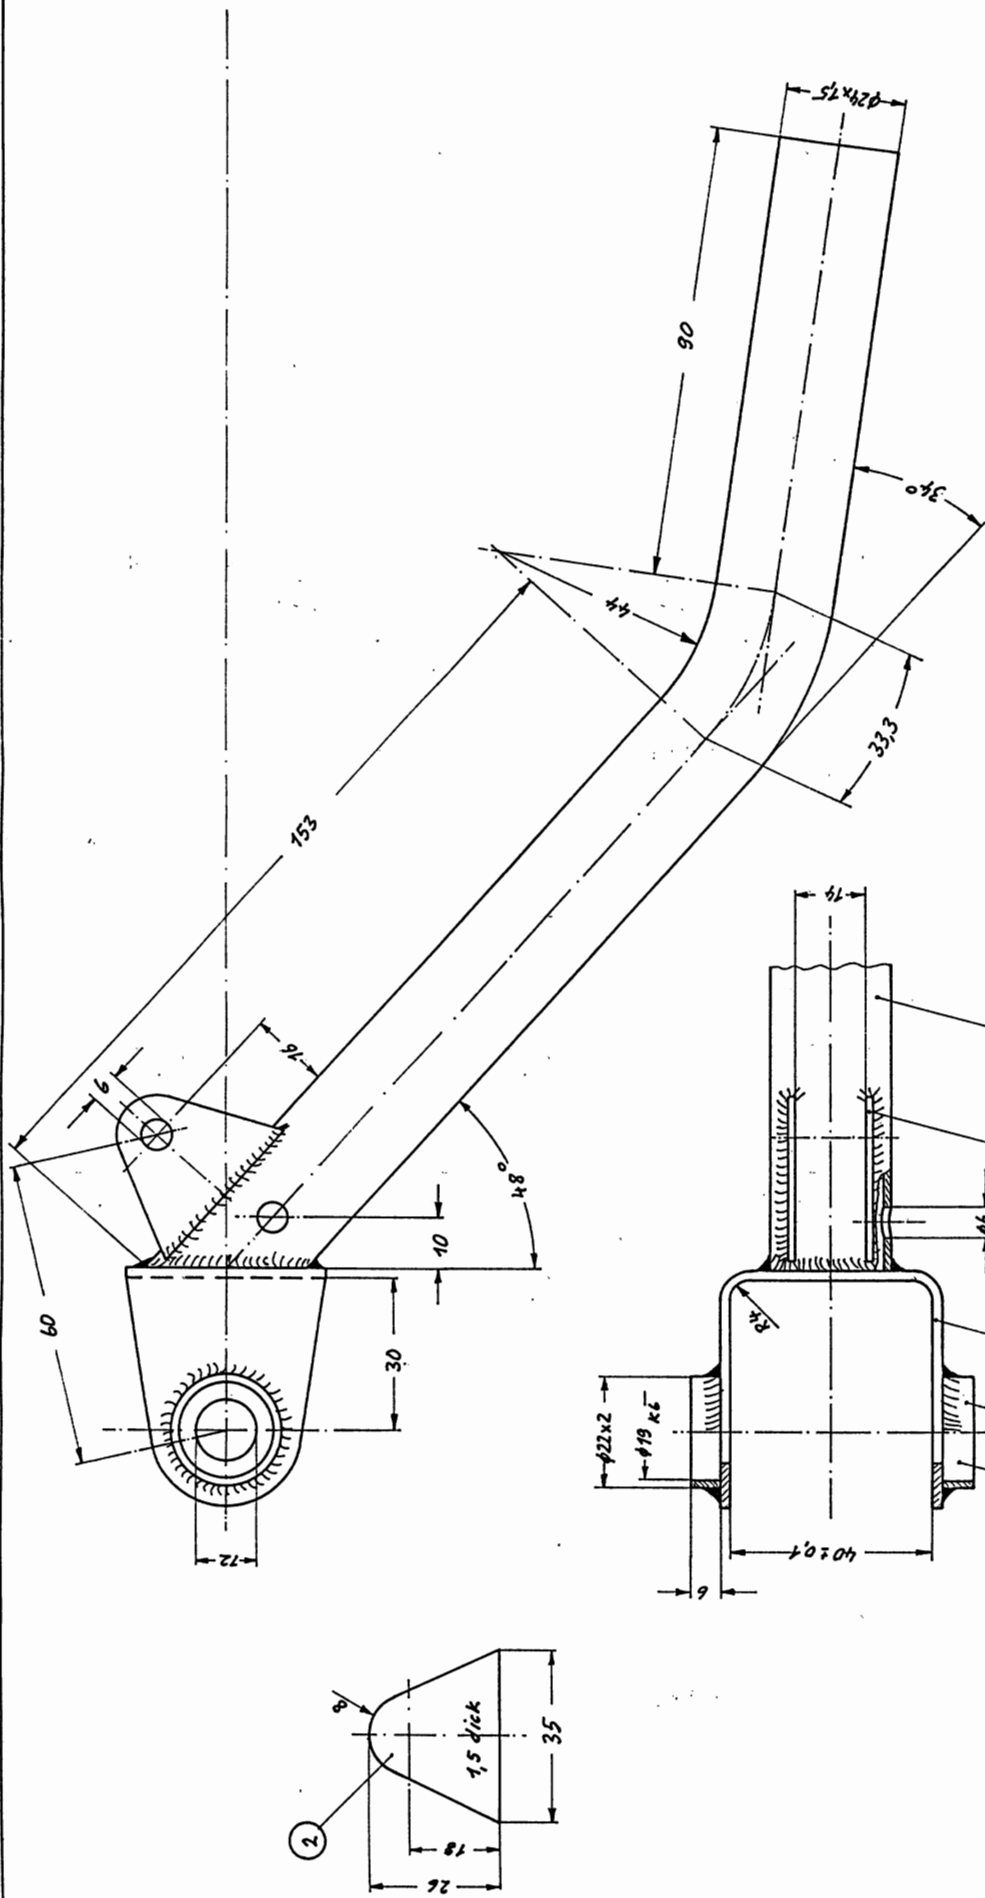
Sticks which are either too much cranked or misplaced too far to the rear, favor PIOs because in rough air the forearm and the hand on the stick are propped up behind the universal joint of the stick and from this unintentional elevator deflections result which still reinforce the maneuvering g-loads.

1. Check that your stick form is identical with the enclosed drawing (200.48.001). Only sticks with this stated crank angle are permissible; sticks differing from that are no longer allowed, even if there should be a previous LBA-approved Modification For A Single Unit for another stick type. Re-install the original stick type. In the case that a brake lever is (to be) fitted to the stick, the extension by means of the wooden compensating piece (200.48.0012) is permissible.
