Subject: Preventive measure against aileron flutter.

Serial number applicability: All ASW 20 variants and serial nos.
20001 thru 20860; 20950 and 20951.

Compliance: Immediately, prior to the next take-off.

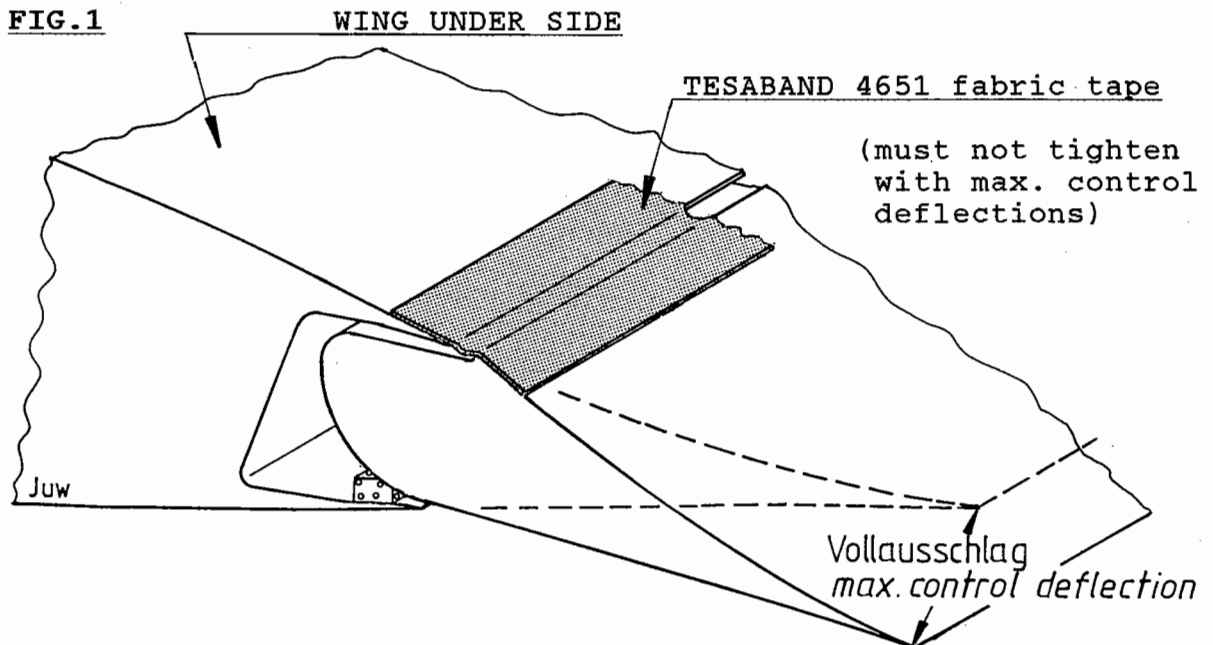
FIG.1

1. Prior to the next take-off it must be checked whether the control surface gap on the wing under side is equipped with a sealing, i.e. either
 - 1.1 with the factory-standard, plastic-treated fabric-tape TESABAND 4651, white, 38 mm wide (see Fig.1); in that case the plastic coat on the fabric must not be damaged, discolored or even weather-worn; the tape must not tighten with full control surfaces deflections.
or

2.1 In case of the factory-standard fabric-tape TESA 4651, white, 38 mm wide, you have to regard the following in addition: if your glider is an ASW 20 or ASW 20 L you do not have to try to make a recess into the wing for the application of the TESA; just tape it onto the wing surface; according to the aerodynamics experts the relatively thick and wide fabric tape serves possibly also as a turbulator preventing laminar separation bubbles on the control surface under sides. But if your ASW 20 and ASW 20 L had already the fabric tape recessed into the wing contour, then you should apply a turbulator in addition (zig-zag or nap tape) which you have to fix directly in front of the fabric tape.

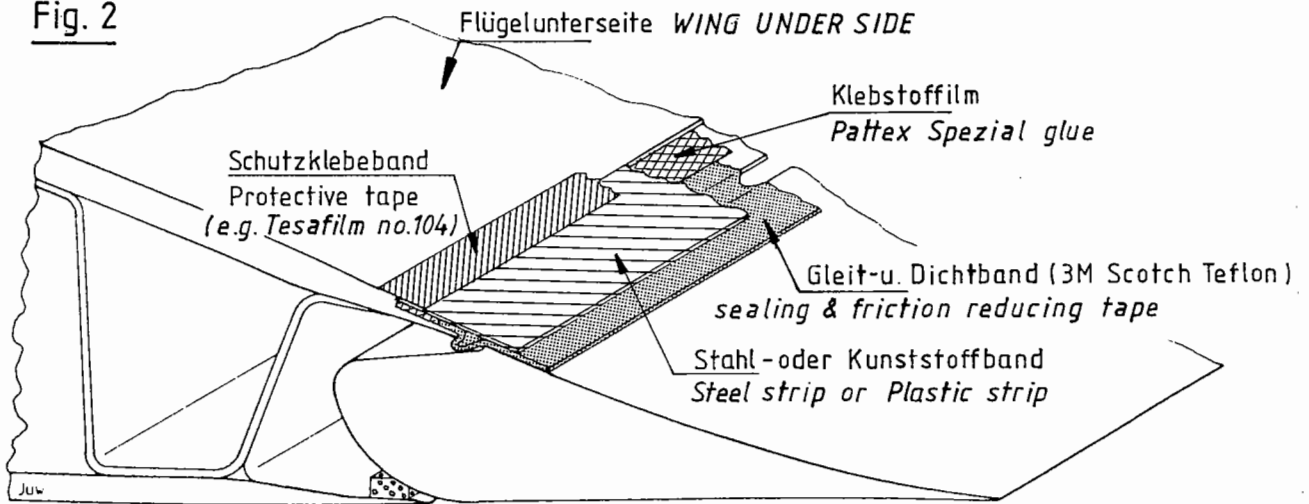
Fig. 2

- 1.2 with the pre-curved steel strip (0,07 mm thick) or the pre-curved plastic tape (MYLAR 0,25 mm thick) respectively; in that case check that both require absolutely a Teflon sealing tape underneath for the purpose of sealing the gap and reducing the friction (see Fig. 2).If 1.1 or 1.2 are positive, the ASW 20 can be continued in operation without any restrictions.

2.2 In case of the elastic lip sealing: this has to be renewed as shown in Fig.2, following the Maintenance Instruction J, Issue III; alternatively, the elastic lip sealing can be new applied instead of the above TESA tape sealing.
