ASW 20 L - Flight Manual

Preventive actions against flutter caused by special conditions of operation

Checking and securing the L'Hotellier quick-close connections of the control circuit

Inspection, maintenance and adjustment of the tow hook

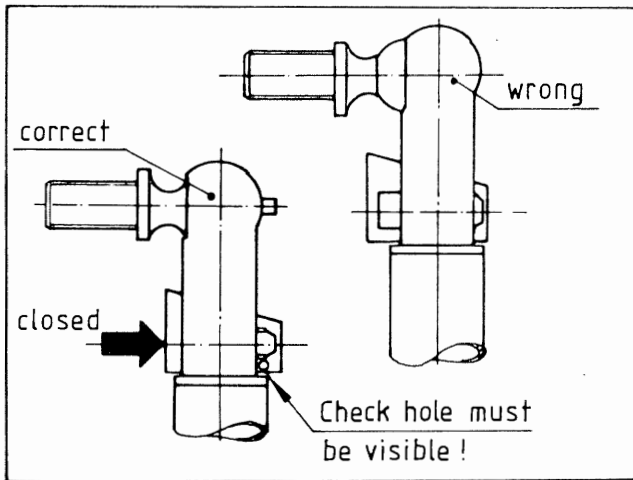
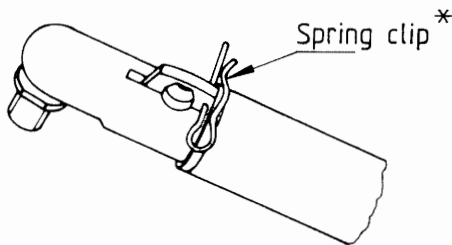
The experience of the past shows that mostly the connection of the elevator was incorrectly fitted or even worse simply was forgotten. A sticker on the fin serves to remind the pilot of the correct connection; in addition the securing by means of a spring pin is recommended.

To do this on older ASW 20 gliders the check hole must be drilled to 1,2 mm in diameter.

Aileron, flap and airbrake connections in the fuselage can be safetied by the same method.

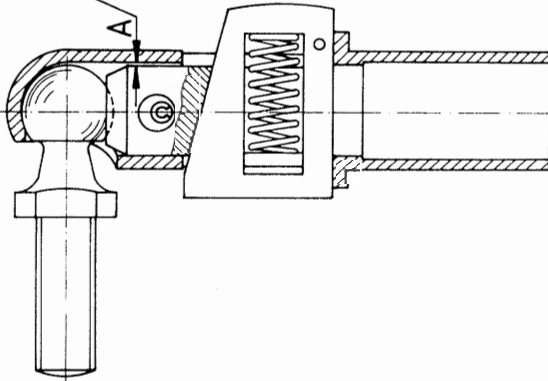
Clearance A must not exceed 0,15 mm (0,006 in);
check by using a wire of 0,15 mm diameter !

Bad wedging effect causing wear of the ball end.

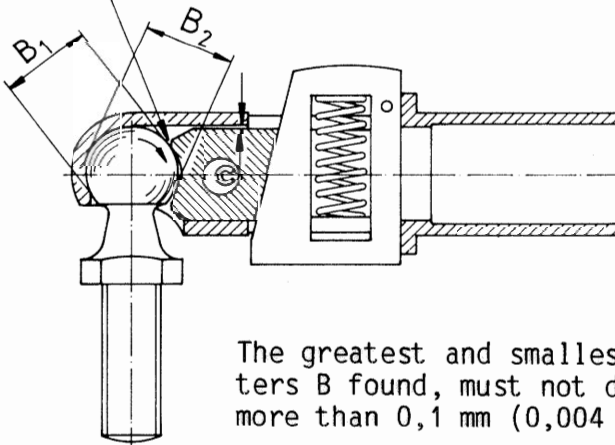
The greatest and smallest diameters B found, must not differ by more than 0,1 mm (0,004 in).

The tight seat of the ball ends inside the fittings must be checked, as loose ball ends may be broken due to bending loads in the thread area.

Gap generated by unscrewing of the ball end or wear out of the fitting material.

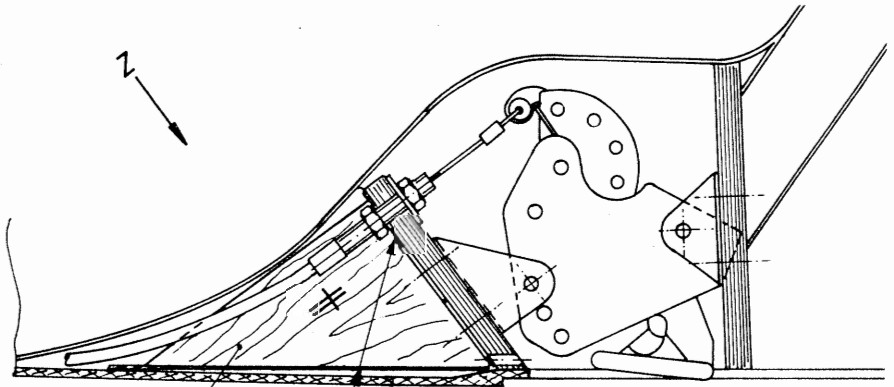
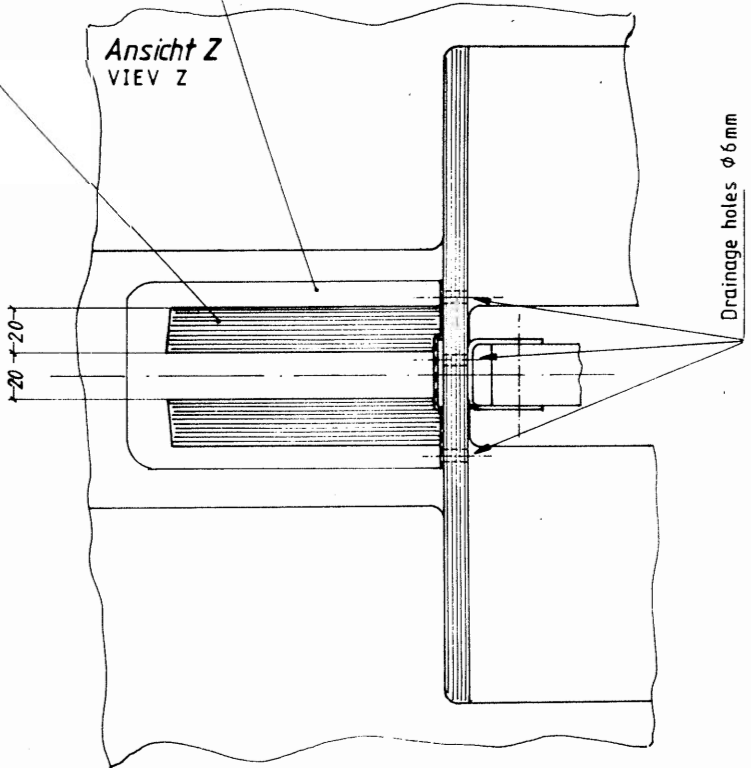
Ansicht Z
VIEW Z

- b) After a belly landing and/or if water has been allowed to stand in the cockpit for a long period, the glued joint between the rear tow hook bulkhead and the fuselage shell may fail. This weakens the tow hook installation to the point where the tow hook may twist under a severe load (such as occurs during cable snatches); this movement may be enough to cause a stiff and/or too critically adjusted tow hook cable to open the latch of the tow hook.

In this case the glued joint between tow hook and bulkhead must be repaired; clean up the gluing surface and fill the slot (e.g. made with a piercing saw blade) with a filler paste consisting of:

100 parts by weight	Epikote 162
38 parts by weight	Epikure 113
10-15 parts by weight	Aerosil.

Filler powders other than Aerosil must not be used, as they produce a weaker joint (micro-balloons) or swell when damp (cotton flock). If necessary, reinforce the repaired areas with an additional layer of glass cloth.

A successful reinforcement to the forward tow hook bulkhead of the C.G. tow hook has proved to be two wedge-shaped plywood blocks (see sketch on page 44h). Two layers of glass cloth 92140 are laid over the joint surfaces of the blocks, with random fiber orientation, and resined together.

Reinforcement
Verstärkung
Sp. 6.1013. Plywood

2 Lagen 92 140, beliebig
2 layers 92 140, any fiber orientation

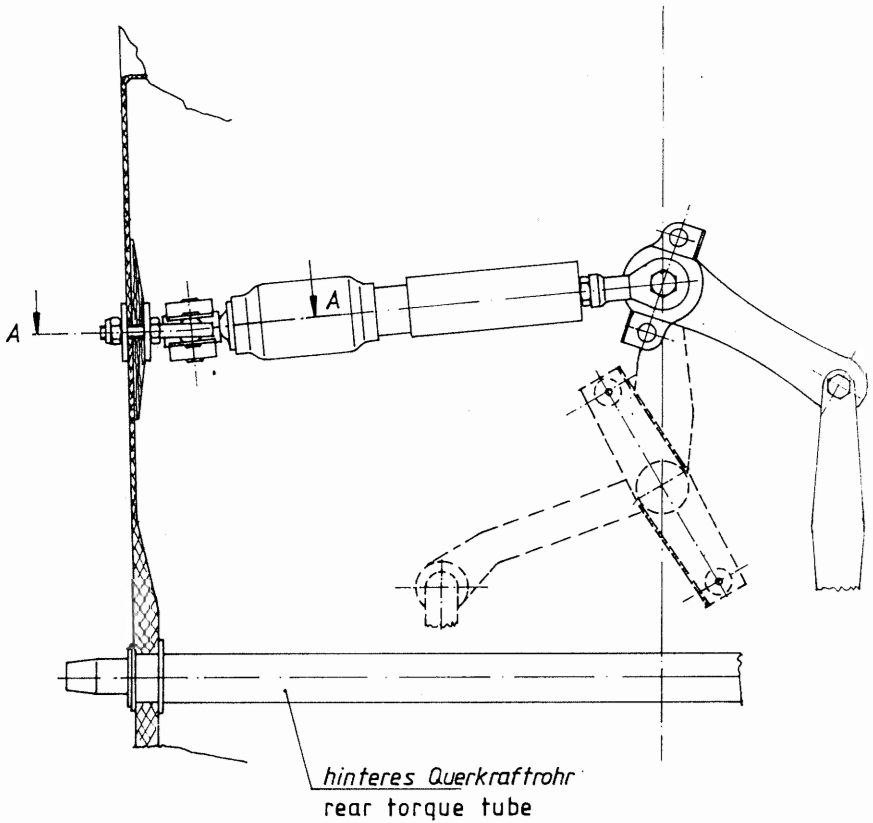
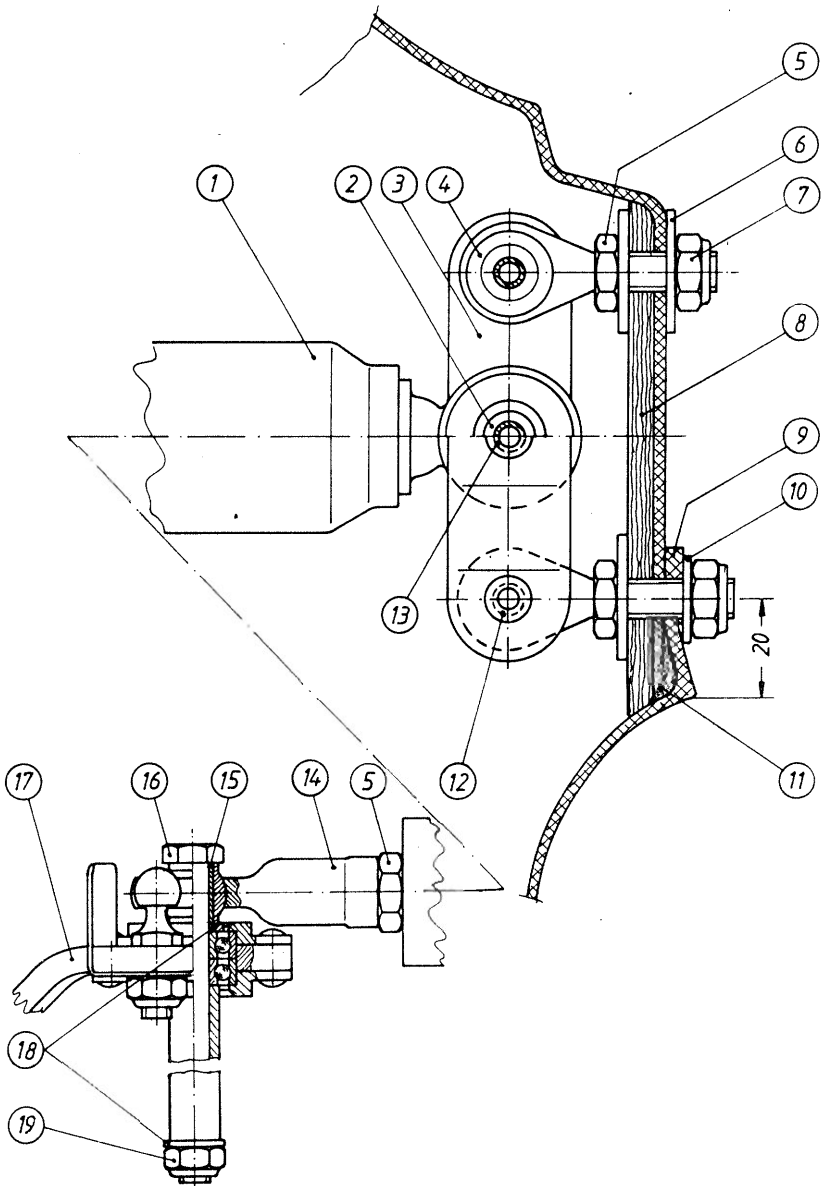
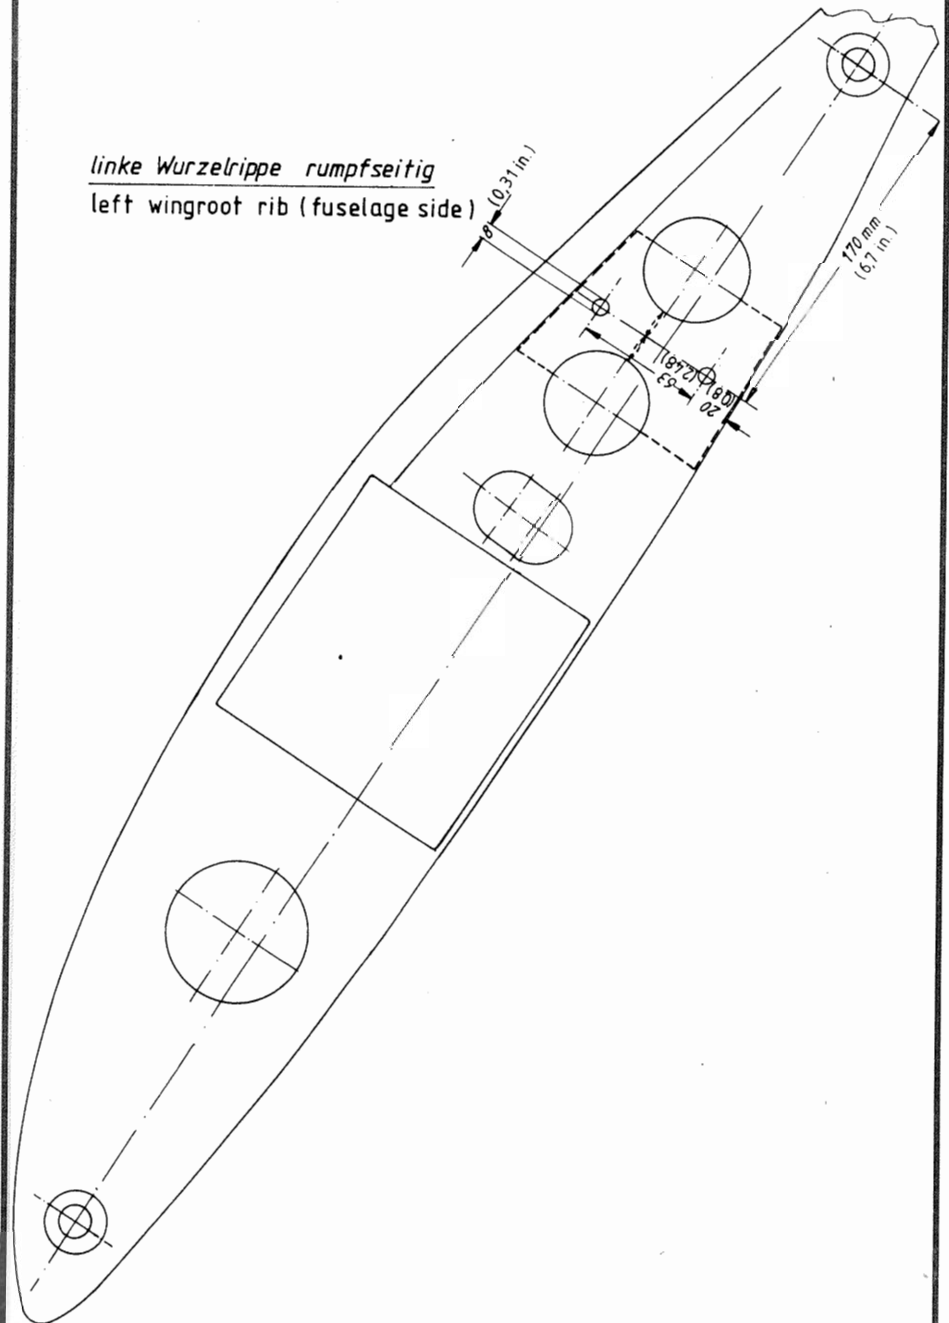
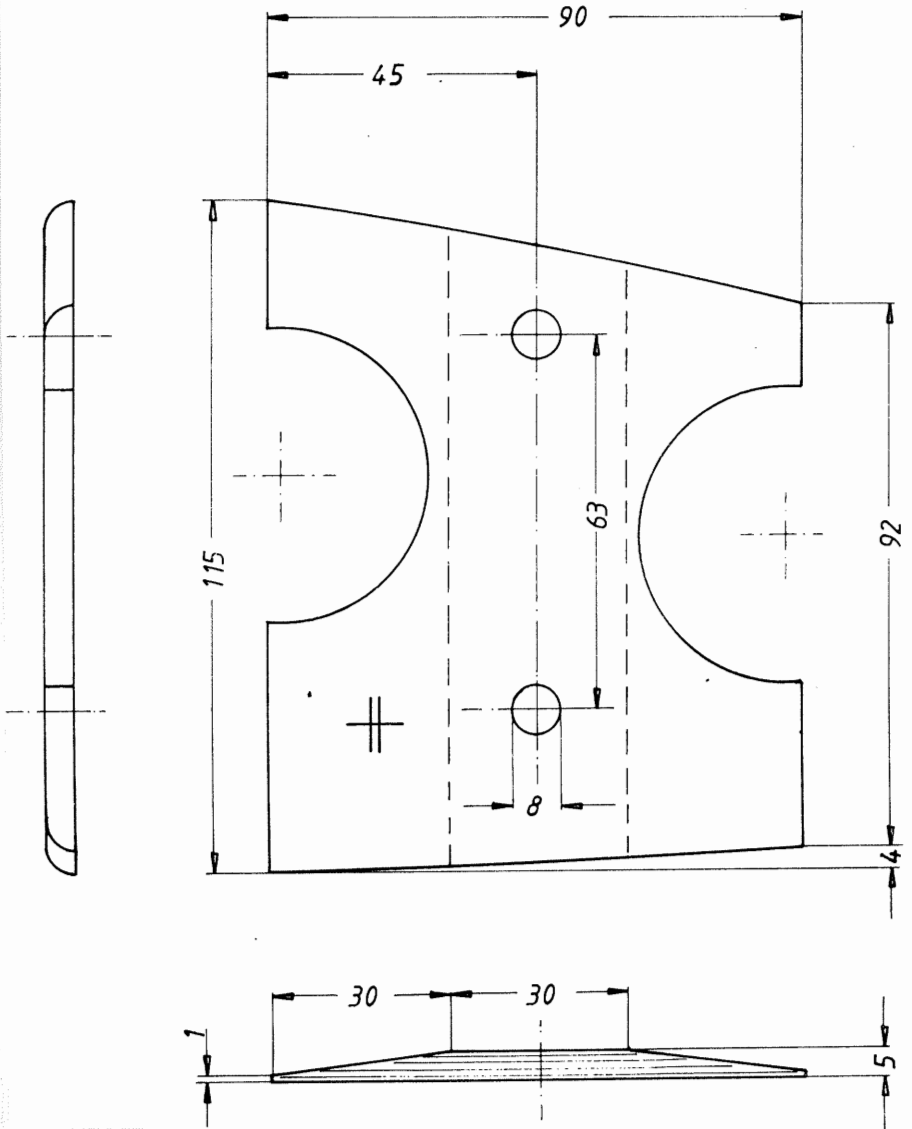
Under operational conditions as detailed on page 18a of the Flight Manual, the installation of a hydraulic damper into the aileron control circuit is strongly recommended. In countries with desert climate where above mentioned conditions may occur several times a year, Schleicher recommends the general installation of this damper.

In the sketches on pages 44n thru 44r the installation of the damper is shown. For proper connection to the aileron control circuit a longer bolt M 6 must be used. For every installation use new self-securing nuts n M6 DIN 980/6 or N M8 DIN 980/6. The plywood ground plate is permanently glued into the wingroot rib (fuselage-side) and well preserved. The cutouts for the pushrods are not prefabricated, as they must be fitted individually for each glider.

After the installation of the damper it is most important to check the aileron control system for free movement in a special test.
