# ASK 21 Technical Note Nr. 4b

Alexander Schleicher GmbH & Co. Segelflugzeugbau D - 36163 Poppenhausen

**Subject:** Trim ballast for spin flights (spin ballast)

Applicability: ASK 21, EASA TCDS EASA.A.0221, Variant ASK 21,

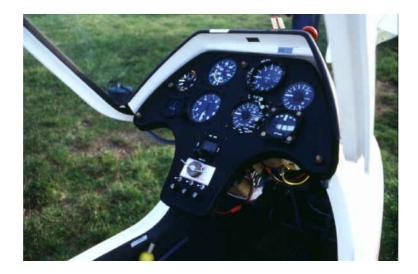
"Attention - Check spin ballast! Only use spin ballast for flights with two pilots!"

Must be either red letters on white ground or white letters on red ground.

One bolt M8 must be fitted into the instrument panel (from the back side) and secured. It must be located such that the securing nut and washer of the spin ballast - when the spin ballast is removed - can be fixed onto this bolt at the front of the instrument panel and thereby cover the text of the above placard.
