Subject: Trim ballast for spin flights (spin ballast)

Applicability: ASK 21, FAA TCDS G 47 EU
All **U.S. registered ASK 21**, which are operated with the FAA-approved manuals:

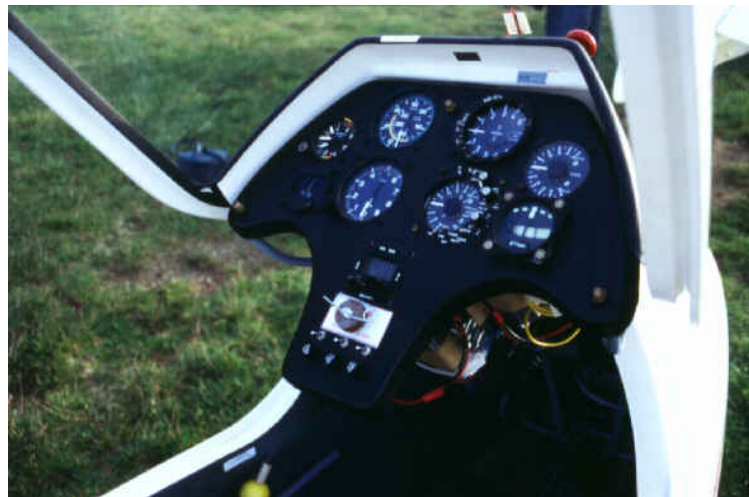
“Attention – Check spin ballast! Only use spin ballast for flights with two pilots!”

Must be either red letters on white ground or white letters on red ground.

One bolt M8 must be fitted into the instrument panel (from the back side) and secured. It must be located such that the securing nut and washer of the spin ballast - when the spin ballast is removed - can be fixed onto this bolt at the front of the instrument panel and thereby cover the text of the above placard.
