Subject: Modification of the release cable fairlead.

Affected gliders: ASK 21, serial numbers 21 001 thru 21 196 incl.

This Technical Note has been approved by the LBA under the date of December 20, 1983, and is signed by Mr. FRIEB.
The translation into English of this T.N. no.15 has been done by best knowledge and judgement. In any case of doubt the German original is authoritative.

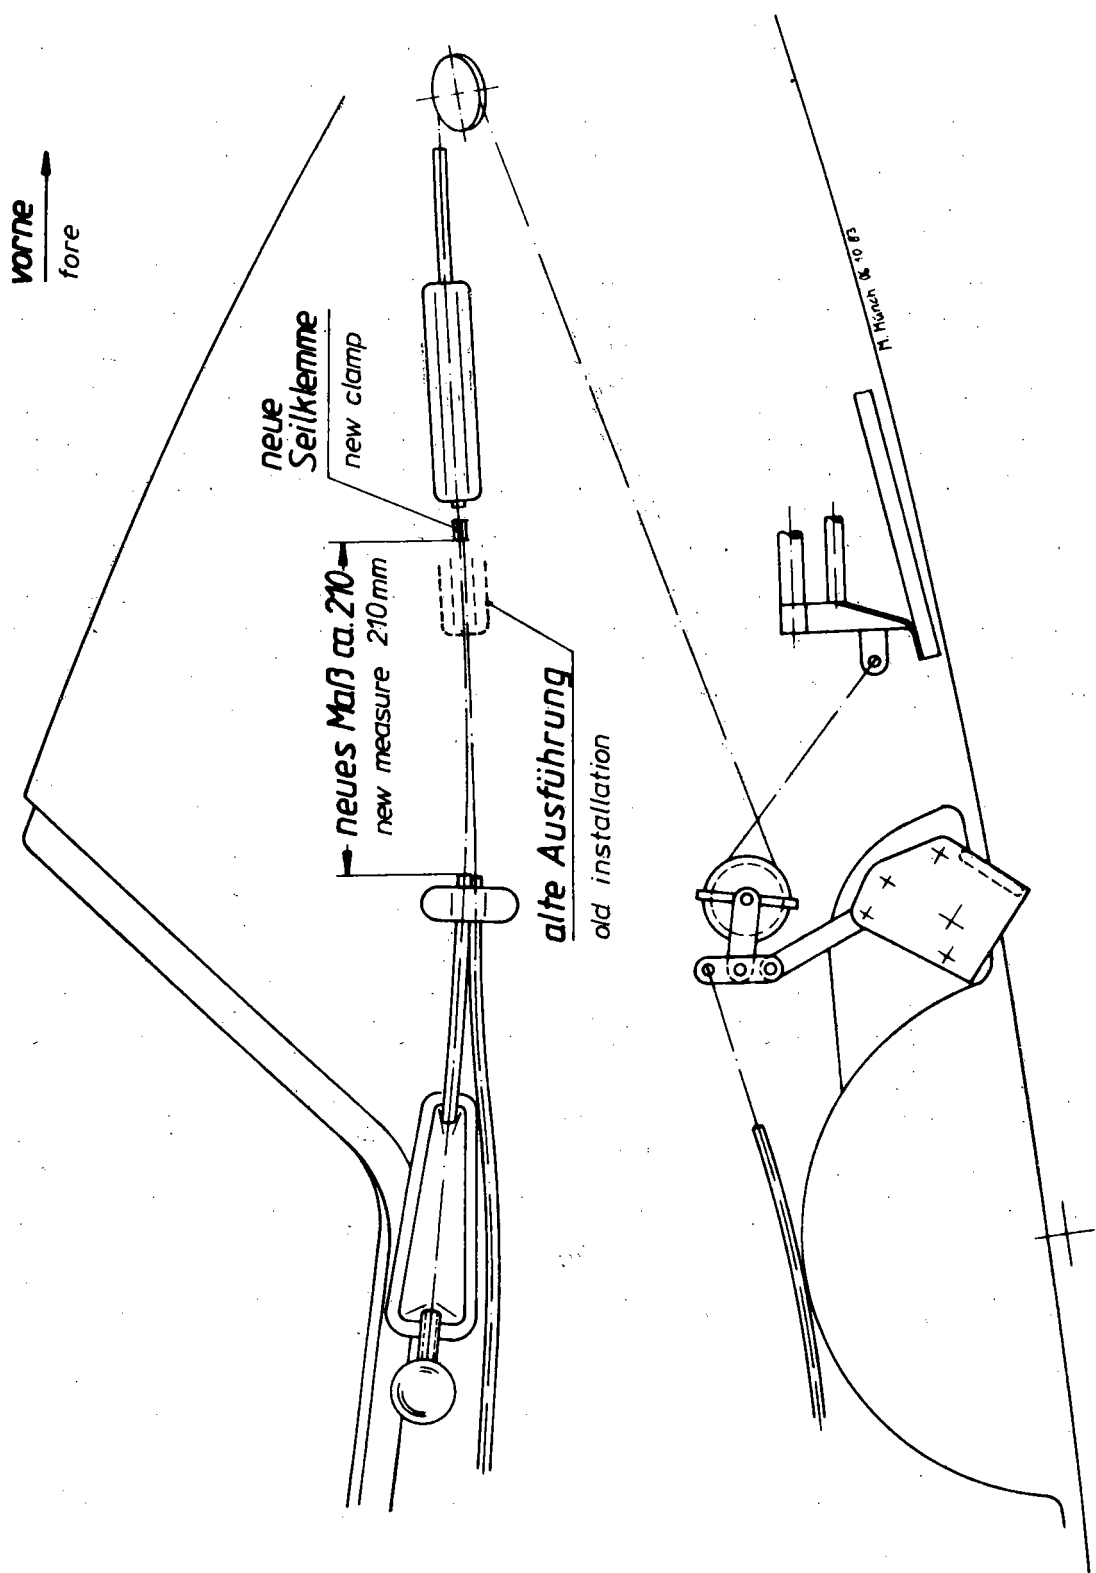
Reason: It has been found that in course of time the tow release cable is prone to create loops. Because these loops are relatively short, they lead to strong bending loads on the cable, mainly at the binding clamp.

1. On receipt of this Technical Note check immediately the tow release cable for possible cracks at the junction clamp.
2. According to the drawing on sheet 2 of this Technical Note the tow release cable must be installed new. It is very important that possibly developing loops do not create strong bending loads on the clamp. The loops form preferably if one knob is forward and the other behind. The new arrangement of the tow release cable shall lead to larger loops forming larger radii and thus bringing about lower bending stresses of the cable at the clamp.
3. Page 43 of the Maintenance Manual must be exchanged against Page 43a; respectively Page 45 of the US-Edition "Instructions For Continued Airworthiness" must be exchanged against Page 45 dated 10.10.83.
