Subject: Inspecting trim indicator and reinforcing bowden cable flexible steel hose.

Affected gliders: All serial numbers up to 21262 including. As of s/n 21263 this is standard serial equipment.

ASK 21
Technical Note
No. 18

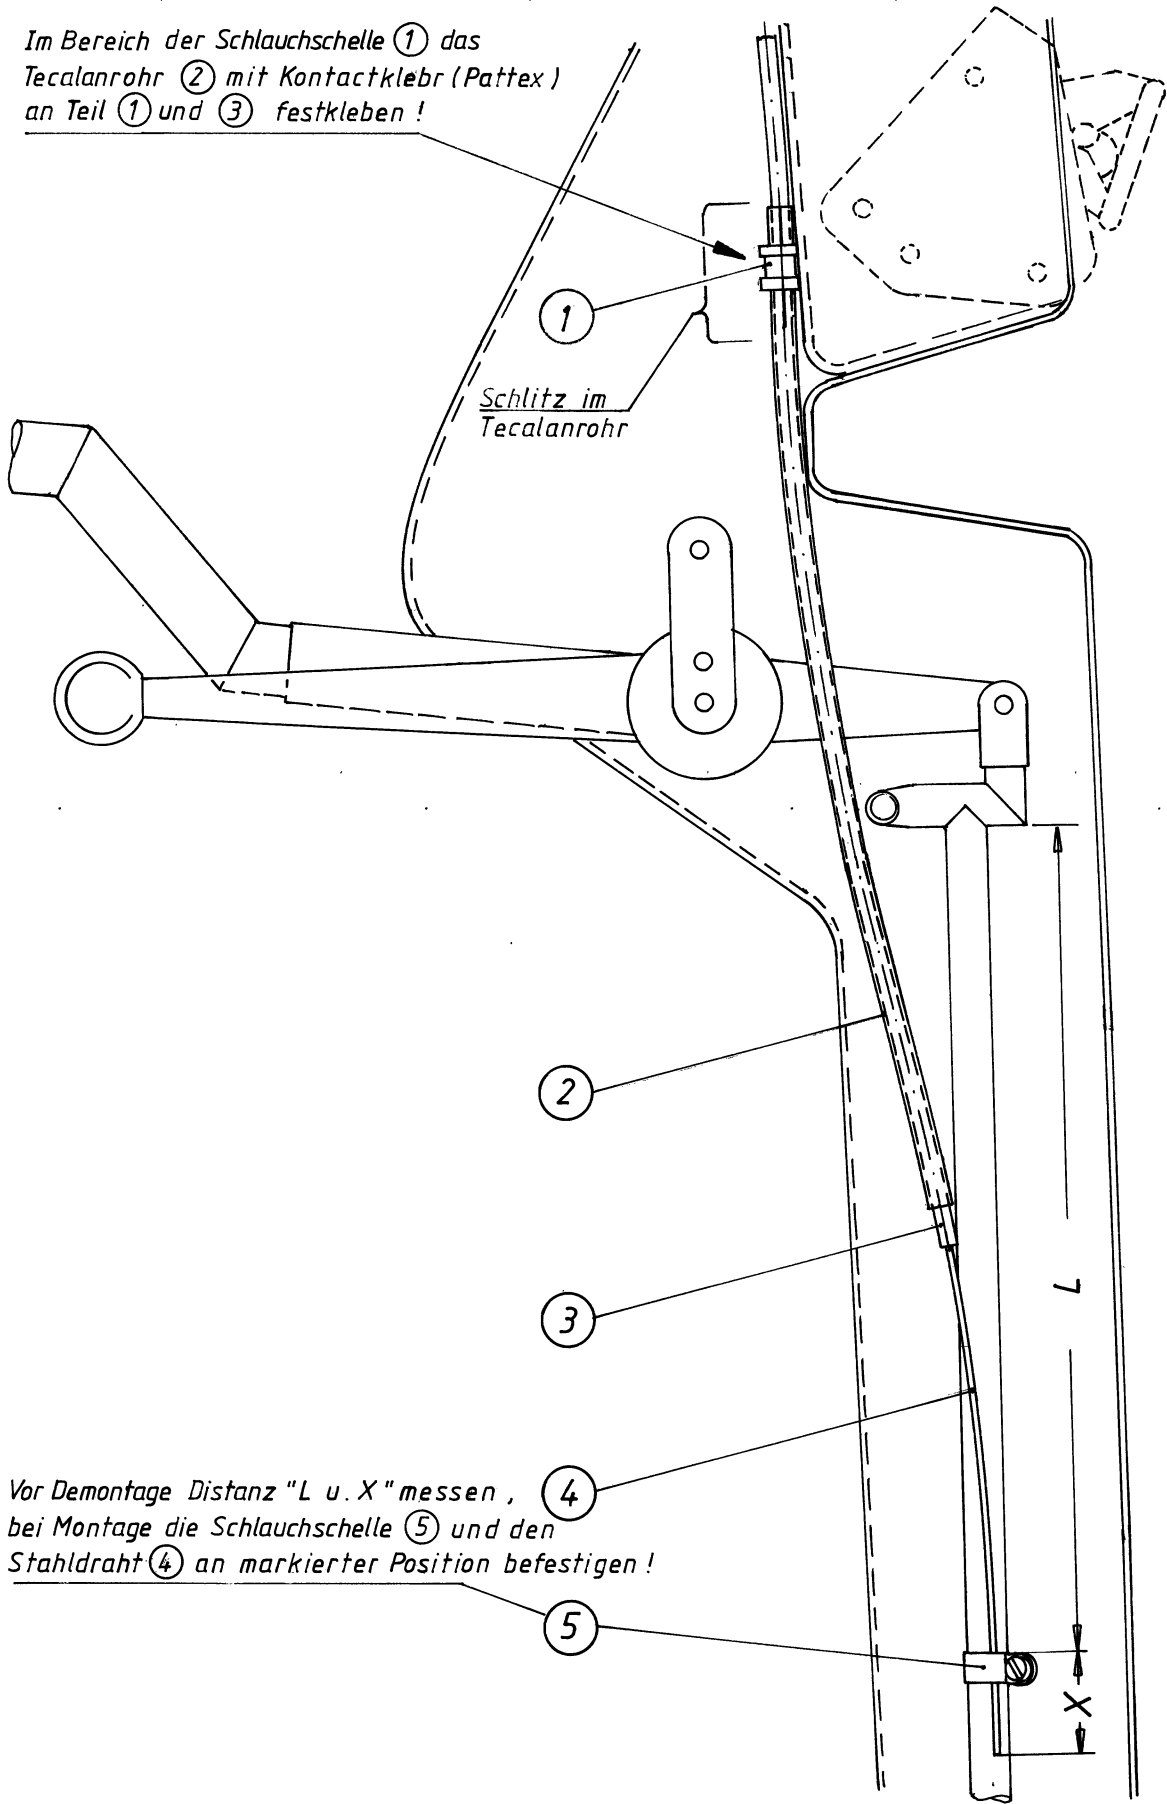
Reason: In some ASK 21s the trim indicator bowden cable at the rear control stick has been jammed between the control shaft and the aileron stop. This results in a slightly smaller stick deflection over to the right and it is possible that the trim indicator fails. This can happen only when the steel wire ④ can no more move clear in the bowden cable's flexible steel hose ③, e.g. owing to fouling and deficient maintenance; see drawing 210.49.S4

3. Mark the positions of the hose clamp ⑤ and of the steel wire ④. Then slip the Tecalan-tube ② over the bowden cable steel hose ③ as shown in drawing 210.49.S4. Now glue the tube in the area of the hose clamp ① to the parts ③ and ①, using contact glue, e.g. Pattex. Finally refix the steel wire ④ with the hose clamp ⑤ to their marked positions.

Im Bereich der Schlauchschelle ① das Tecalanrohr ② mit Contactklebr (Pattex) an Teil ① und ③ festkleben!

Vor Demontage Distanz "L u. X" messen, bei Montage die Schlauchschelle ⑤ und den Stahldraht ④ an markierter Position befestigen!
