Inspection and exchange of the rudder pedal support fitting.

Affected gliders: All ASK 21 serial numbers 21001 thru 21312; as of serial number 21313 this is factory standard.

ASK 21 Technical Note No.19 Alexander Schleicher Segelflugzeugbau 6416 Poppenhausen

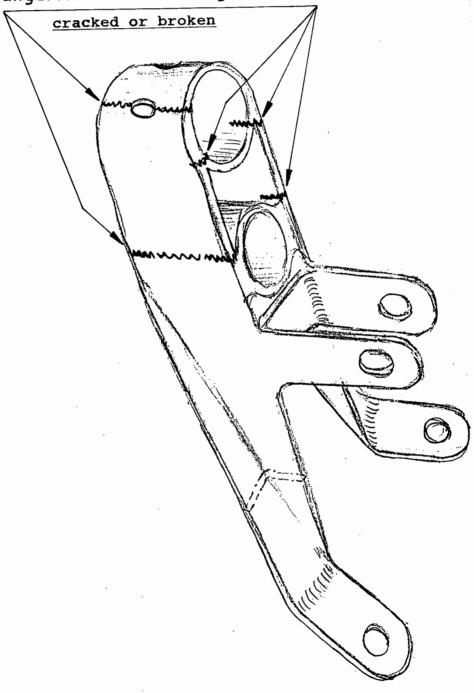
Fig. 1

On three ASK 21s which each have flown more than 1300 hours and more than 6000 take-offs respectively, this support fitting showed cracks or was broken (see Fig.1).

angerissen bzw. durchgebrochen

- 1. Check the rudder pedal support fitting prior to the next take-off.
- 2. If cracks are found in this fitting, it must be <u>im</u> mediately exchanged for a new one. If cracks are not yet visible, the support fitting must be exchanged in any case by April 1, 1987.

- 1. Order a new support fitting from the manufacturer; P/N 99.000.2174.
- 2. Remove the old support fitting; for this purpose the $\phi 4$ mm blind rivets must be drilled off.
- 3. Measure the position of the $\emptyset 4$ mm rivet holes on the removed fitting and transfer them accordingly onto the new fitting.
- 4. Install the new fitting and fix the upper pedal guide tube to the fitting using ø5 mm blind rivets.
