Subjects:

1. Inspection of the rudder pedals.
2. Change/supplement to the Flight and Maintenance Manuals in order to provide the owners with new inspection and assembly instructions.
3. Inspection and exchange of the airbrake bellcrank in the fuselage.
4. Inspection and if the case arises, reinforcement of the rear canopy hinge.

Serial number applicability:

All serial no.s 21001 thru 21345 including;
this is factory-standard as of serial no. 21346.

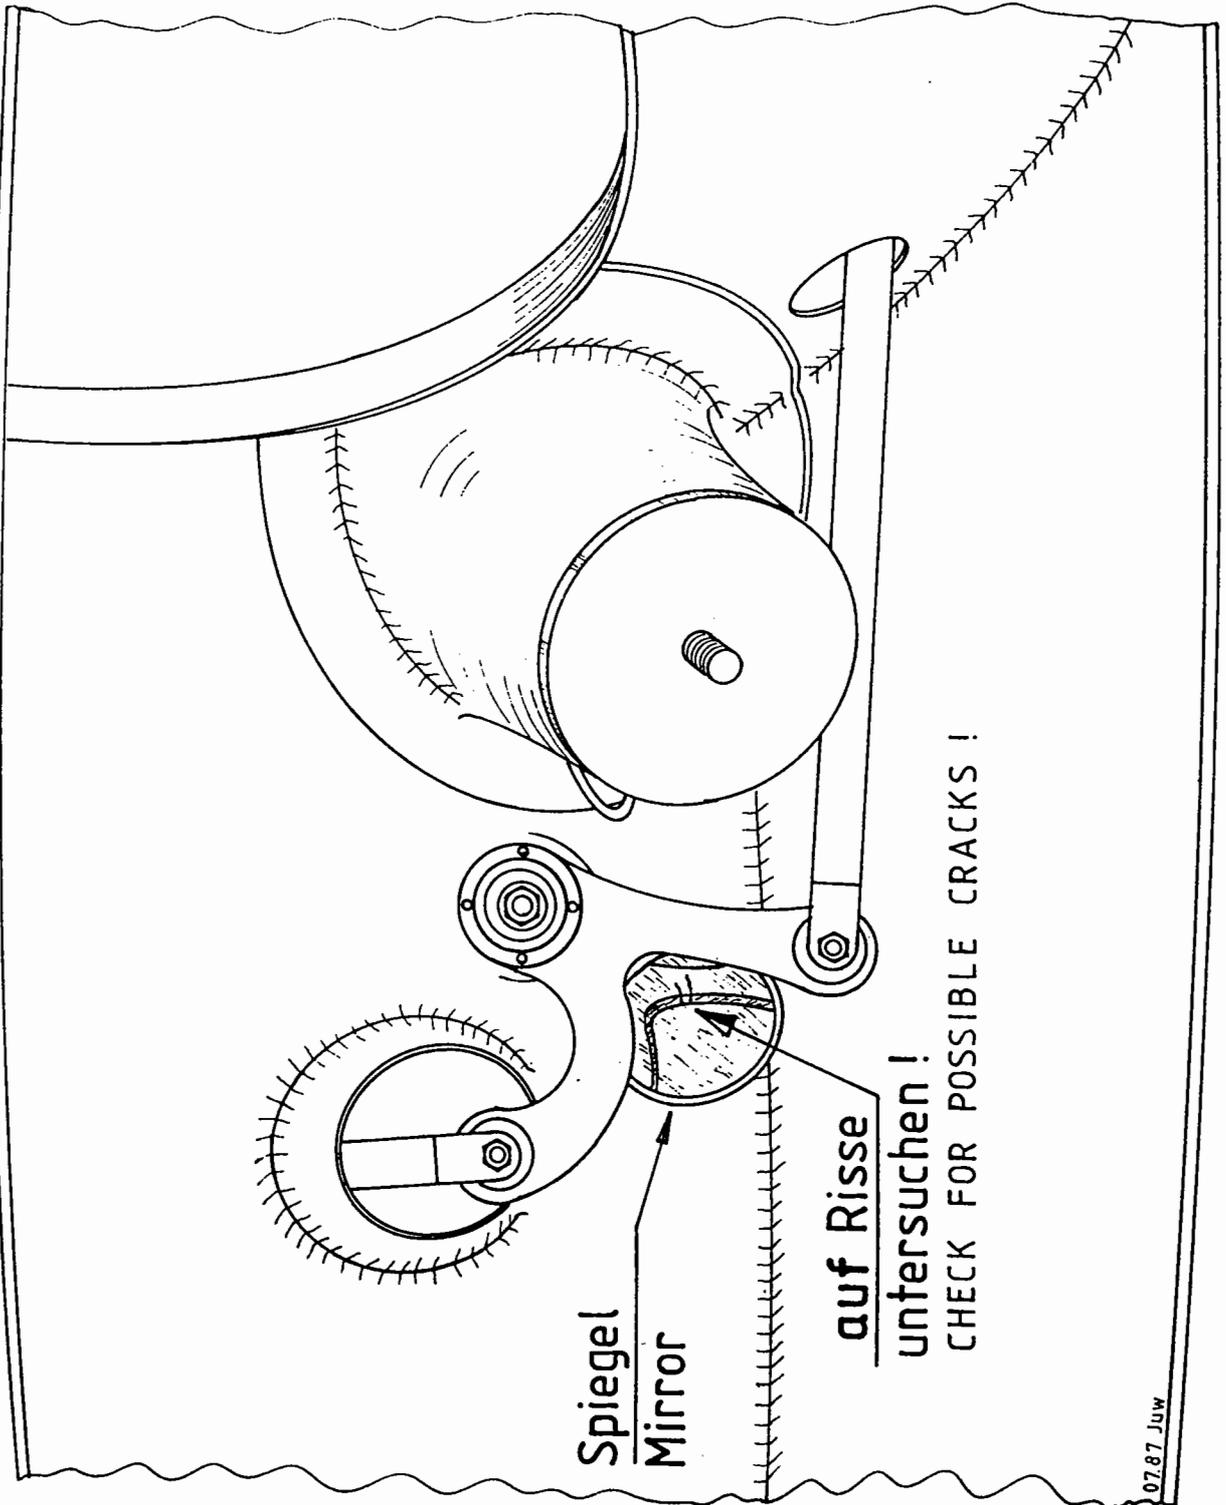
3. In two cases the pre-flight checks on the ground with the ASK 21 showed the airbrake bellcrank in the fuselage (210.43.0005) cracked --> see Maintenance Manual p.16, item 5 (for the US-edition of the manuals see the corresponding "Instructions For Continued Airworthiness" p. 19, item 5).

For the FAA-approved US-Edition of the manuals this applies to the following pages:-
Flight Manual: pp. 2, 3, 4, 30, 31, 42, 42a, 43.
Instructions For Continued
Airworthiness: pp. 2, 3, 43, 45, 45a, 45b, 60.
- 2.2 The accomplishment of the change/ supplement to the Manuals must be documented on the respective page "Amendments Record" (for the FAA-approved US-edition this applies to the page "Log Of Revisions").
- 2.3 The inspection and assembly instructions provided on the new manual pages must be duly regarded !
- 3.1 Prior to the next take-off it must be checked if the air-brake bellcrank in the fuselage shows cracks or deformations --> see Fig. 1.

3.2 If cracks or deformations are found, the airbrake bellcrank must be removed prior to the next take-off and the new bellcrank with an additional support must be fitted --> see drawing 210.43.S5.

3.3 If no damages are found, flight operation can be continued for the present. Until the next annual glider re-inspection, however, at the latest by April 30, 1988, the new bellcrank in the fuselage (210.43.0005) must be fitted.

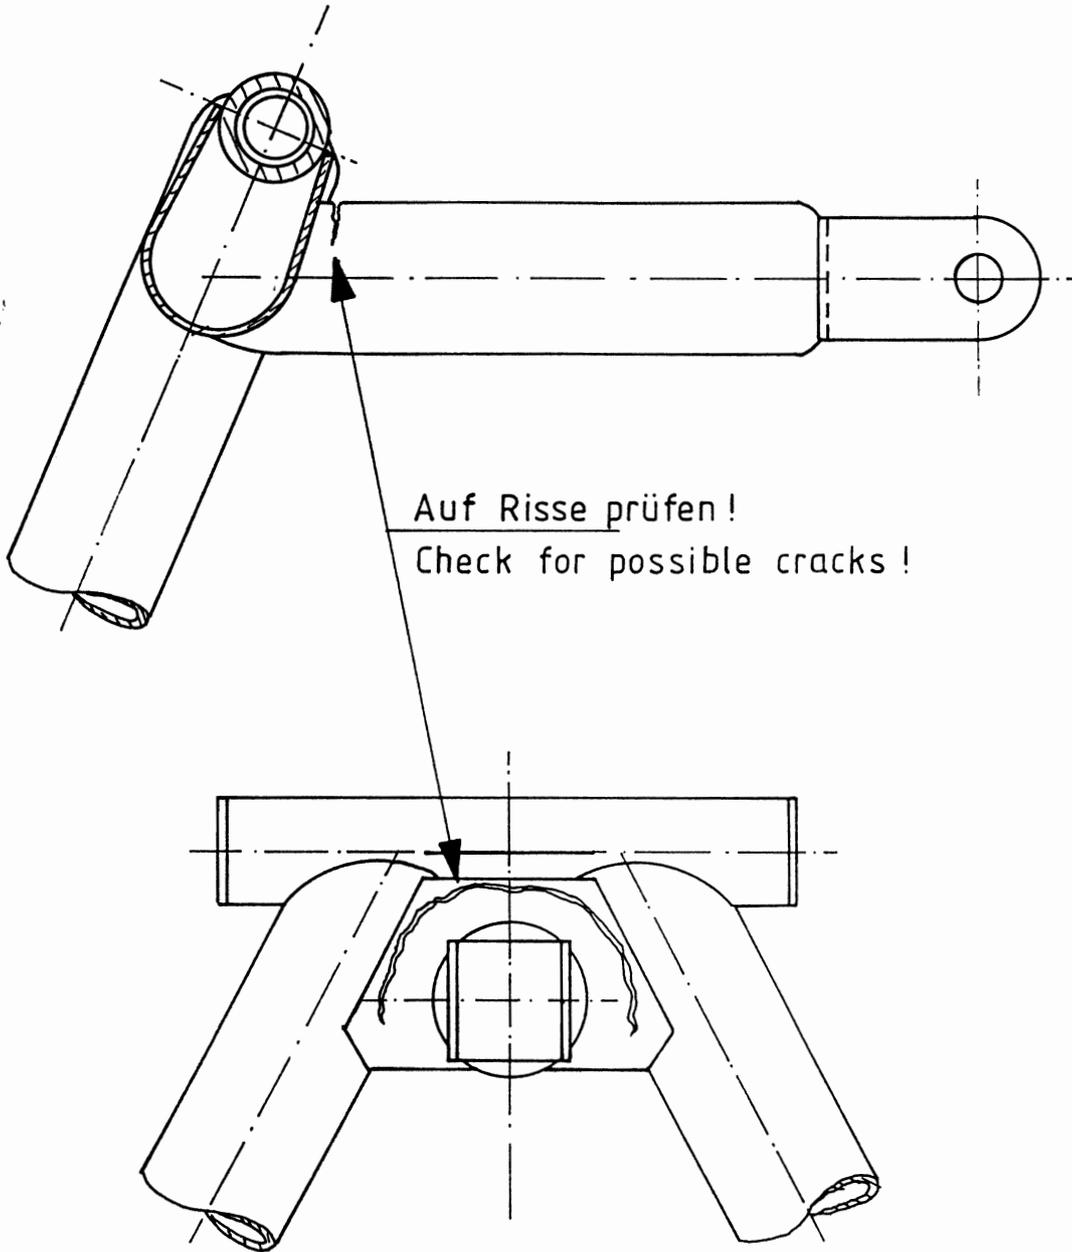
4. With a few ASK 21s the support tube for the gas spring at the rear canopy hinge was broken. These cracks result from the fact that the gliders were left outside with the canopy open for a longer period of time and by this an overload of the canopy hinge due to continuous shaking in the wind was caused. This is a gross operating error ! On the Flight Manual p. 37, V.3, it is clearly stated "When parking the sailplane the canopies have to be locked." (For the FAA-approved US-Edition of the Flight Manual this is p.43, V.3. !).

4.1 Prior to the next take-off it must be checked if the rear canopy hinge shows cracks --> see drawing 210.12.S5.

Auf Risse prüfen!
Check for possible cracks!

4.2 If cracks are found, prior to the next take-off the rear canopy must be disassembled and the canopy hinge must be reinforced as shown on drawing 210.12.S5.

4.3 If no damages are found, flight operation can be continued. As the canopy hinge is sufficiently rigid under normal conditions and with proper operation, we are of the opinion that it is not necessary to make the canopy hinge reinforcement mod obligatory. However, this mod can be accomplished optionally.
