# Mandatory Service Bulletin No. MSB-AE50R-006

**Engine Control Unit**

Type: IAE50R-AA

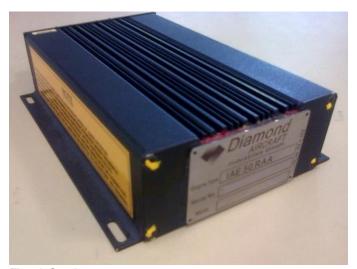
Fig. 1.2 - 1

The serial number label can be found on the housing of the ECU opposite to the connector. See Figure 1.2 - 1.
