1. Increase of service life of the airframe from 6000 to 12000 hours.
2. Inspection of the elevator control linkage after fuselage and landing gear repairs.
3. Additional safety device for the landing gear rear bolts; change to maintenance intervals.
4. Insertion of the AD-Note No. 1993-001/3 (covering the compulsory use of safety devices for the L'Hotellier quick-release connectors) into the Flight and Maintenance Manual.

Serial number applicability: Sailplane ASH 25, Data Sheet No. L-364, all production versions and serial numbers. Powered sailplane Data Sheet No. L-858, *only* production version ASH 25 E, all serial numbers.

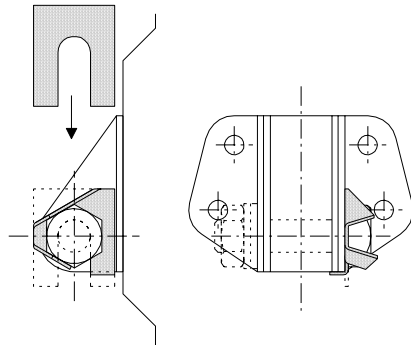
3. The two bolted connections of the landing gear H-strut to the fittings at the rear landing gear bulkhead have come loose in single cases. If these bolted connections are not covered with screw safety varnish, the bolted connection on each side must be undone and a lockplate must be added which must be bent upwards after the retightening of the bolted connection.
If screw stop safety varnish was applied and is undamaged, this action is not applicable as in that case the connection was already secured with Loctite ex factory.
An annual check of the rudder cable pulley in the fin is no longer necessary. Operation experience with more than 200 sailplanes of the types ASH 25 and ASW 22 has demonstrated that this cable pulley is not critical with respect to its service life.
The grease intervals for all control surface bearings can also be distinctly extended as they are sufficiently protected from dust or other environmental influence by their elastic sealing tapes on both sides.

2. The elevator control linkage must be inspected in accordance with the „Check list to inspect the elevator control linkage ASH 25, all production versions“. If damages or insufficient control stiffness are found, the control linkage must be repaired and the “reinforcement for L/G bulkhead, rear“ (drawing no. 250.11.0209) must be installed. If the control linkage is undamaged, the installation of the reinforcement bulkhead is not necessarily required at once. But at the latest at a total flight time of 3000 h, the installation becomes compulsory.
3. Where necessary, lockplates from Messrs. Schleicher must be fitted according to the following sketch.
