Page 1 of 2 ASW 22 / B / BL Technical Note No. 16 **ASH 25 ASH 25 E**

Technical Note No. 20 Technical Note No. 28

Replacing a lever of the flap control system in the fuselage Subject:

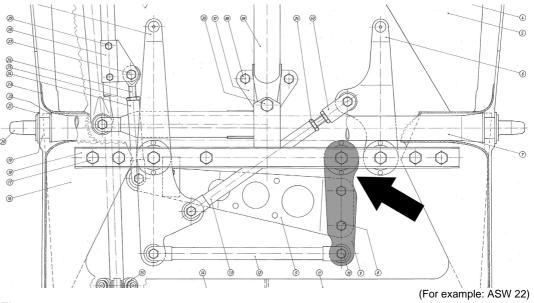
Reason: In an ASH 25 a partially broken lever of the flap control system was found in the fuselage.

On a few further sailplanes, gaps between the bearing flange and the lever plate were diagnosed indicating a bent lever. Black borders around the rivet heads also indicate dam-

age of the lever.

Fig. 1: Position of the flap lever behind the rear cross tube.

If a damaged lever is diagnosed during the check, which has to be made until April 30, 2008, the lever has to be changed immediately for the stronger new one (AS Part-No. 250.45.0070).

To change the lever, both U-shaped crossbeams must be unfastened. The complete substruction of the old lever has to be mounted on the new one. New secure nuts have to be used.
