ASH 25 M

Technical Note No. 15 **Alexander Schleicher**

Subject: Inspection and exchange of the exhaust damper of the power-plant. Amendment and

Affected: ASH 25 M, Data Sheet No. 858, all serial numbers.

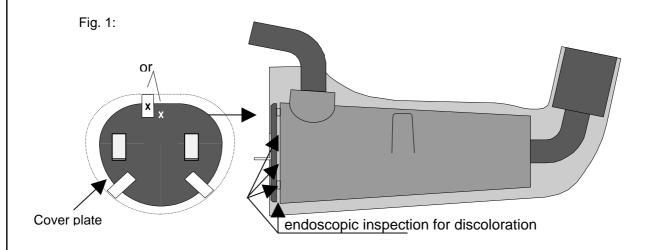
version of the exhaust damper has been installed. The upgraded exhaust dampers were marked with the letter 'X'. This marking is located on the front side as shown in Fig. 1:

Where the operating time of the exhaust damper is above 40 hours, the front side of the exhaust damper behind the cover plate (see Fig.1) must be additionally inspected for tempering coloration using an endoscope. If this inspection does not reveal any discoloration from the golden-yellow basic coloring changed to a gray or bluish coloration so, a further engine operation in another two hours intervals is allowed. This inspection must be repeated in 2 hours intervals up to a maximum operating time of the exhaust damper of 60 hours.

The high grade steel plate from which the first exhaust dampers were made from, unfortunately turned out to be insufficiently resistant for the inner areas. In one case an exhaust damper system showed cracks in this inner area after about 45 hours operation. As of 1996 the factory serial production used a superior material for the inner parts of exhaust damper. These upgraded exhaust dampers were marked with an 'X' at the front plate. At the time yet there was no reason for exchanging the earlier version.

If damages or discoloration are found during any of the above inspections, the exhaust damper must be exchanged prior to the next engine flight.

- a) If the inspection shows that an exchange of the exhaust damper becomes necessary, the customer must obtain a new exhaust damper from Schleicher GmbH. The part must be installed in accordance with the instructions supplied with it.
- b) If the exhaust damper is marked by an 'X', it must be removed and returned (together with the CFRP fairing) to Schleicher GmbH for inspection at the latest on expiry of the deadline stated in para "Compliance under b)".
