Subject: Inspection and where necessary replacement of one fuel line.

Affected: All ASH 25 Mi (production series ASH 25 M with fuel injection, Engine IAE50R-AA).
No longer applicable to all ASH 25 Mi serial numbers as of 25234.

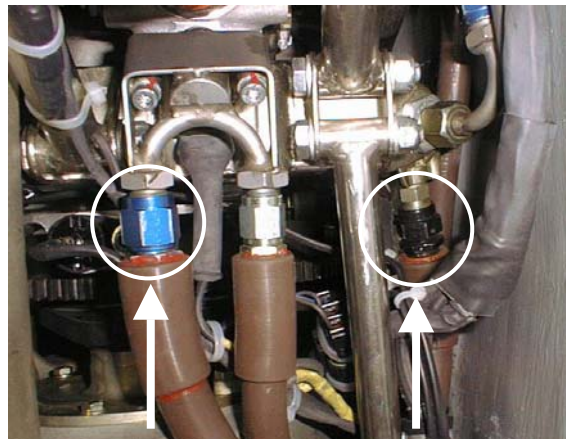
Action: With the engine bay doors open, the fuel line between injection valve and pressure regulator must be checked. The color of the connecting fitting at the injection valve must be **blue**, and the connecting fitting at the pressure regulator must be **black**.
If this is the case, no replacement is necessary, only the para "Notes" must be met.

blue

black

If this is not the case, and the fuel line uses **blue** connecting fittings at both ends, then the following action must be accomplished:

Normally the engine unit need not be removed for this purpose. With the propeller extended, the incorrect fuel line must be removed and replaced for the following fuel line:

Fuel line A

Drawing no. 803.62.0040, revision 12.02

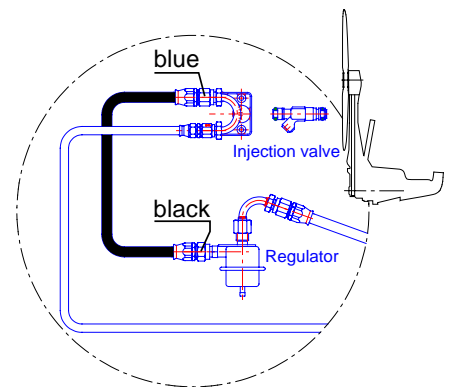
Across Flats:	blue fitting	A/F 11/16" (17,5 mm)
	black fitting	A/F 19 (mm)

Location of the fittings: **blue** > at the injection valve
black > at the pressure regulator

The new fuel line must be fitted the same way like the old one.

Torque: 1,5 –1,8 daNm
