Part I: Installation of a fixed re-fuelling system in the fuselage
Part II: Return of the wing tank ventilation into the fuselage tank

Subject: Fixed re-fuelling system

Subject: Return of the wing tank ventilation into the fuselage tank

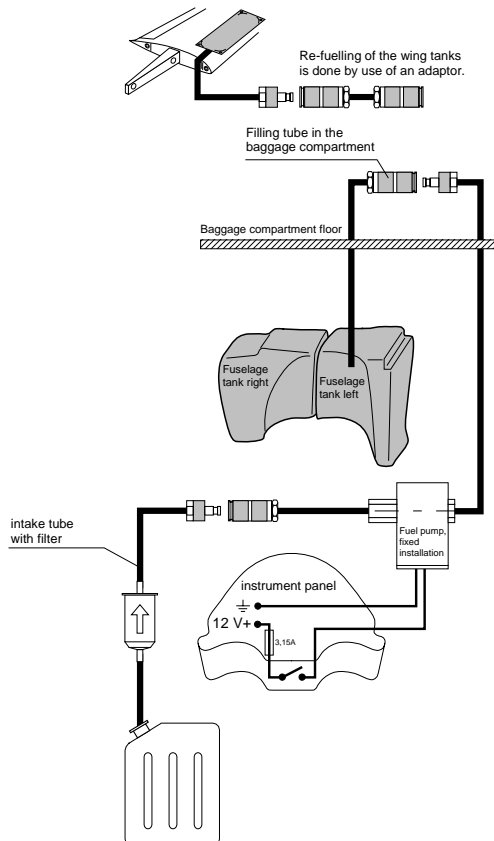
The components of the external re-fuelling system may also be installed fixed in the fuselage; this is offered as an optional extra. Two versions are available:

1. Fuel pump behind barograph box in the fuselage

The fuel pump is located behind the barograph box. The fuel line runs (fire-protected behind the engine bay side wall) forwards to the baggage compartment. Here the re-fuelling system can be connected to the filling tube which is supplied as standard equipment item. The connecting coupling for the external intake tube with filter is located in the barograph box.

2. Fuel pump in front of fire bulkhead

The fuel pump is fitted in front of the fire bulkhead in the area of the control linkage system. The fuel line runs to the baggage compartment. Here the re-fuelling system can be connected to the filling tube which is supplied as standard equipment item. The connecting coupling for the external intake tube with filter is located at the rear shut-off wall of the landing gear compartment; it can be accessed from below through the landing gear box. There is a cover to protect the connecting coupling from dirt; and additionally it is closed by a dust plug.

268.62.9006 „Installation re-fuelling system (optional extra)“

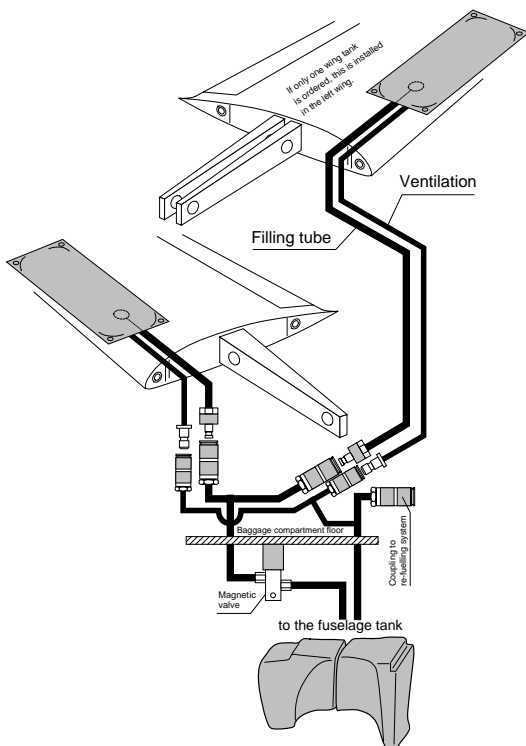
If during re-fuelling the wing tanks are overfilled inadvertently, fuel could escape via the ventilation at the end rib of the inner wing, fuel which better should be collected for environmental reasons. In order to avoid such the vent tube can be returned into the fuselage tank. This tube however requires a separation joint at the fuselage to wing intersection; a separation joint which **must** be connected additionally during each rigging. The couplings used at this point are different from the existing wing tank couplings to exclude a mix-up.

Material and Drawings:: 268.62.9005 „Wing tank ventilation, return into the fuselage tank “
