**Subject:** Check of control circuit clearance inside the fuselage tail boom to fin intersection.

**Serial number applicability:** All ASW 27, Document No. 04 - 389, Serial Numbers 27002 through 27 104 .

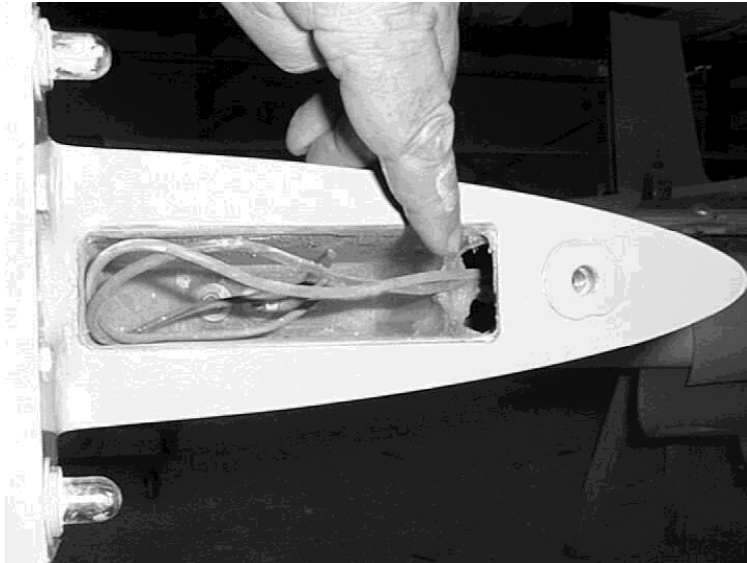
**Fig. 1A**

**Reason:** An ASW 27 owner in Sweden reported light jamming in one flight and abandoned the take-off. Rubbing of the 90° lever with its attached mass balance lead weights and connecting bolt against the cut-out of the lower fin rib has been determined as the only likely cause.

**Action:** **1)** De-rig the horizontal tailplane, look through fin ballast box as shown in Fig. 1A and check the clearance left and right of the mass balance weights, see Fig. 1B. A strong light which is held to the outside of the fuselage to fin intersection close to the critical area improves the visibility remarkably.  
**NOTE:** The critical situation is reached, when the elevator actuator is fully down. When the clearance (including bolt head and nut or bolt end) is about symmetric and 2,5 mm (1/10 inch) wide, no further action is needed.
