Subject: A) Improved attachment of the RPM-sensor
B) Improved attachment of the fuel pump
C) Upgrade of the hardware of the power-plant instrument
D) Exchange of manual pages

Applicability: All ASW 28-18E, Type Certificate EASA.A.034, all S/N up to 28742 inclusive, serial standard from S/N 28743 on

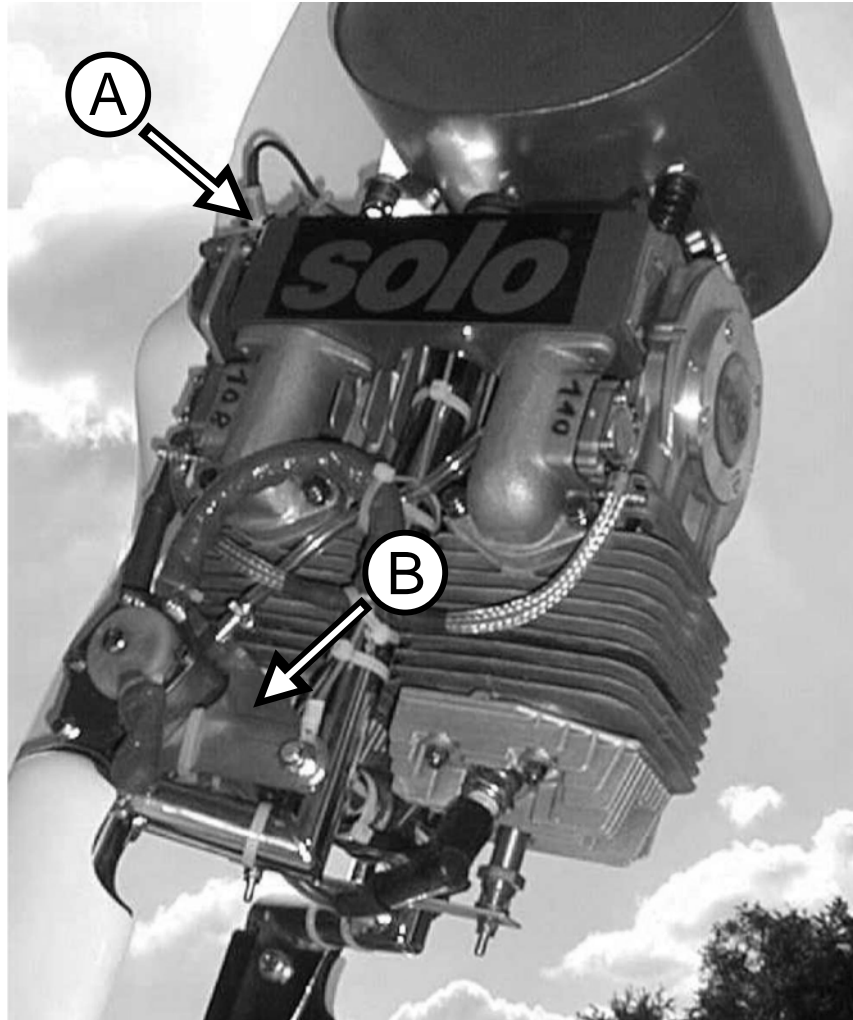
Position of the involved parts:

Reason: Higher fatigue strength

Action: A) The attachment made of FRP (850.72.203) replaces the aluminium part (850.72.0021).
B) The attachment plate (850.72.0088) of the pneumatic fuel pump is replaced by a more convenient formed part.
