<b>Subject:</b>	Potential cracks in the left and right engine bearer and the attachment of the fuel pump
<b>Applicability:</b>	ASW 28-18E TCDS EASA A.034, all serial numbers
<b>Urgency:</b>	A) Within 30 days after the effective date of the corresponding AD If the inspection proves that the engine bearer is affected: B) Within 30 days after the effective date of the corresponding AD C, D) Within 30 days after the effective date of the corresponding AD, provided the conditions described in the actions are fulfilled E) Within 10 months after the effective date of the corresponding AD F, G) After completion of actions C and D respectively E
<b>Reason:</b>	Cracks appeared in the horizontal tube of the left or right engine bearer (Fig. 1). Not affected are engine bearers of the following two kind: <ul style="list-style-type: none"><li>• Either those, which are already reinforced and were marked by a punched X (Fig 2).</li><li>• As well as those, which were installed due to TN 10, action A (drawing number 850.67.0110).</li></ul>

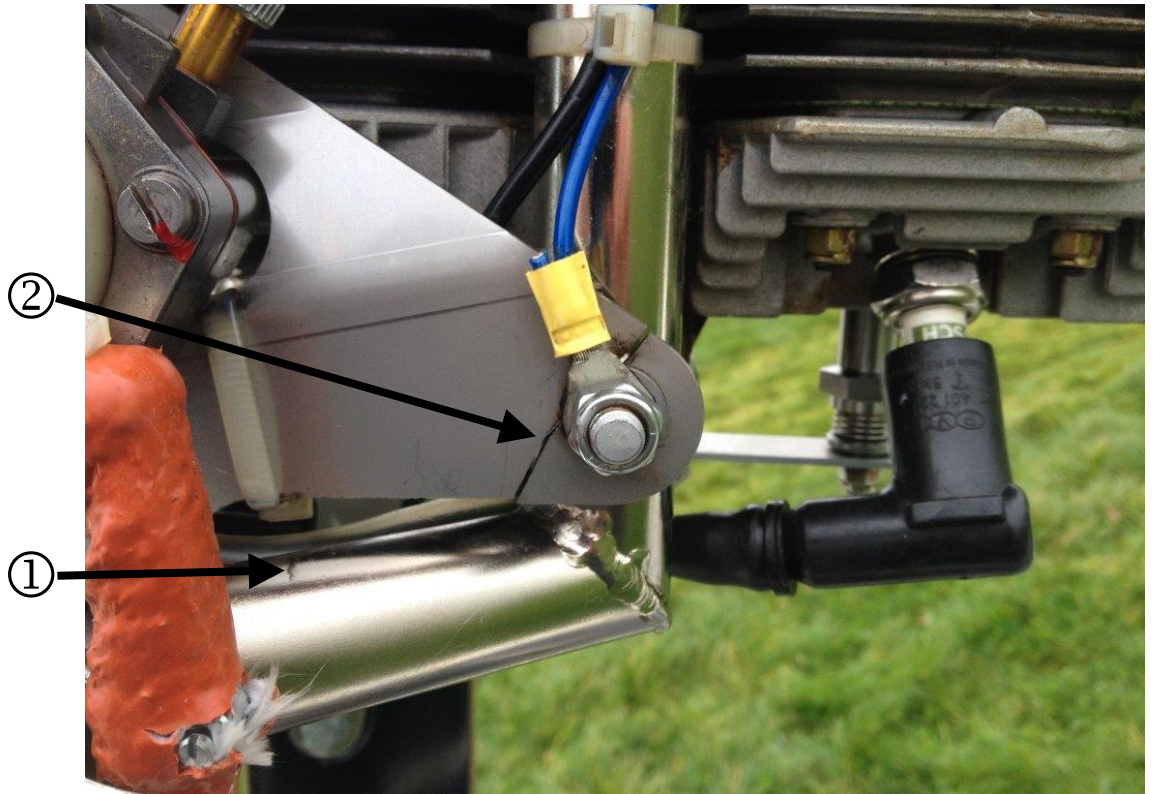
**Fig 1:** Engine bearer with a crack ① in the horizontal strut, and - most probably as a result - with a broken attachment ② of the fuel pump. (picture: BGA)

- E) Unless accomplished as specified by action C or D, the right engine bearer and the left engine bearer and the attachment of the fuel pump are to be replaced against serviceable parts.
- F) After the replacement of the LH and RH engine mount (engine bearer) and the fuel pump attachment with serviceable parts, as required by action C and D or by action E of this TN, as applicable, the placard as required by action C or D of this TN and the exchange of the Flight Manual pages, as required action B.1 of this TN, can be reversed.

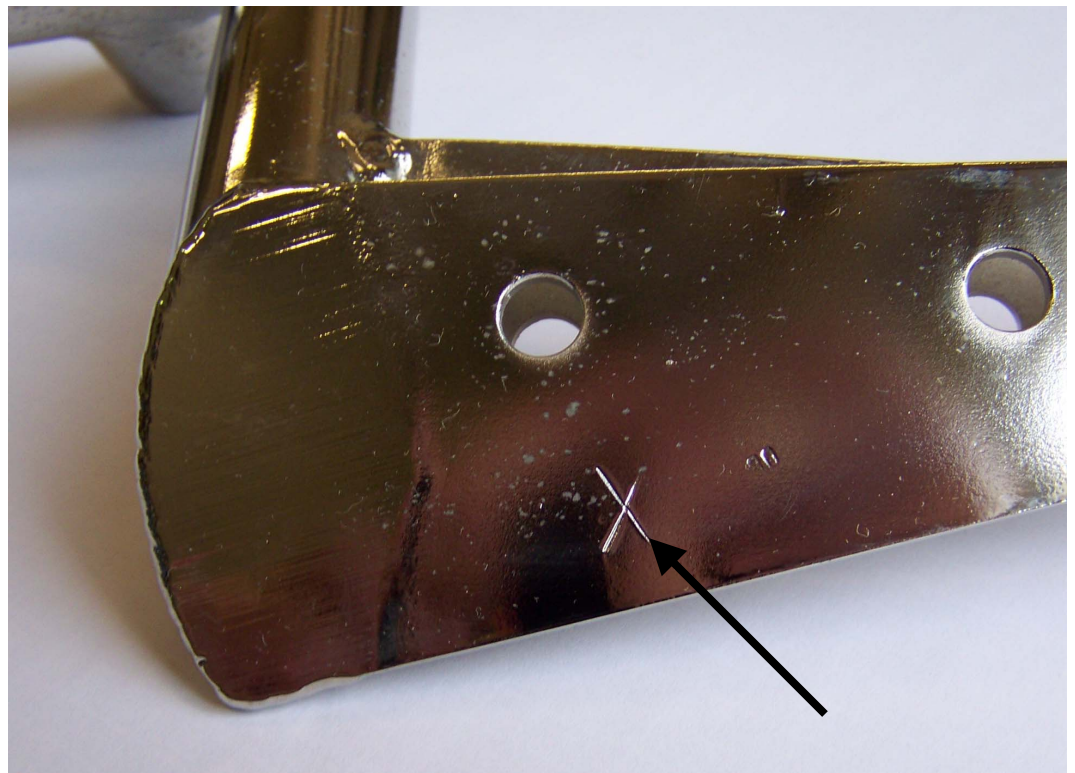
**Fig 2:** Engine bearer marked with a punched X (arrow)

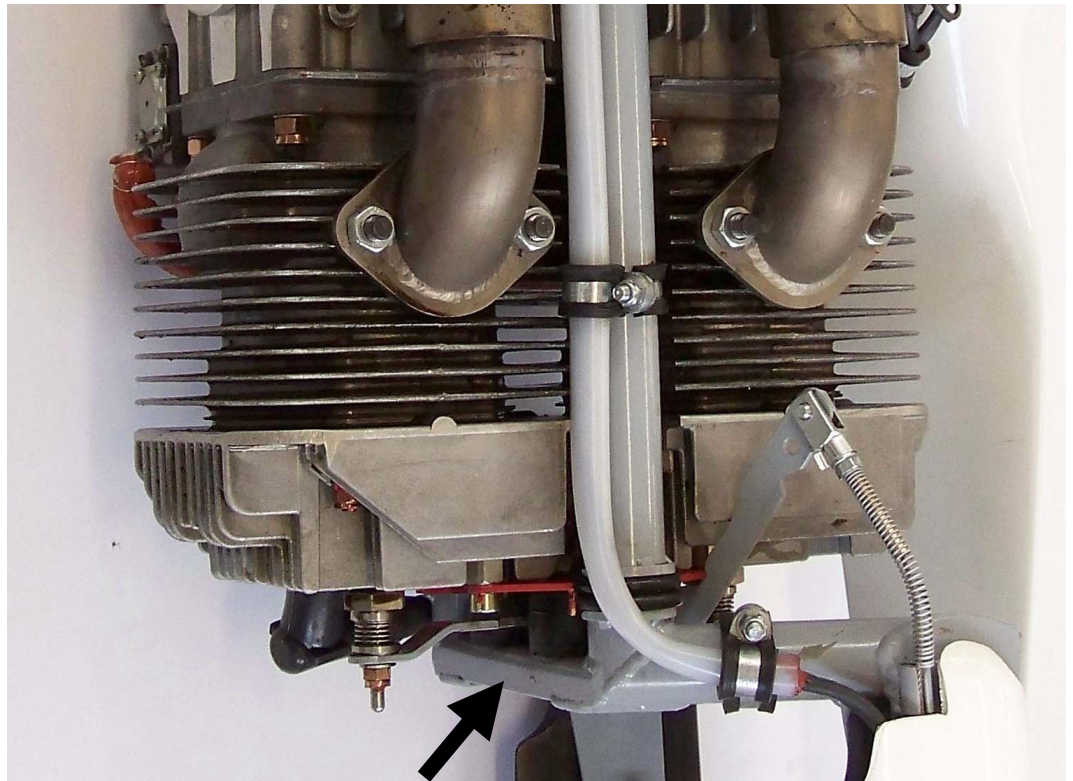
**Fig 3:** Engine bearer according to TN 10, action A. It can be identified by the bridge (arrow) welded to both left and right side of the engine bearer.
