**Airworthiness  
Directive  
1993-001/3**

**L`Hotellier ball and socket connectors**

L`Hotellier ball and socket connectors with lock plates if installed in sailplanes, powered sailplanes and aeroplanes

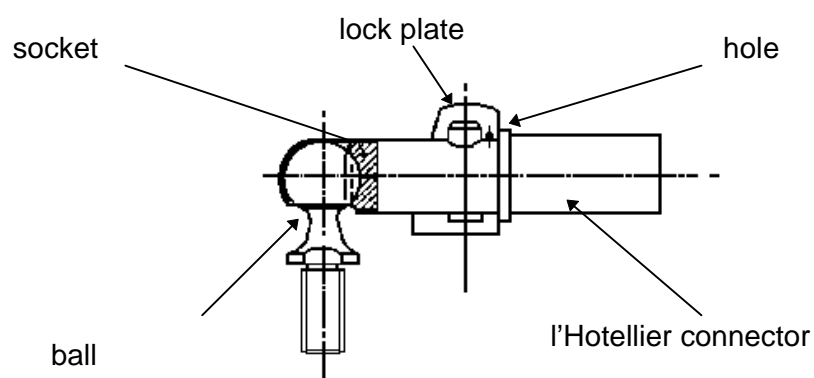
If the connectors are not yet equipped with safety pins (e.g. l'H 140-31 made by Hotellier), these safety pins have to be retrofitted. In certain cases it may become necessary to rebores the hole in the lock plate, which is provided for visual inspection, to  $\varnothing 1.2$  mm so that the safety pin can be inserted.

Unsecured ball and socket connectors may open automatically in flight!

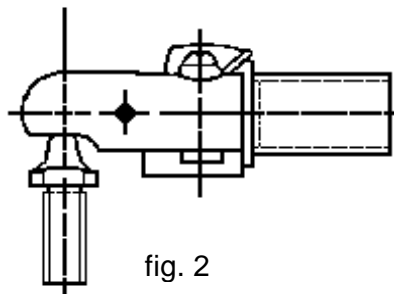
fig. 2

The following systems to secure l'Hotellier ball and socket connectors are LBA-approved: Uerlings sleeves or Uerlings type sleeves (see section III), safety pin (figures 2 and 2a), LS-safety sleeve (figure 3), Schempp-Hirth spring (figure 4) und Wedekind locking system (figure 5).

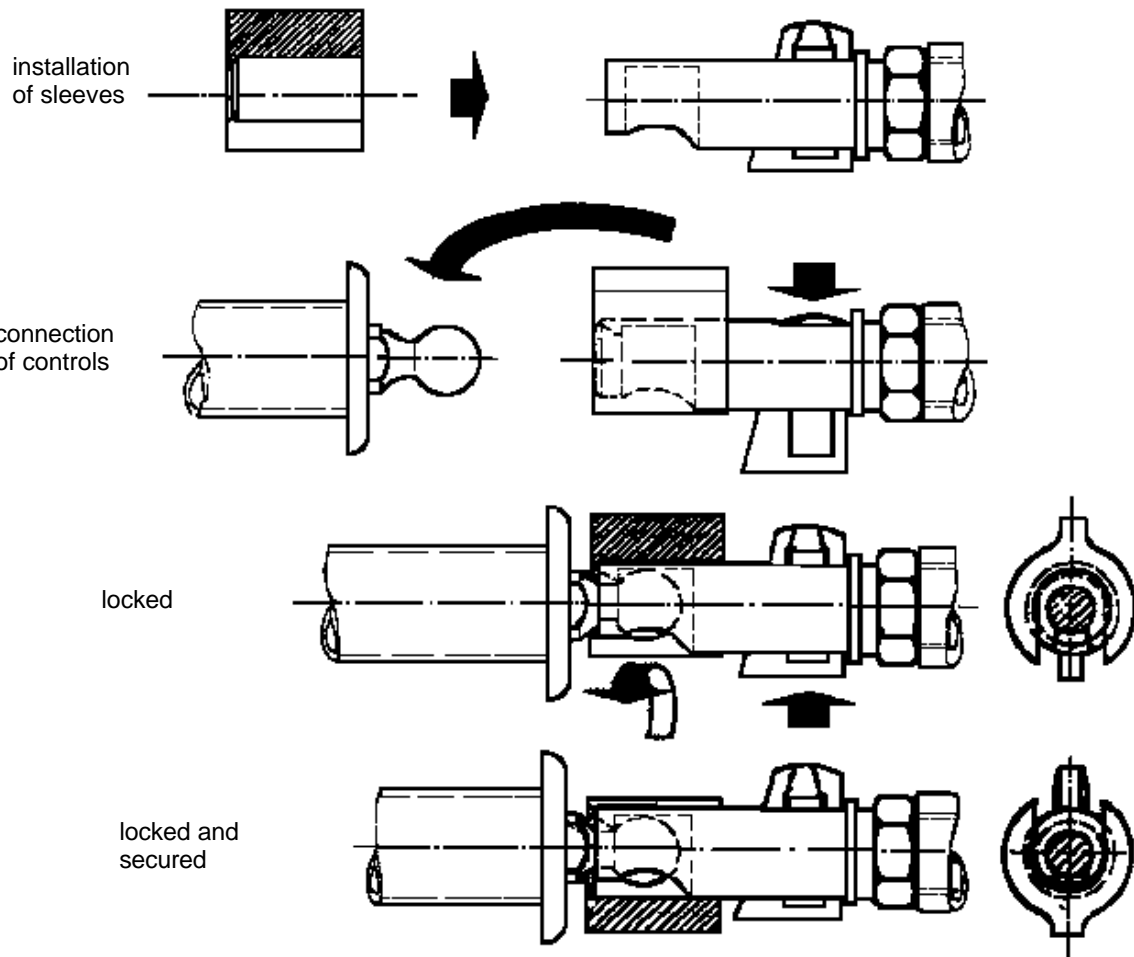
They may by no means be clipped radially onto the l'Hotellier ball and socket connector. Radial clipping (excessive opening of the sleeve) may lead to cracks or ruptures due to overstressing so that the sleeve cannot function properly any more.

For installation, the sleeves have to be slid axially onto the l'Hotellier ball and socket connectors.

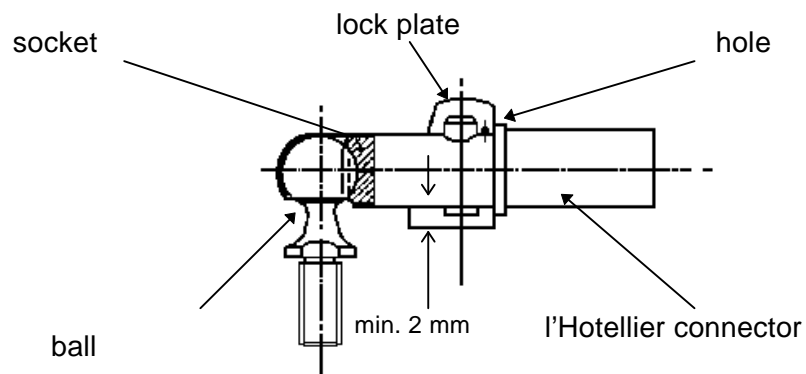
The socket is to be slid completely over the ball with the lock plate pressed down. During locking the lock plate moves back slightly so that in a correct connection the hole on the narrow edge of the lock plate becomes visible.

Unsecured ball and socket connectors may open automatically in flight.

The safety pin is to be inserted in this hole thus securing the ball and socket connector.

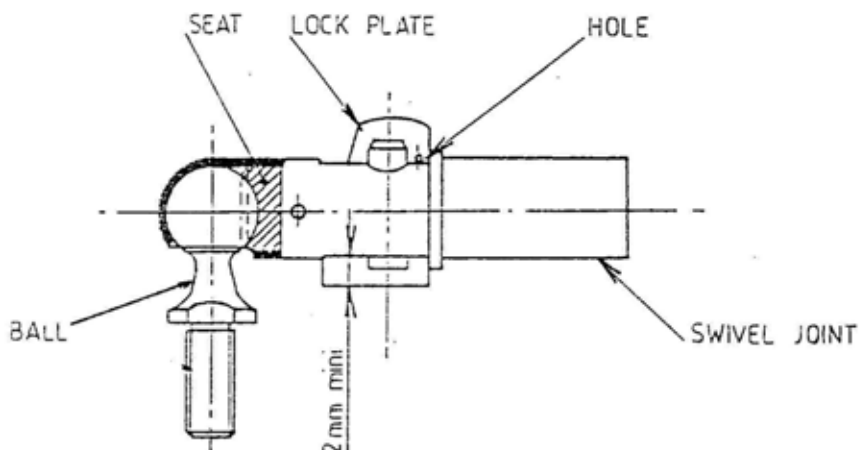
FIG. 1

**2.5. MEASUREMENT OF THE LOCKER LOWER PART PROJECTION AFTER ASSEMBLY OF THE SWIVEL ON THE BALL (see fig. 1)**

This projection must be higher than 2 mm.

The aim of this requirement is to verify the efficiency of the automatic take up clearance

If after these verifications, one of the above check is out of tolerance, it is mandatory to replace both ball and swivel. nevertheless it is recommended to replace this assembly every 10 years or every 3000 flight hours.

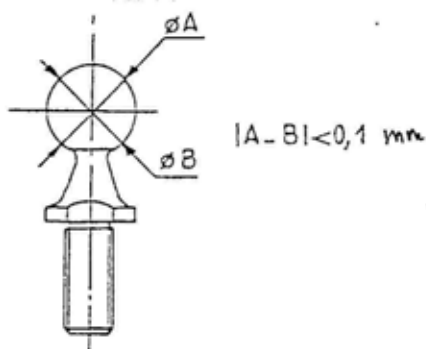
FIG. 2

**2.2. BALL SPHERICITY MEASUREMENT (See fig. 2)**

The variation between several measures of the ball diameter must not exceed 0,1 mm.

This check aim is to detect an abnormal ball wear.
