82-216

Date of issue: November 9, 1982

Subject:

Sleeves on cable splices

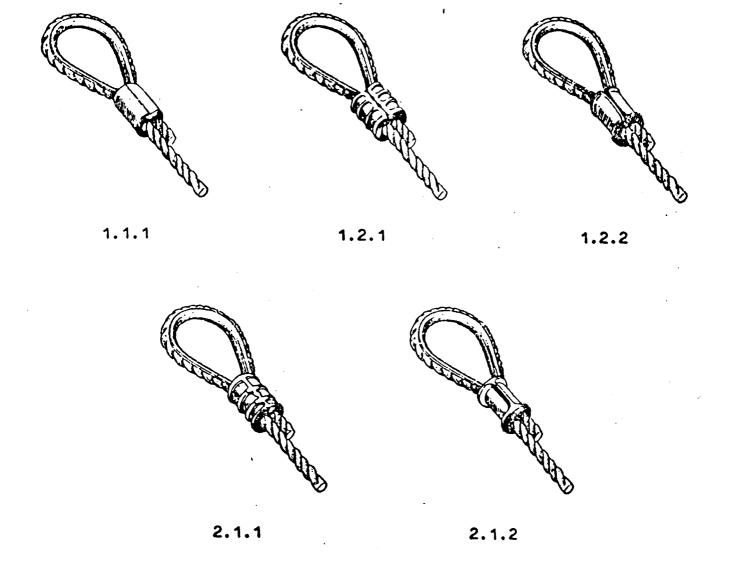
1. Admissible cable splices

- 1.1 TALURIT sleeve pressed with a TALURIT tool:
 - 1.1.1 Cable diameters 3.2 mm and 2.4 mm, smooth sleeve without any noticeable rims and grooves.
- 1.2 NICOPRESS sleeve pressed with a NICOPRESS tool:
 - 1.2.1 Cable diameter 3.2 mm, sleeve shows two opposite longitudinal grooves and three pressed grooves around its perimeter
 - 1.2.2 Cable diamter 2.4 mm, sleeve shows two opposite longitudinal grooves and one pressed groove around the perimeter.

2. Inadmissible cable splices

- 2.1 TALURIT sleeve pressed with a NICOPRESS tool:
 - 2.1.1 Cable diameter 3.2 mm, sleeve shows two opposite longitudinal rims instead of grooves and three pressed grooves around its perimeter.
 - 2.1.2 Cable diameter 2.4 mm, sleeve shows two opposite longitudinal rims instead of grooves and one pressed groove around the perimeter.

All control cables with inadmissible cable splices are to be replaced by airworthy ones.
