Modification No. 8  
Glider Ka 2 a. Ka 2 B  
L - 140 a. L - 203

Check of stick attachment in the rear cockpit.

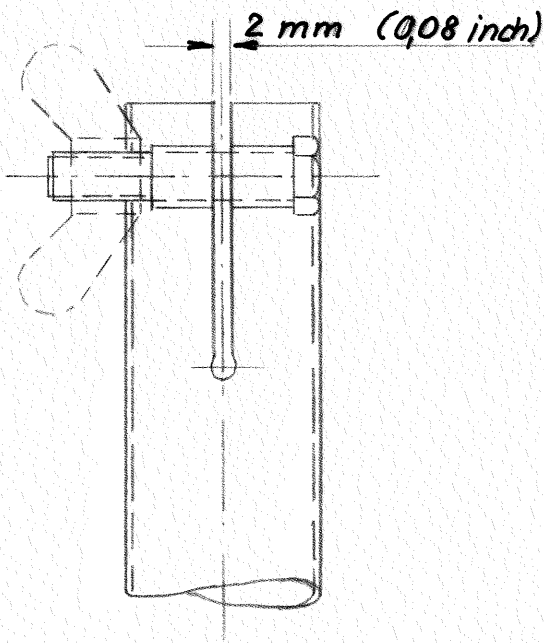
Probable by deformation on the tube nozzles there has been found a loose stick although the wing nut was fastened.

- 1) Check if the both tube nozzles are not bended by the screw so that it is possible to pull out the stick even when the wing nut ist fastened.
- 2) Check the gap for the wide of 2 mm (0,08 inch). If neccessary make it wider by a file. (See scetch). With fastened wing nut, the stick must be reliably fixed.
