Subject: Strengthening of the upper Vertical-Rudder Bearing-Jack.

Betr.: Segelflugzeugmuster

LBA-Lufttüch

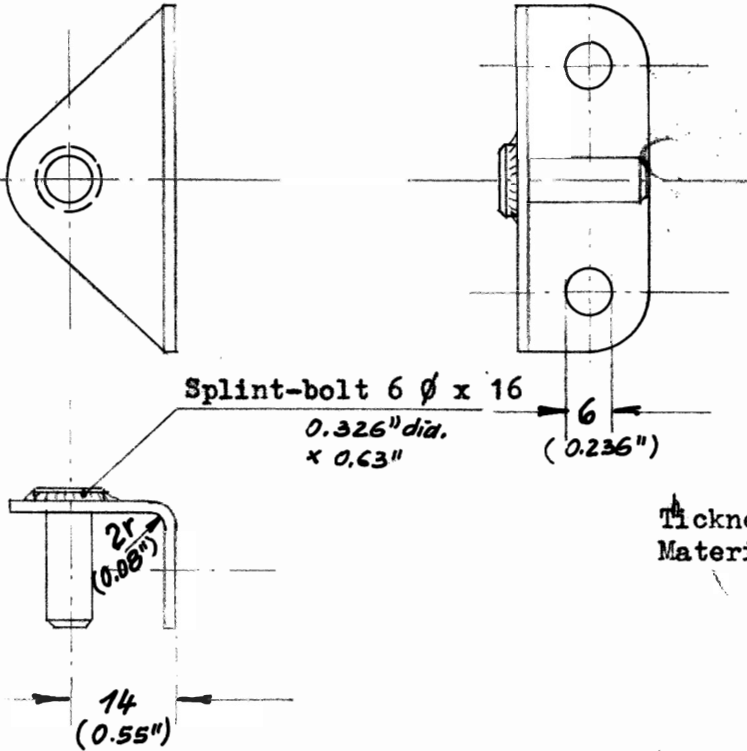
Argument and Proceedings: Breaking of the vertical-Rudder Bearing-Jack, in all probability due to fatigue.

8-125-8-8
0.314 0.291 0.314 0.314
einen Segelflugzeug "Ra-
brochen. Der
einen Verbruch hin,
(1.44")

Thickness = 1,5 mm (0.06")
Material 27 Mn Cr 4 strength: 60 kg/mm²

Chrom moly steel of
min Ft_u = 90 Ksi

Remove rudder, take off the fabric on one side above in front.

Change rudder bearing. Nuts to be fastened with locknut.

Fabric and varnish to be renewed. Build in rudder. Control of easy movement, safety and correct sense of the rudder movement.
