Name of Modification: Free pass of elevator cable at the control shaft.

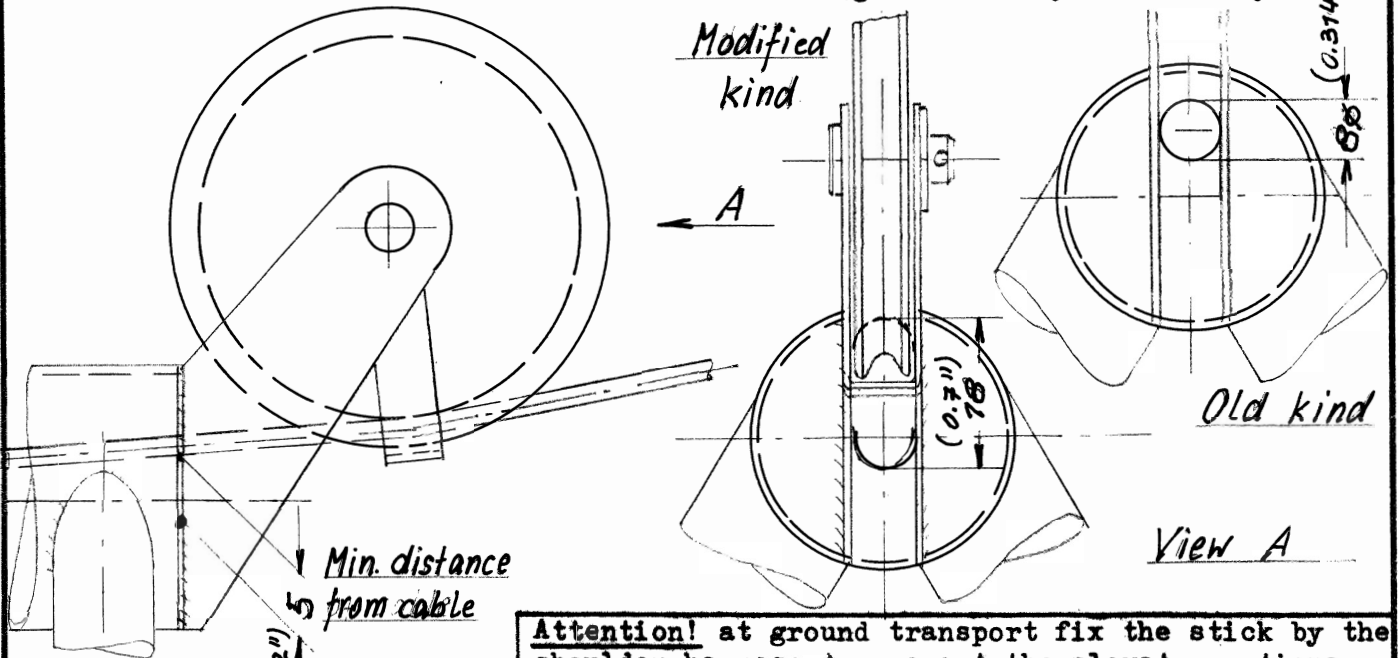
Cause: It is supposed a cable break is caused by friction on the pass through the rear end of the control shaft in front of the pulley.

- a) Control the elevator cable for cracks and wear (Disconnect the connections and pull the cable through).
- b) Check freegoing of the cable at the hole in the rear end of the control shaft, above and beneath the cable.
- c) Control tension of cable. (cable must be not too slack, yet not too tight. Attent, high temperatures will cause slack cables).

Enlarge the hole to $18 + 20$ mm, so that the minimum distance between cable and metal is 5 mm. To be used best a round file of 8 mm dia. The pulley is to be removed. Be carefully not to injure the cable. To be checked with build in pulley and cable in tension. Reinstall all safety pins etc.
There is again referred to the handbook about treating the control cables.
