Alexander Schleicher - Segelflugzeugbau - Poppenhausen/Wasserk.

Modification No. 10 Glider Rhönlerche L - 164 ( US 7G6 )

Check of stick attachment in the rear cockpit.

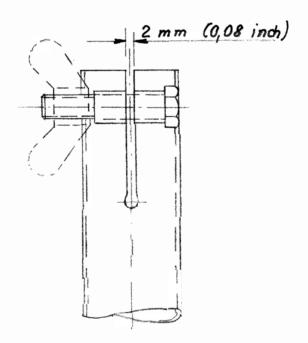
Probable by deformation on the tube nozzles there has been found a loose stick although the wing nut was fastened.

- 1) Check if the both tube nozzles are not bended by the screw so that it is possible to pull out the stick even when the wing nut is fastened.
- 2) Check the gap for the wide of 2 mm (0,08 inch). If neccessary make it wider by a file. (See scetch). With fastened wing nut, the stick must be reliablely fixed.
