Technical Note  
no. 13

Alexander Schleicher  
Segelflugzeugbau  
6416 Poppenhausen

**Subject** : Strengthening of the control shaft

**Effectivity** : Glider Rhönlerche II

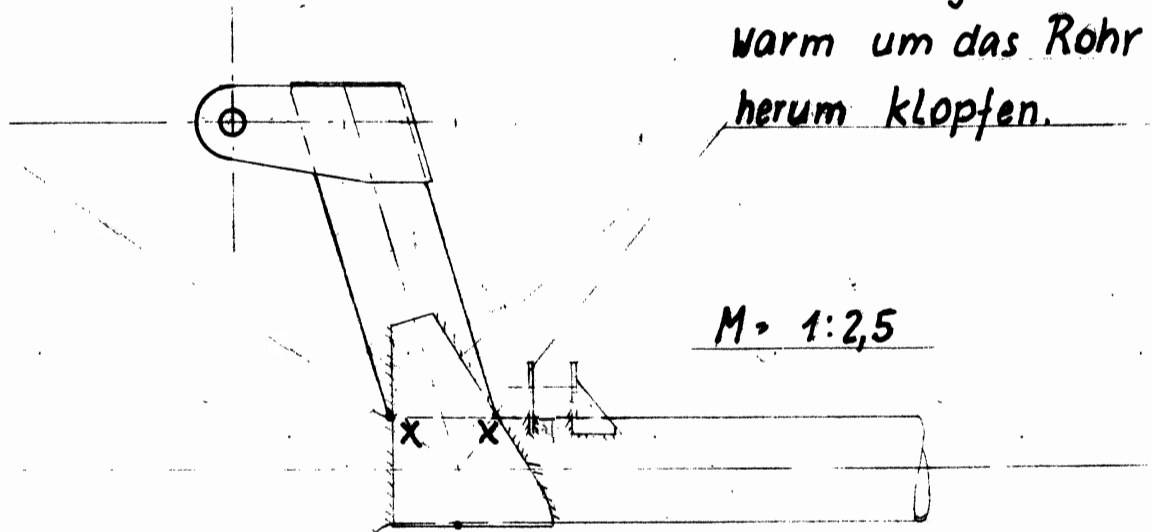
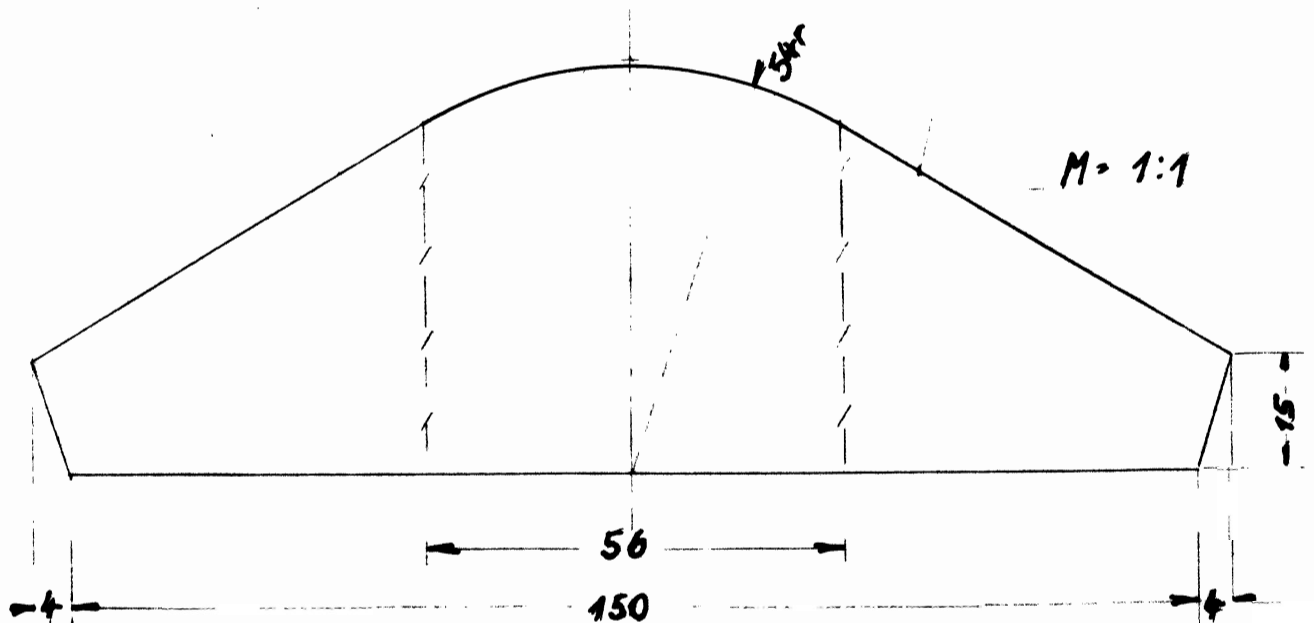
**Instruction** : There has to be made an investigation of the control shaft at the X marked spots for cracks immediately.  
In case there are cracks, these have to be welded and the modification according Technical Note no. 13, sheet 2, has to be made.  
Therefore the control shaft has to be removed, the control cable has to be renewed.  
Unscrew the skid covering along the skid.  
In all other cases the modification has to be made until the next annual inspection.

Bend sheet metal  
around the tubes with  
a hammer while hot.

Stahlblech 1.72 14.4 od. 1.77 34.4 1.0 mm dick
