Alexander Schleicher  
- Segelflugzeugbau -  
Foppenhausen/Wasserk.

Modification No. 2  
Glider Ka 6 a. Ka 6 B  
(US 7G1)

LTA Nr. 7

Appearance of wear.

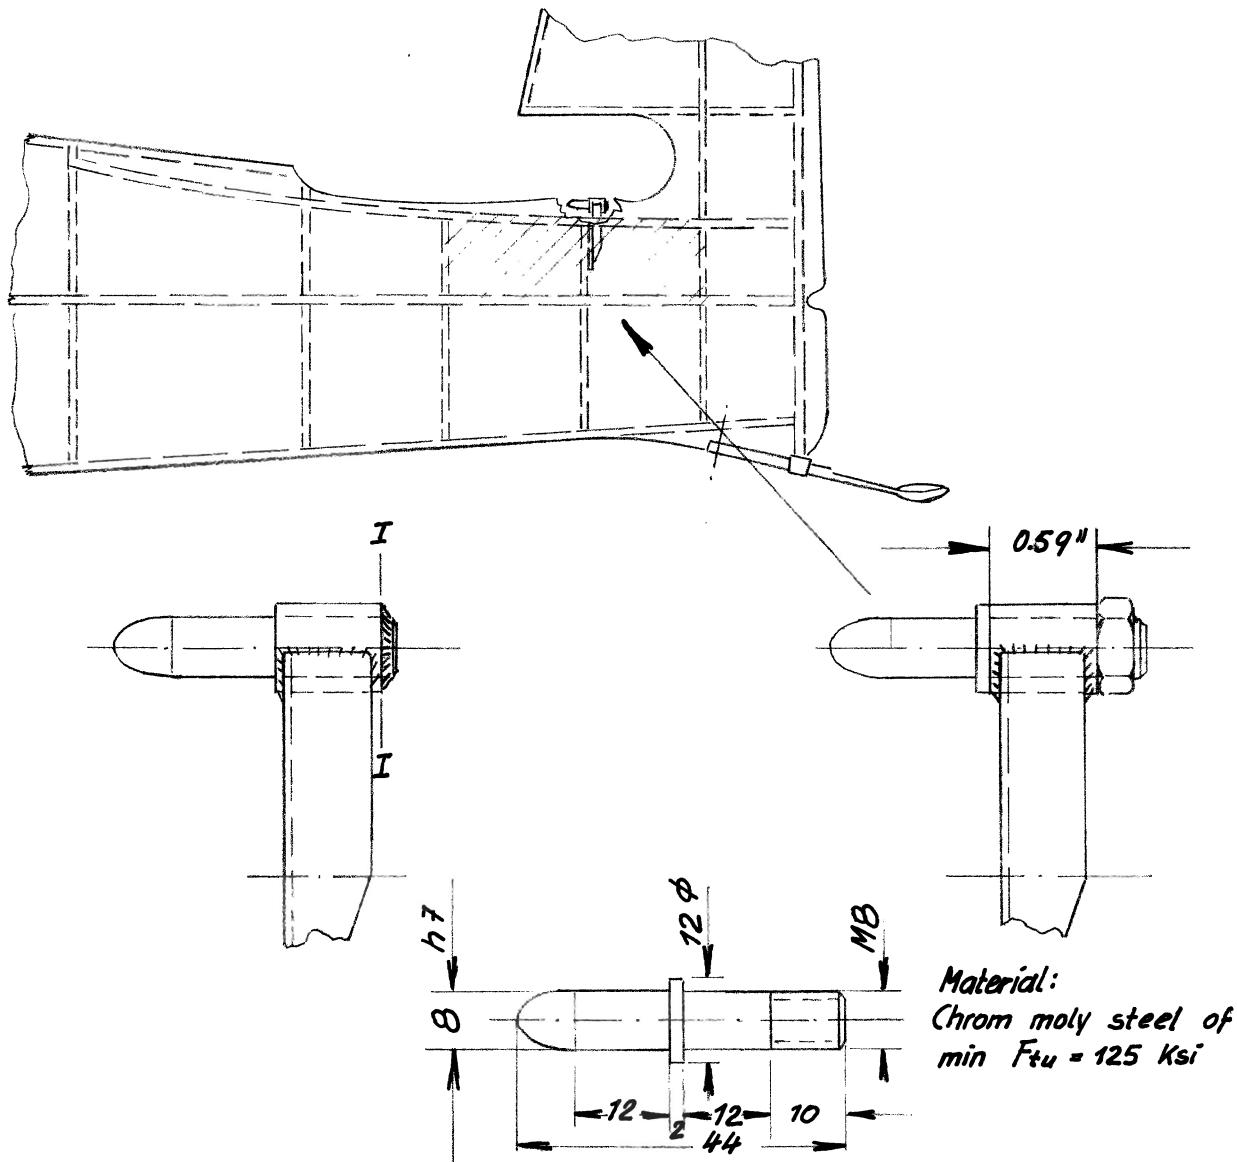
AM 2/1

1.) Interchangeable bolts at the rear stabilizer connection.

Urgency: At all new aircraft. At all others when heavy backlash occurs.

Remove plywood on both sides of the fuselage at the hatched spots. Build out the supports and sign it with R. a. L. cut off the weld in section I - I. and take out the bolt. Put in the new bolt. (Supplied by the firm A. Schleicher). Before reinstallation a 0,08 " thick plate of plywood of the same size of the already present plate is to be glued on additionally. Then build in the supports again and secure the screws. Finally complete the plywood covering, 0,06" birch plywood to be used.

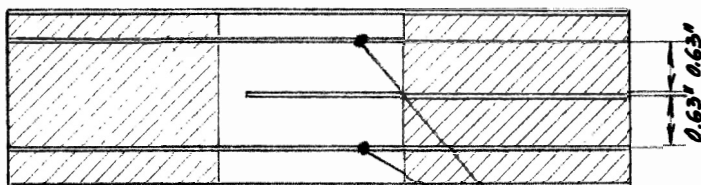
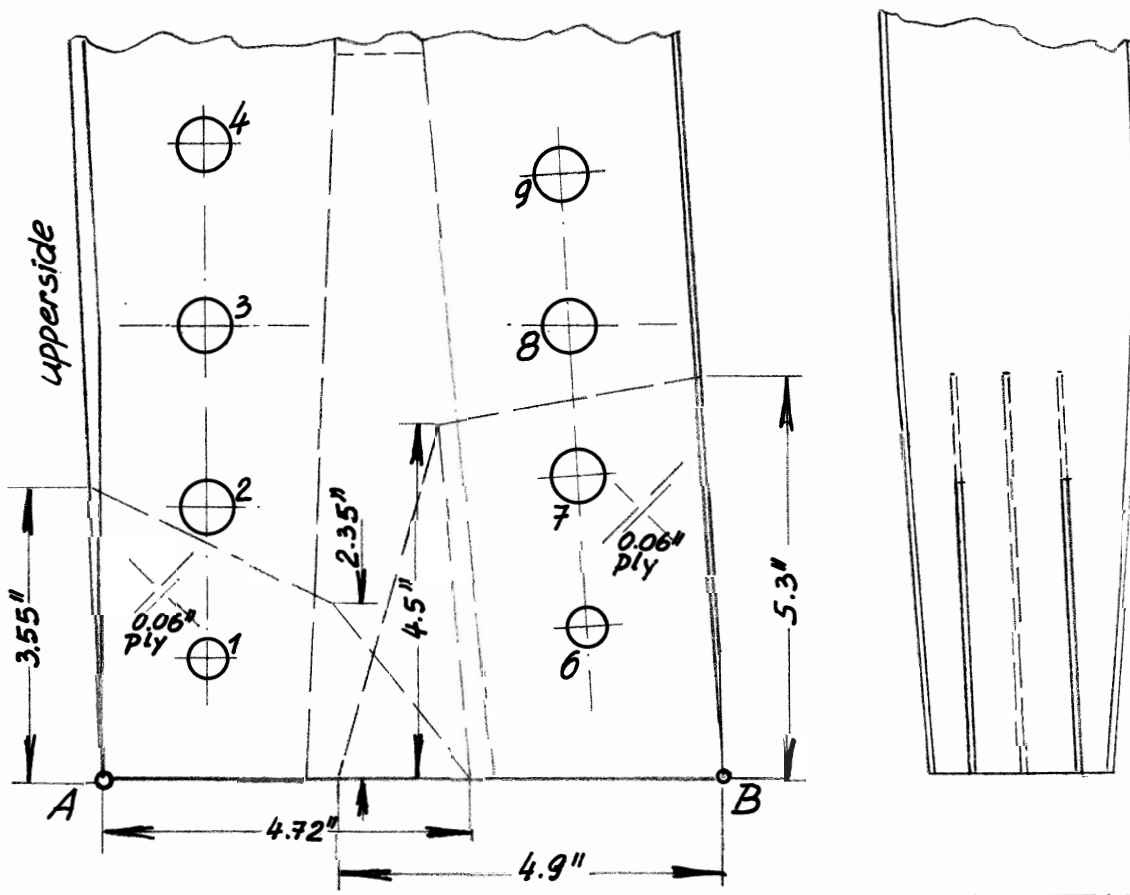
2.) Plywood inserts in the spar root to prevent cracks due to shrinkage.

Urgency: At all new aircraft. At all others until the next annual inspection.

*adjoining of the both  
 outer plywood inserts*

Remove bolt 1 ; 6 a. 7. With a hole saw cut in from the corners A and B beginning. The saw must be set so that the 0.06 " plywood can be easily bushed in but without excessive oversize. (Try it on a test sample). This work needs quite a lot of workmans skill. It is to prevent that by not exact guidance of the saw the cut will grow to wide.

After cleaning of the cuts the prepared plywood is glued in. Notice the grain direction! The whole root part is then pressed by clamps which are put on the fittings. The applying of the glue must be done very carefully, the plywood is to be bevelled on the front edge to prevent the glue pushed out of the joint. Best suitable glue is a resorcinol glue such as Aerodux 185. After setting of the glue the spar root is cleaned and the bolt holes are reamed. Finally the bolts are set in again. Use new nuts only!
