Strengthening of connecting lap of forked airbrake push rod in fuselage.

LTA Nr. 7/62

Leistungseinsitzer
Schleicher Ka 6
Bearb. R. Kaiser 13.9.62.

Zeichnung zu
Änderung Nr. 7

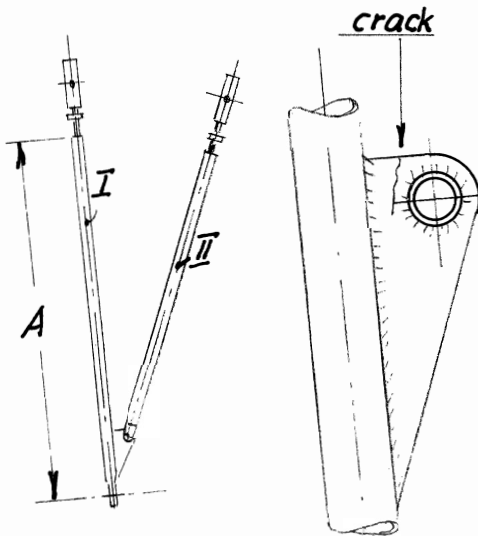
There have been found cracks on several pieces as shown in figure.

- 1.) The pushrod I) is to be build out and replaced by a modified one. Secure all screws and pins by split pins properly. The quick - connecting head is to be adjusted at the assembled glider and secured by the nut. Check proper closing of both airbrakes!
- 2.) The modified pushrod is to be ordered by the Firma of A. Schleicher or one of the License firma. The distance A) must be given exactly when ordering.

- 3.) The modification is made from S.No. 6067 incl. 0.04"
The ~~modification~~ modified push rod has 2 plates 1,0 mm thick. A few samples are modified with 1.5 mm thick plates, this is taken as equivalent.
a. 0.06"
