ALEXANDER SCHLEICHER KG Segelflugzeugbau Poppenhausen/Wasserk.

Technical Note Glider Ka 6 E L - 205

No. 17 LTA Nr. 68/109

Suspension of the thermosbottles beow the baggage

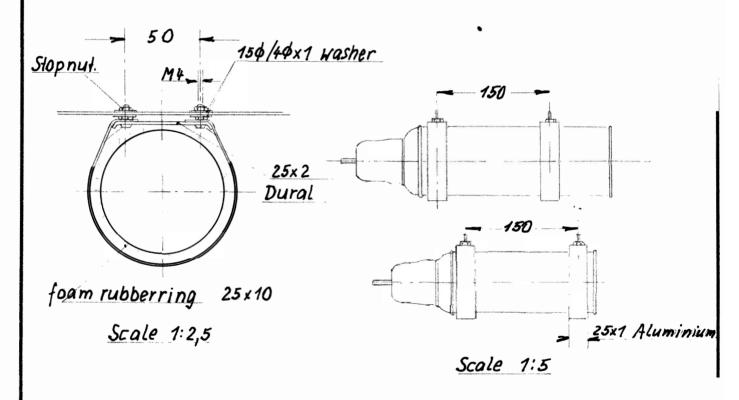
There is the suspicion, that a bottle got loose and

blocked the controls.

Remove the bottles and cut off the existing screws. Place new clamps over the bottle and install rubber ring in between. Adjust correct distance of the clamps (see sketch). Drill holes for the attaching screws in the plywood bottom floor from the inside of luggage compartment. Any existing equipment

Install bottles using 15 mm Ø washers on each side

of floor bottom. Reconnect the bottles in the

correct sense to instrument lines.
