Alexander Schleicher
- Segelflugzeugbau -
Poppenhausen/Wasserk.

Modification No. 3
Glider K 7
US 7G3

LTA Nr 15

Changing of the middle elevator bearing support.

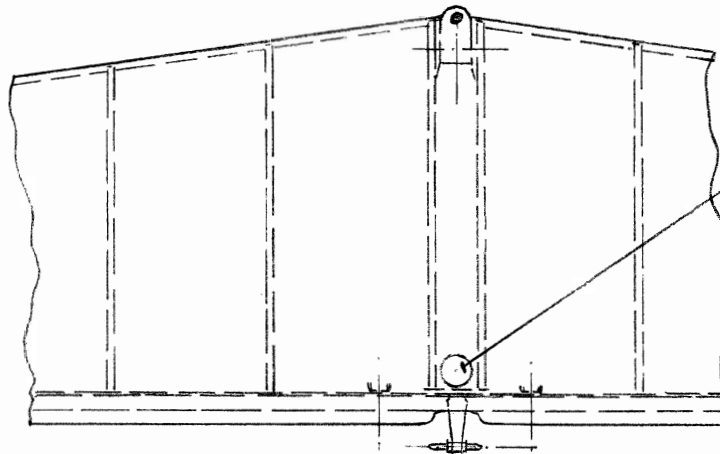
The bearing support of an aircraft cracked along the weld due to excessive grinding of the ground plate.

1. Cut in a hole into the plywood covering on the lower side.
4. Close later the hole with 0.04 " plywood.
