Additional support of the elevator push rod.

The modification 8 must be made at all gliders, except the after Modif. 7 modified ones.

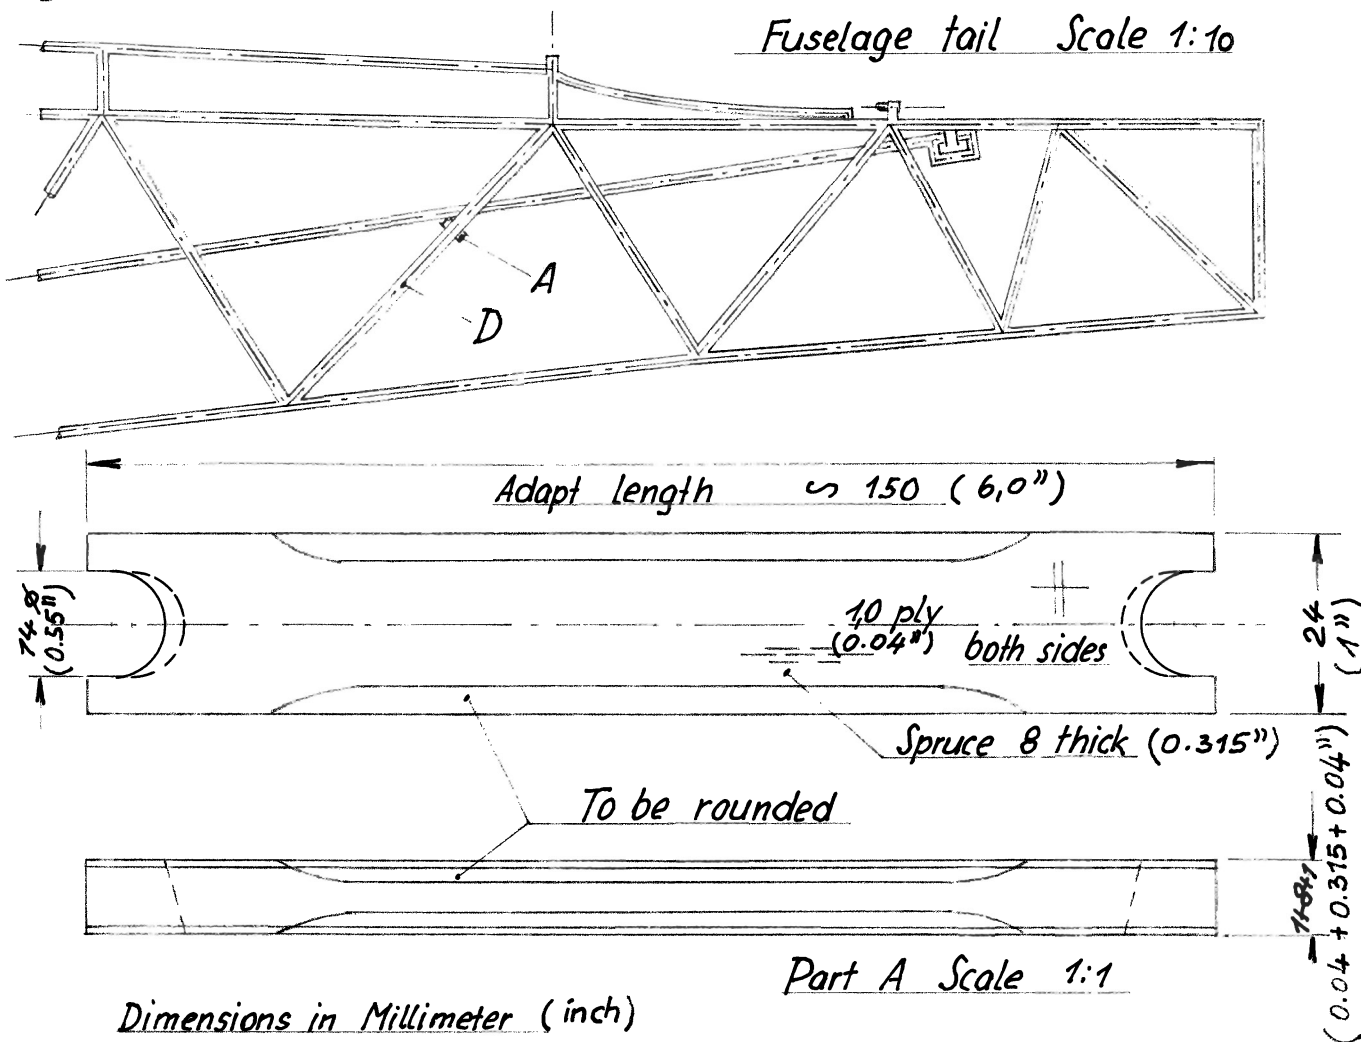
It is supposed that by elasticity of the push rod the ball bearing of the elevator lever has sprung out.

Part A to be put into the V-steel tubes D so that the elevator push rod in its lowest position is going just free (about 1 mm distance). Part A must sit tight in the tubes without damaging or bending the tubes. Part A is then fixed with the tubes by lino tape and adhesive dope.

The works can be done from the opening for the tailplane.
