Additional support of the elevator push rod.

Urgency: Immediately.

The modification 7 must be made at all gliders, except the after 6 modified ones.

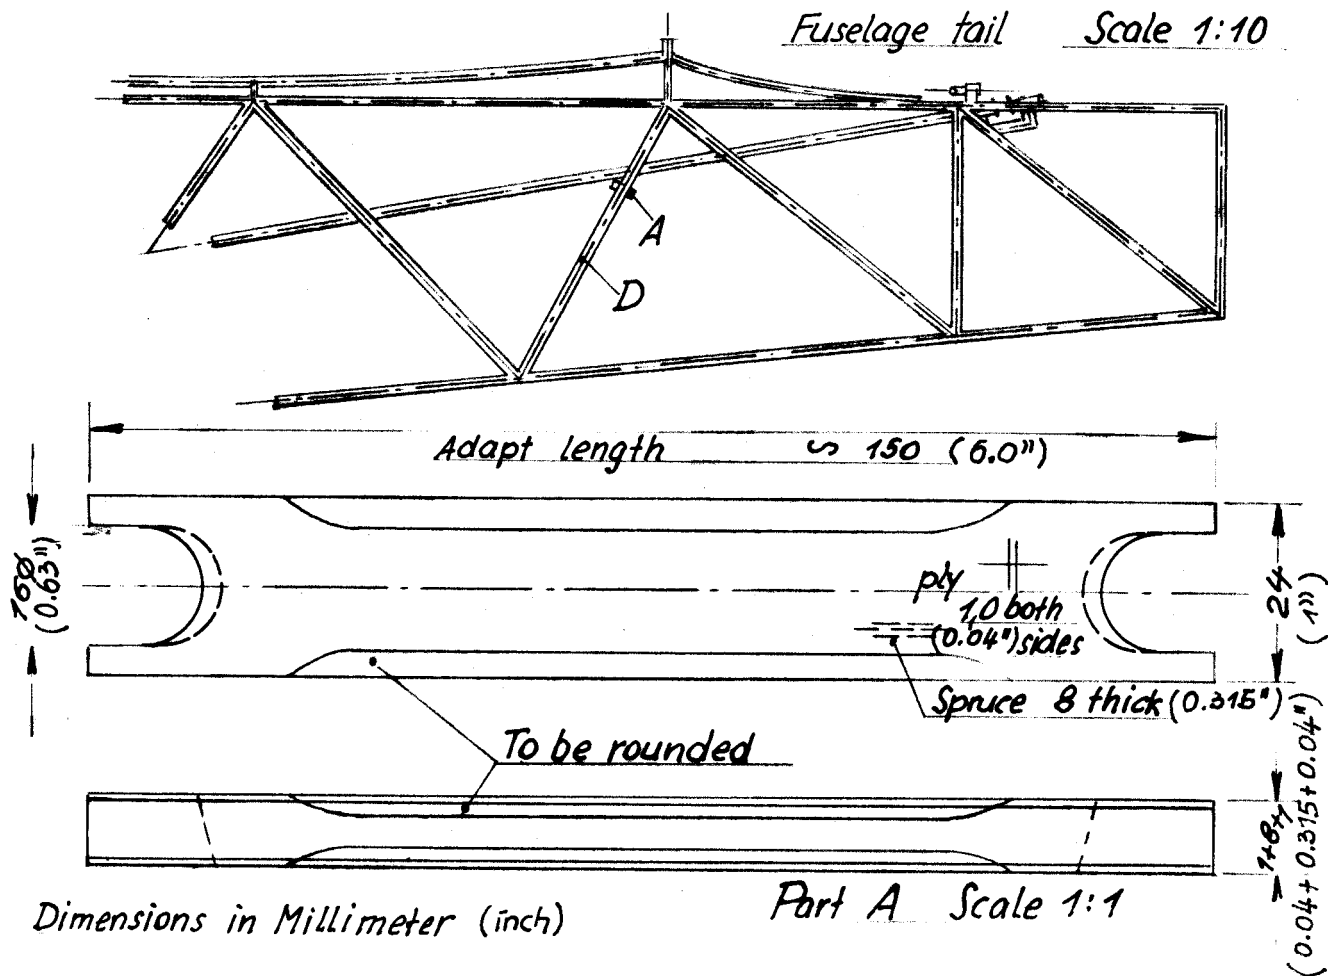
It is supposed that by elasticity of the push rod the ball bearing of the elevator lever has sprung out.

Part A to be put into the V-steel tubes D so that the elevator push rod in its lowest position is going just free (about 1 mm distance). Part A must sit tight in the tubes without damaging or bending the tubes. Part A is then fixed with the tubes by linon tape and adhesive dope.

The works can be done from the opening for the tailplane. At gliders having a flettner trim there may be some sliding of the control wire. This point should be well rounded.
