(US 7G4)

Strengthening of connecting lap of forked airbrake push rod in fuselage.

Leistungseinsitzer
Schleicher K 8
Bearb. R. Kaiser 13.9.62.

Zeichnung zu
Änderung Nr. 9

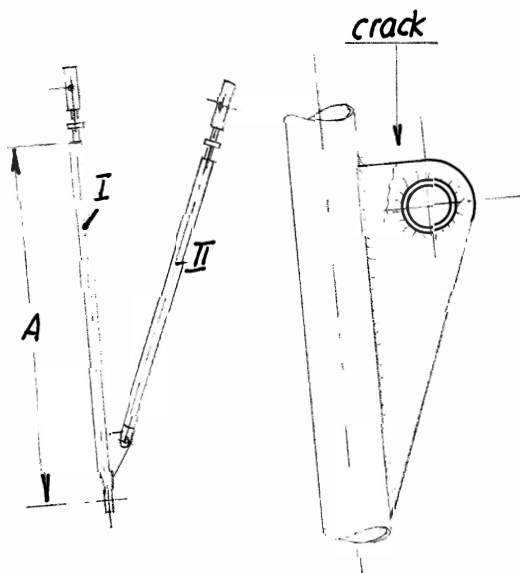
There have been found cracks on several pieces as shown in figure.

- 1.) The pushrod I) is to be build out and replaced by a modified one. Secure all screws and pins by split pins properly. The quick - connecting head is to be adjusted at the assembled glider and secured by the nut. Check proper closing of both airbrakes!
- 2.) The modified pushrod is to be ordered by the Firma of A. Schleicher or one of the License firms. The distance A) must be given exactly when ordering.
