Strengthening of the inner bearing of the airbrake bellcrank at the main bulkhead.

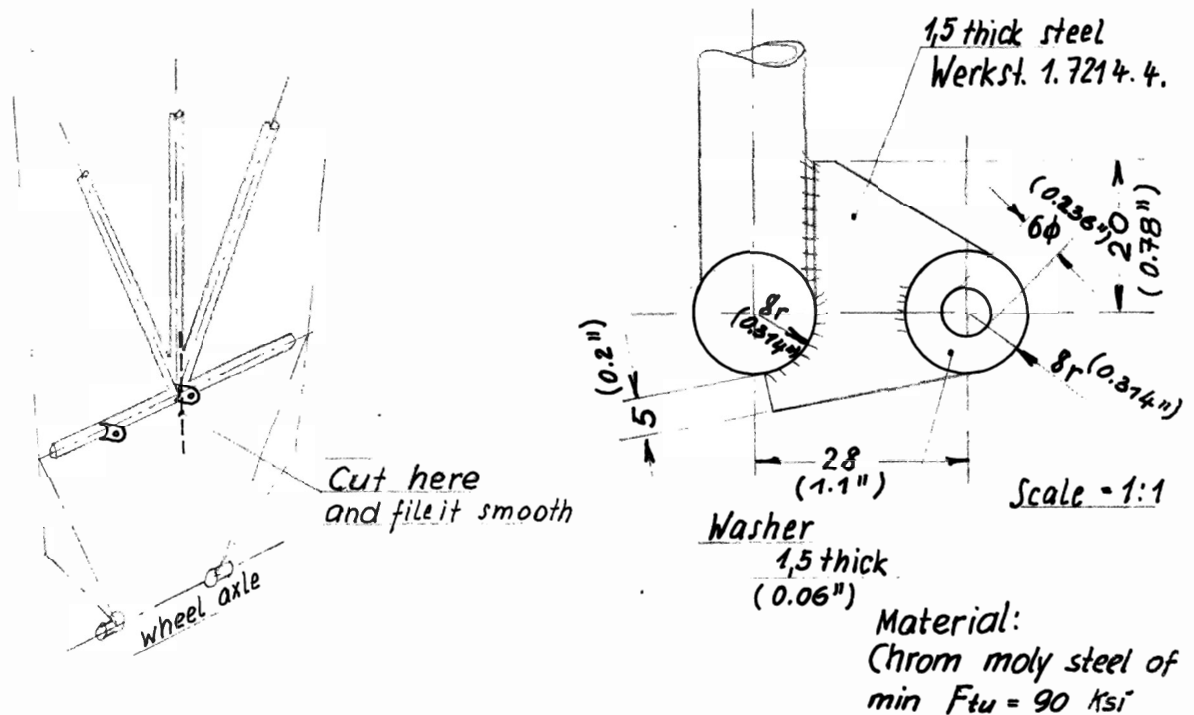
There have been found broken bearings.

- 1) Remove the bellcrank.
- 2) The middle bearing lap is to be cutted of by a saw (see scetch).
- 3) Weld on the new lap after the drawing.  
**Caution:** There must be a fire extinguisher present.  
The adjacent fabric is to be covered with wet cloth s.  
Remove fabric as far as necessary.
- 4) Paint the welded parts with new laquer.
- 5) Build in the bellcrank again and secure with split pins.
- 7) Repair the fabric.
- 8) The pushrods are to be adjusted at the <sup>adjusting</sup> heads. Make a function test of the airbrakes.

The welding must be done by a licenced welder.
