Subject: Installation of a pneumatic tailwheel in exchange for the tailskid.

Affected gliders: All K 8s.

ALEXANDER SCHLEICHER  
GmbH & Co.

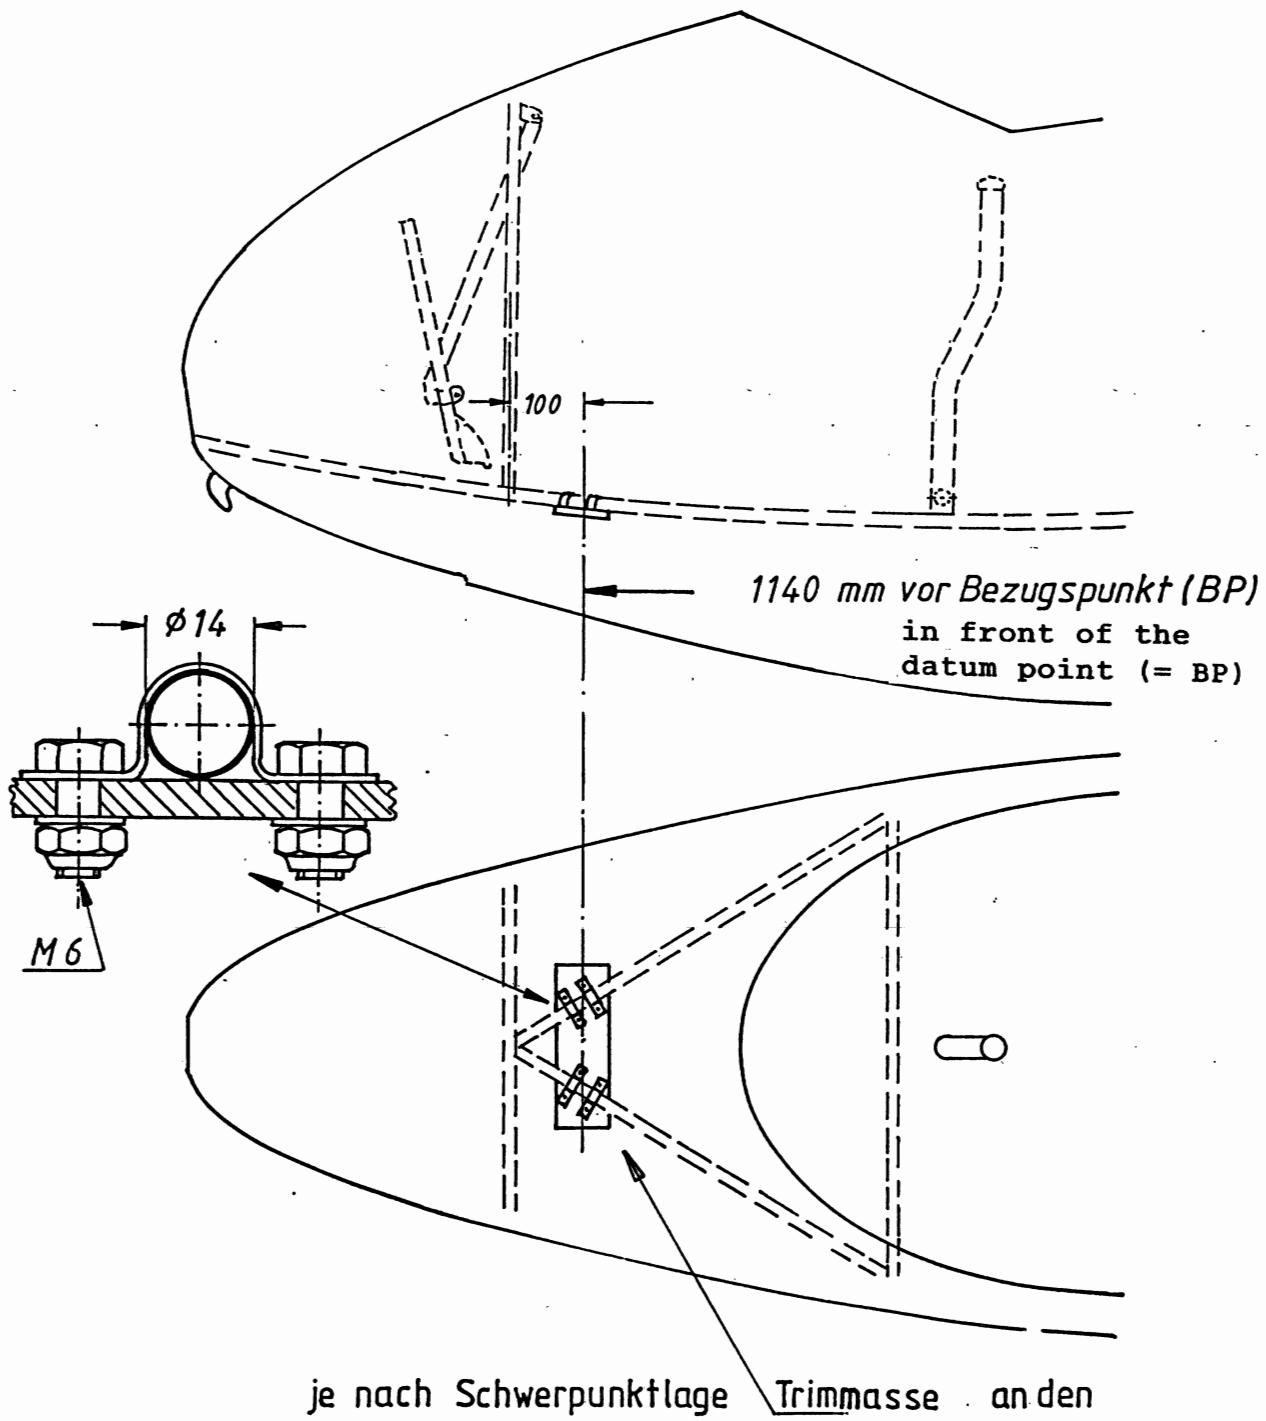
Fig. 1

According to the measured C.G. data the corresponding trim mass must be fixed at the bracings below the foot panel!

Action: According to drawing "Installation of pneumatic tailwheel" dated Feb.1, 1986, the fuselage is modified and the tailwheel installed. Depending on the new C.G. position a corresponding trim mass must be fixed in the fuselage nose below the front foot panel (see Fig.1).

Mass and C.G.: Owing to this modification the mass of the non-lift producing parts is increased by approx. 250 g and the C.G. is moved back by approx. 3 mm (0,12 in). Therefore, it is necessary to redetermine the mass and C.G. data. If the result of the C.G. weighing shows that the permissible C.G. range is exceeded, the short mass must be calculated and a corresponding trim weight must be fixed in the fuselage nose (see Fig.1).
