Subject:

K 8
Technical Note
No. 24

Alexander Schleicher
GmbH & Co.
Segelflugzeugbau
XXXXX
D-6416 Poppenhausen

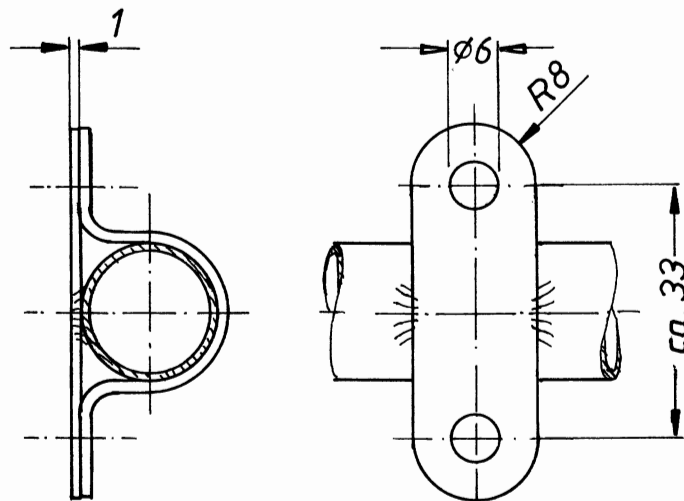
Fig. A2

ad A2) In case of extreme overloading the rudder pedals the attach collars of the pedal boards may bend. As a result also the full deflection of the rudder can become restricted.

- ad A2) Checking the rudder pedals:
With the rudder neutral the pedals left and right must be evenly adjusted. Check the pedal board angle versus the pedal (dimensions see drawing L-216.42-U01). The angle must meet the specified dimension.
Engage the pedal adjustment into its foremost position and check full deflection of the rudder.
Where pedals or attachment collars are bent, these can be either repaired or replaced by new ones.
In order to impede the bending of the pedal boards it is optionally recommended to weld an additional butt strap onto the attachment collar (see Fig.A2).

Reinforcing the attachment collars for pedal boards at the pedal assembly. Material: 1.7734.4

Welding procedure WIG to spec DIN 1912, welding wire material: 1.7734.2
