Reason: Installation of larger buffer plates for the rubber buffer of landing gear.

LTA Nr. 68/110

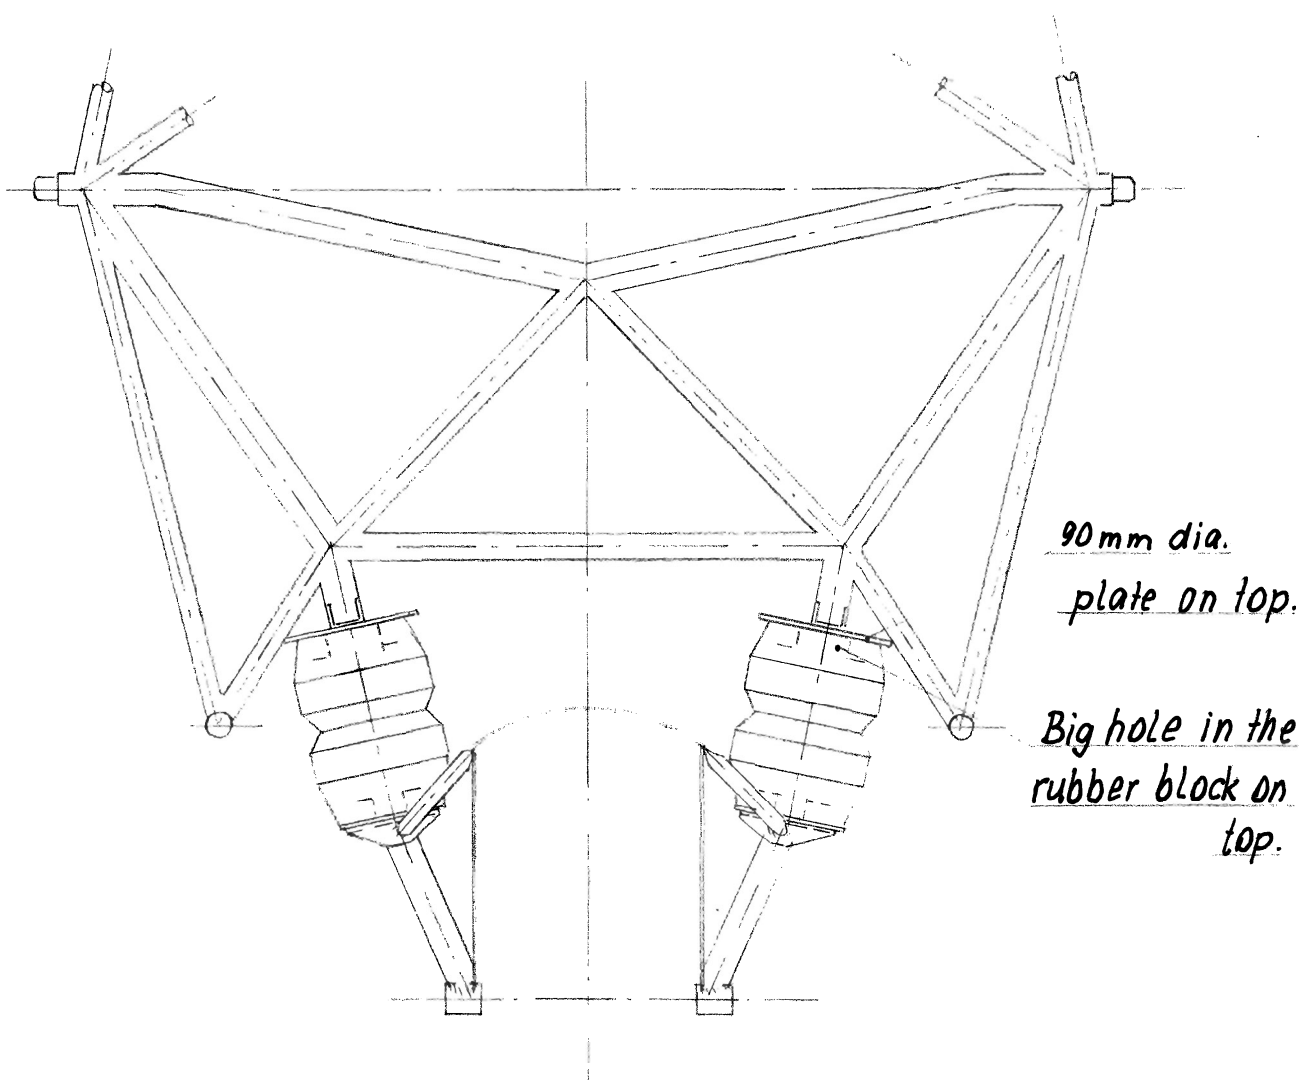
On one occasion the 70 mm dia. buffer plate slipped into the rubber buffer end with the big hole.

Description: Remove the rubber block and replace the buffer plate at the end with the large hole by a plate of 90 mm dia. This new plate is to be installed on top of the rubber block.
