Subject: Inspecting the bearing brackets and the toggle force of the airbrake control circuit.

Serial number applicability: Glider ASK 13, Data Sheet no.267.
A) Serial no.s 13000 thru 13689 including;
B) All serial no.s.

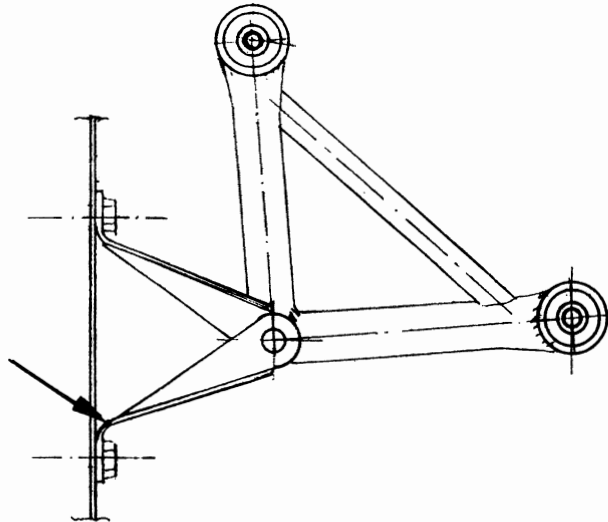
Material & drawings:

Reason: On some gliders of the model ASK 13 the bearing brackets of the airbrake control circuit have broken at the wing root rib. The failure was caused by too high toggle forces which resulted from a wrong adjustment of the toggle in the airbrake control circuit.

1. Carefully inspect the bearing brackets of the airbrake control circuit at the wing root ribs as well as the root ribs themselves for damage, cracks etc. In case of doubt the paint must be removed off the bracket. In most cases the breaks were found at the bottom of the front bearing bracket; refer to the drawing on Sheet 2 of this TN !
Where damages at one bearing bracket are found, this part must be exchanged; where a root rib is damaged, it requires repair.

2. Check the toggle force as described under Point 3.) and where necessary adjust.
3. Adjustment Instructions For Airbrake Toggle
 - 3.1 Undo the airbrake return spring at the front operating lever in the cockpit.

- 3.2 The airbrake toggle - each side separately - must be adjusted such that a force of approx. 3 to 4 daN is obtained at the front airbrake operating lever when measured from above (measurement distance from the pivot point of the operating lever towards the hand grip = 300 mm).

- 3.3 Adjustment of the toggle force is done by turning in or out the adjusting heads in the fuselage. If the correct adjustment values cannot be achieved here, the thickness of the airbrake stop blocks inside the wings must either be increased or cut back.

- 3.4 Take care that the toggle must not go over the dead point which would cause the airbrakes to extend again.
- 3.5 For both airbrakes together, the hand forces must not exceed approx. 6 daN, when measured at the front airbrake operating lever from above.
- 3.6 Re-fit the airbrake return spring at the front operating lever in the cockpit.
4. This Technical Note must be inserted as appendix into the ASK 13 Flight and Maintenance Manual and this action must be entered into the "Amendments" on page 2.
5. The inspection of the bearing brackets and of the toggle force of the airbrake control circuit (as described under points 1. thru 3.) must be included from now on within each annual C. of A. inspection.
