Subject: Tube spar of the elevator.

Effectivity: All gliders.

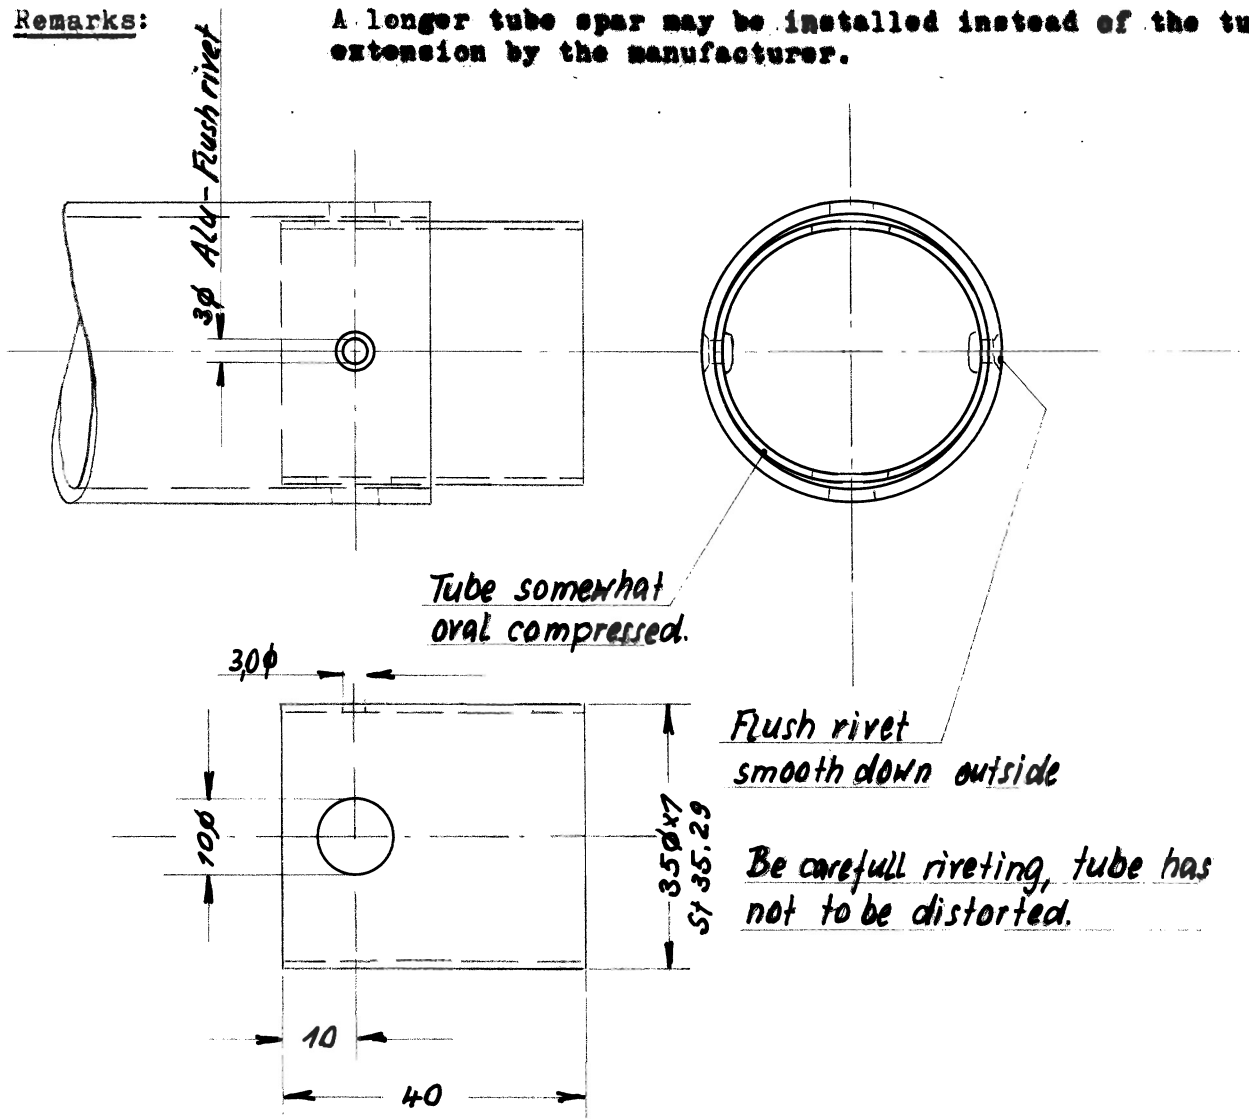
Reason: It is possible to insert erroneously the safety pin outside of the tube end, without the elevator showing remarkable gaps to the fuselage junction. The elevator is then not secured.

Instruction: A tube extension will be riveted in. See drawing.

Remarks: A longer tube spar may be installed instead of the tube extension by the manufacturer.
