Subject: Additional ventilation of the wing nose boxes through the wing root rib.

Effectivity: All ASW 15 from serial number 15001 to 15163 inclusive, except 15014, 15042, 15048, and 15162.

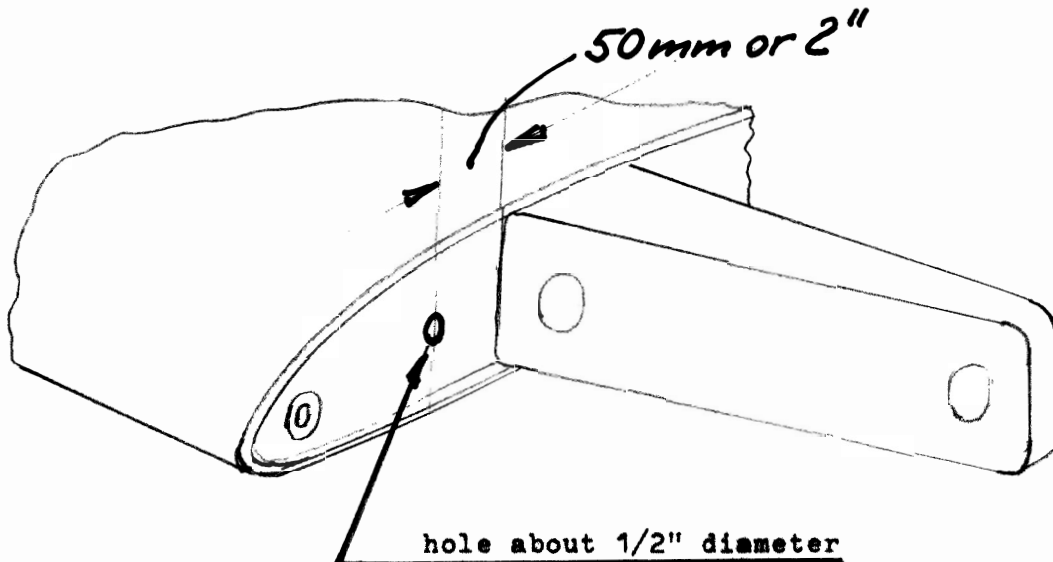
Reason: The ventilation of the wing nose boxes works through holes in the rear wing part. These ventilation holes in the aileron region of the wings are no more visible when the wing is assembled. For safety, a second possibility for the ventilation is bored through the forward wing root rib.

Instruction: Derigg the sailplane and bore the holes of about 1/2" diameter (10 to 15 mms). The rims of the holes must be coated with some paint afterwards.
