Subject: Inspection and stiffening of the rudder nose.

ASW 15

Technical Note

N° 10

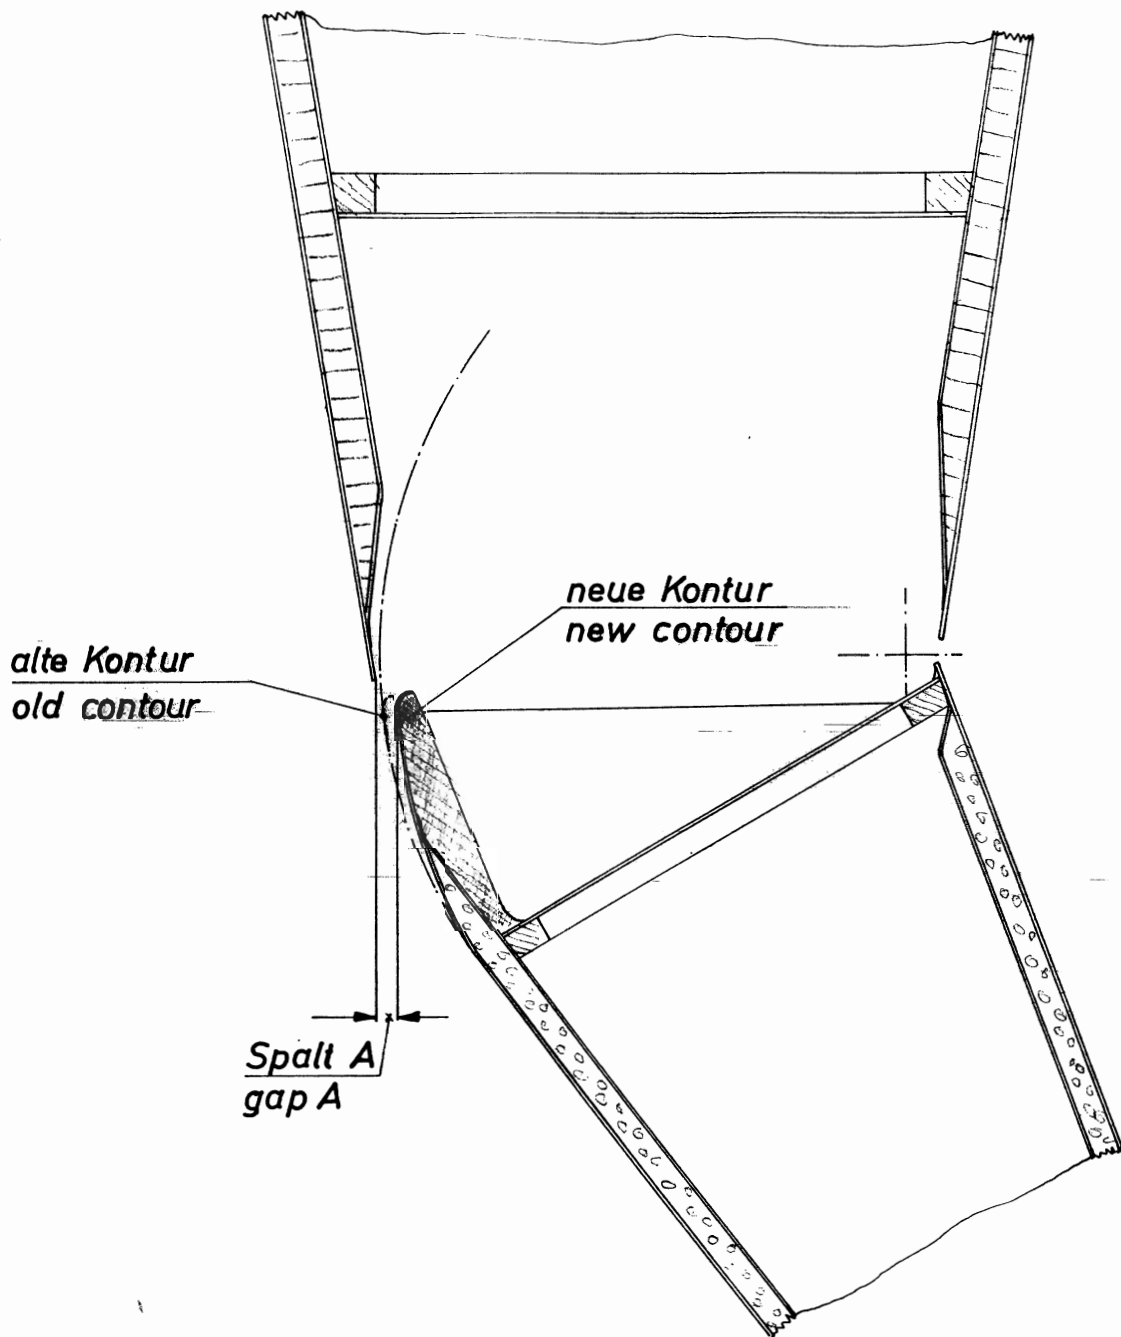
Skizze 1 (drawing N° 1)

The reason for the jamming was a deformation of the rudder nose between the reinforcing ribs per T.N. 3 because of great heat. The deformation was great enough to cause interference between the rudder nose and the shroud of the fin.

Instructions: 1. Inspect the gap between the fin and the rudder to determine if the gap is the size indicated on drawing No. 1.

Spalt "A" hat eine Breite von 2 - 3 mm am unteren Gelenk und verjüngt sich auf  $1 \div 2$  mm am oberen Ende des Seitenleitwerks.

Gap "A" is  $3/32$ " wide on the lower hinge and is tapered to  $1/16$ " width at the upper end of the vertical tail.
