1. Inspection of the elevator actuator bellcrank.
2. Amendment to the Operations Manual.

All ASW 15, ASW 15 B including existing modifications into motorgliders.

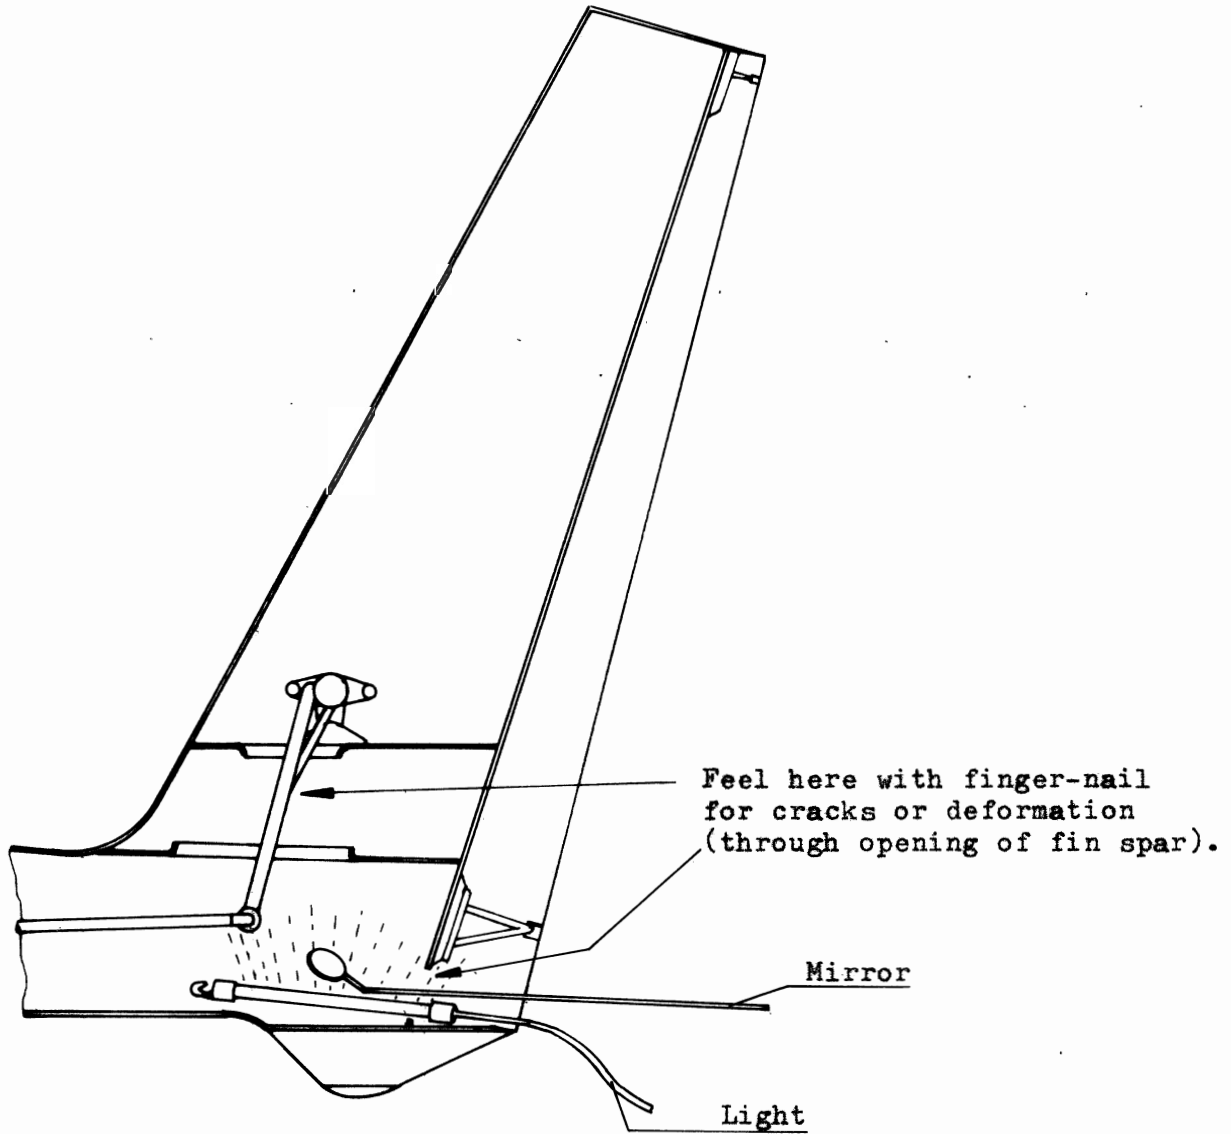
With an ASW 15 the bellcrank actuating the elevator failed in flight (see attached sketch). Luckily the pilot could save himself by parachute. An inspection of the bellcrank showed that an older crack most likely caused by a hard landing some years ago resulted in fatigue failure of the bellcrank.

1. The elevator actuator bellcrank must be inspected for cracks. To do so the rudder has to be disconnected from the fin, as the inspection is possible through a hole of the fin spar (see attached sketch). The inspection area is not directly visible. However, with the finger-nail a major crack can be felt. Smaller cracks may be found by using a mirror and a small light which is fixed to a small strip of wood or a piece of wire.  
If no cracks are found, the rudder can be rigged again to the fin and safetied.
2. If cracks are found, the bellcrank must be exchanged against a new one, i.e. a bellcrank according to drawing 151.35.1011 (showing the correction note "TM 21 dated 24-11-81"). For carrying out this job the Repair Instruction "A" for the ASW 15 is to be used.
3. A copy of the inspection report must be sent to the manufacturer.
